DEFERRED MAINTENANCE STUDY

Caryl School

Dover, Massachusetts

30 April 2003

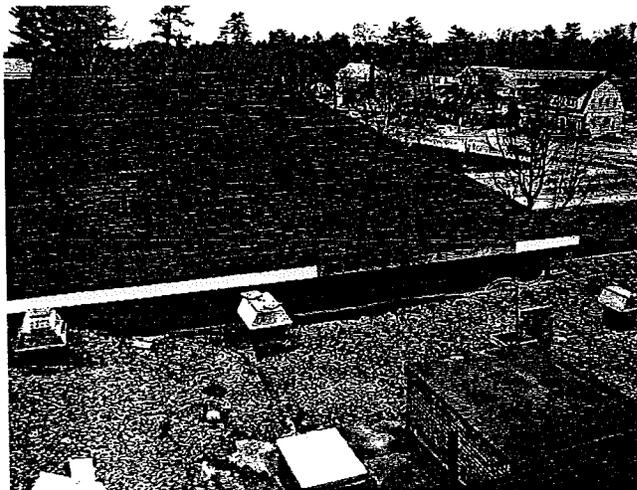
P1010365.JPG

The other two flat roofs at the 1971 link and upper portion of the main roof are ballasted membrane systems over previously installed built-up roofing. The link area is in very bad condition and has been riddled with leaks during recent years. In fact, the school removed damaged acoustical ceiling tiles and replaced them with eggcrates to allow water to drip through them and facilitate collection of the leaks into buckets. The perimeter flashings are also in poor condition. There are currently no active leaks due to temporary patching, but the roof should be replaced as soon as possible. The upper area of the main roof was not visible during the site tour. According to the 1999 roofing survey, the conditions are a little better than at the link roof. The upper roof membrane system does not appear to require immediate attention but should be replaced within the next few years.

1971 Link Roof in Foreground of 1910 South Roof Slope

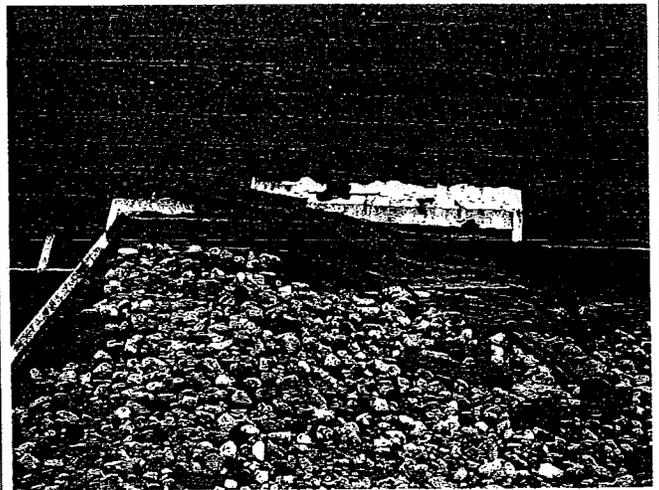
P1010360.JPG

Detail of 1971 Link Roof Intersection with 1910 South Slope

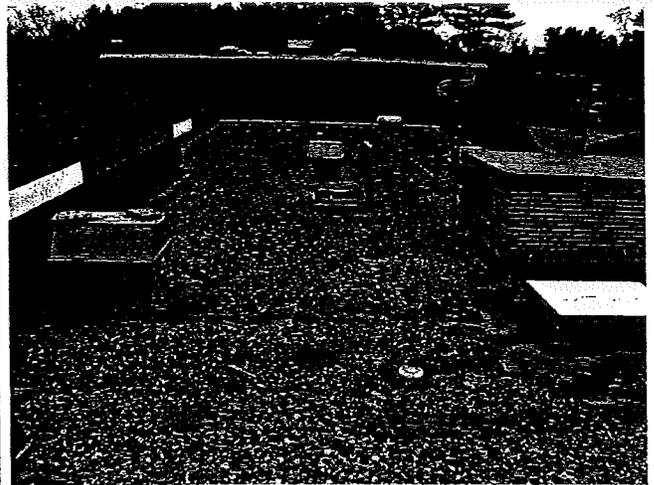
P1010359.JPG

*Looking East Across 1971 Link Roof;
Ballasted Membrane over Built-Up Tar & Gravel Roofing*

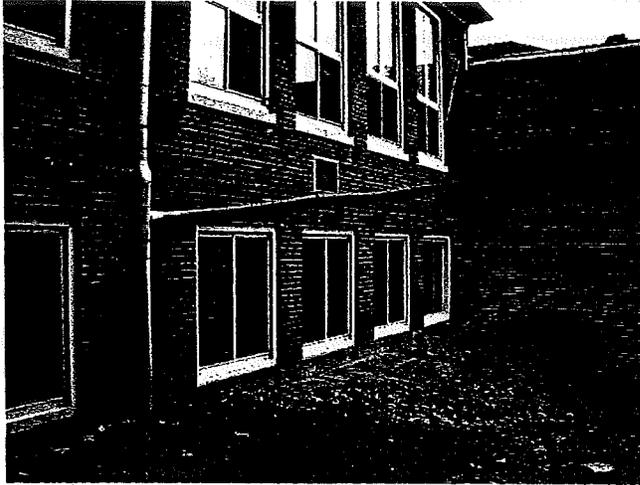
P1010340.JPG

The downspouts empty into cast iron rain leader boots that lead to underground drywells. The condition of the drywells is not known. At the east wall of the 1931 addition, one of the downspouts is not connected to its cast iron boot and the boot appears to be clogged. At the southwest corner of the 1931 addition, a newly installed corrugated aluminum downspout penetrates the driveway paving in an area that is highly vulnerable to damage from vehicular traffic. In fact, the bricks on this corner are nicked, indicating that this area has been damaged in the past. Presumably this repair was performed without extending the cast iron boot system above grade in order to provide a more durable rain leader system. Square copper downspouts at the southwest corner of the 1910 building are also exposed to damage and appear to have been crushed multiple times.

Downspout Array at East Elevation of 1931 Addition

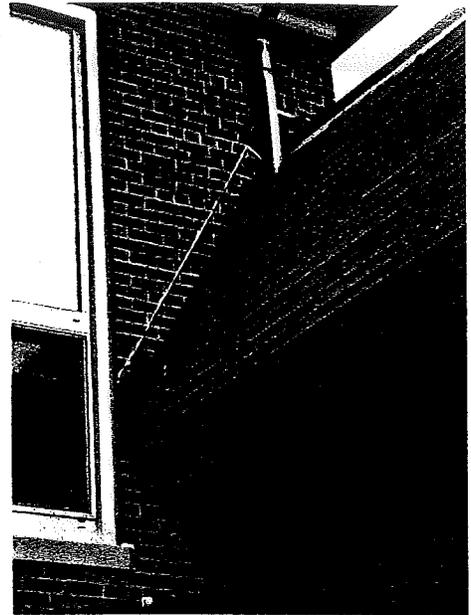
P1010335.JPG

Missing Counter Flashing at Intersection of 1971 Roof with East Wall of 1931 Addition

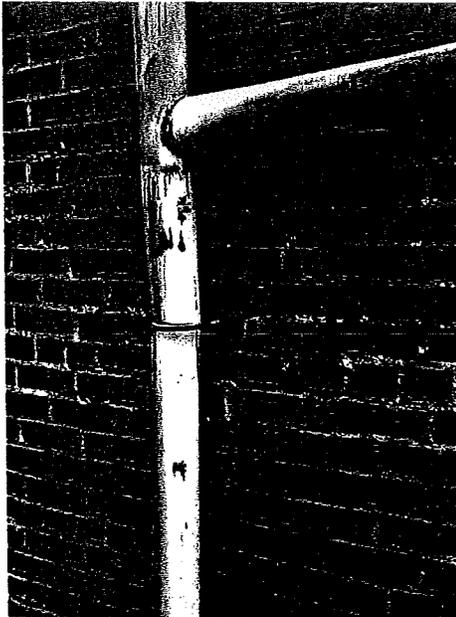
P1010337.JPG

Detail of Downspout Array at East Elevation of 1931 Addition; Note Loose & Missing Mortar from Water Damage

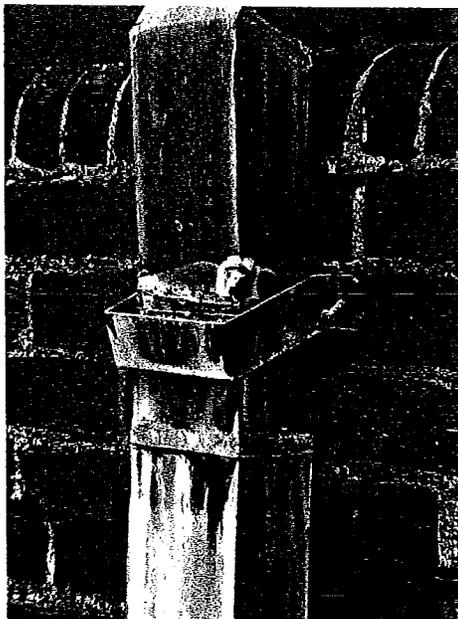
P1010318.JPG

Loose Copper Bracket at North Wall of 1910 Building

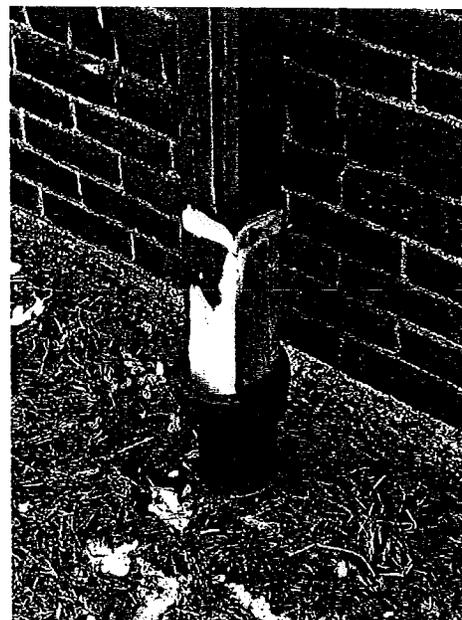
P1010315.JPG

*Square Copper Downspout Transitions Into
Rusted Galvanized Section Above Cast Iron Boot
at North Wall of 1910 Original Building*

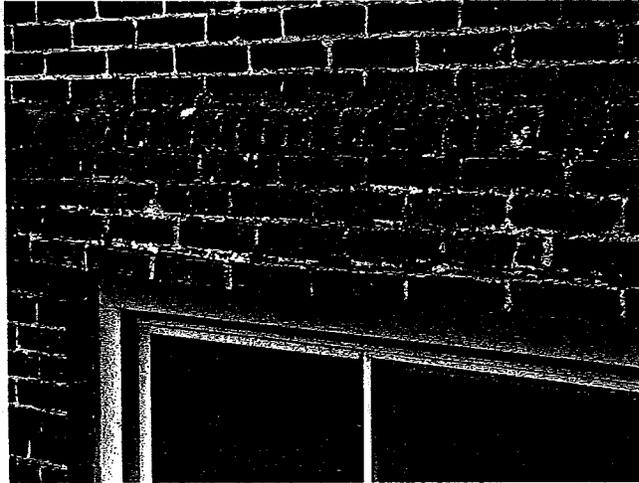
P1010314.JPG

Loose and Missing Mortar at Water Table Brick Coursing of 1910 Original Building Above First Floor Window Opening

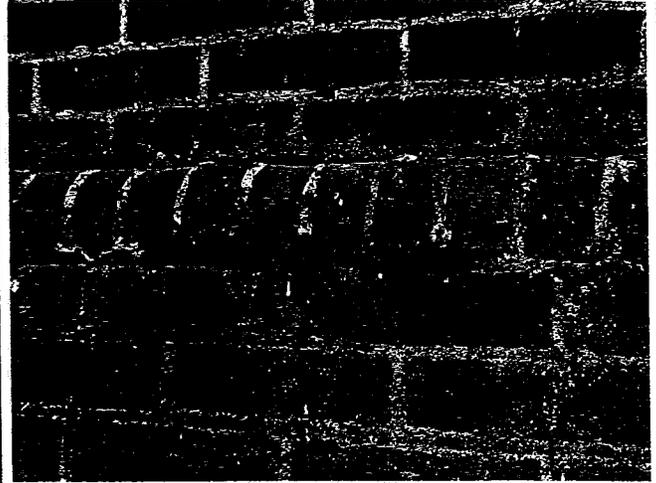
P1010319.JPG

Algae Growth at Water Table of 1910 Original Building

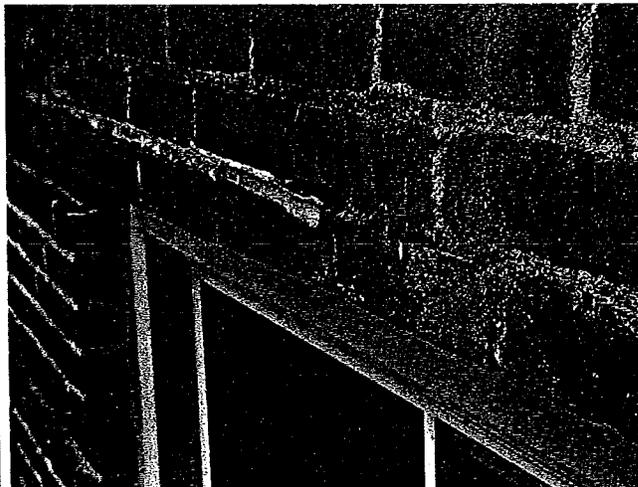
P1010353.JPG

Displaced Mortar at Water Table Brick Coursing of 1910 Original Building Above First Floor Window Opening

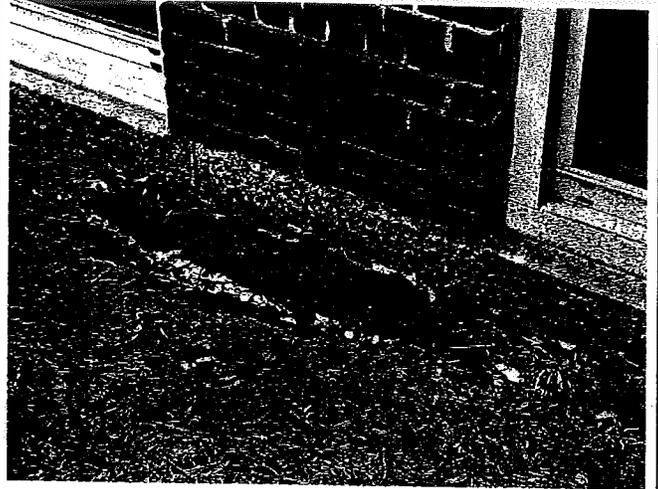
P1010352.JPG

Algae Growth at Depressed Area Adjacent to Foundation Wall of 1910 Building

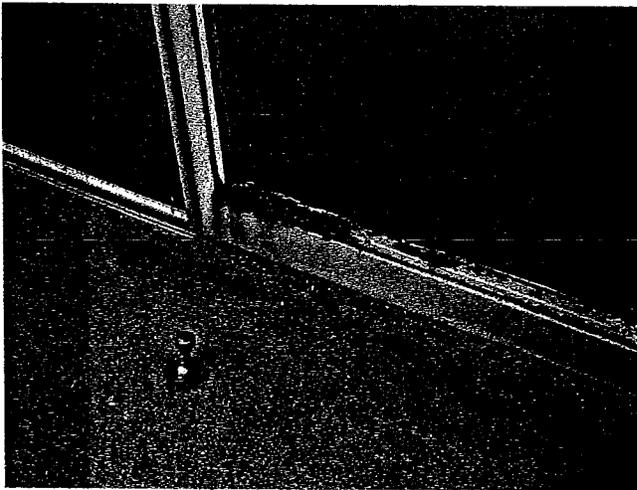
P1010330.JPG

The primary, central entrance to the facility is located in the 1971 link at the north façade. This entrance has a pair of aluminum doors and is at grade, thereby providing an entrance that is handicap accessible. The original entrance to the facility, positioned in the center of the 1910 building, was removed in 1971. There are a variety of other entrances and exits in various locations around the perimeter of the facility. A central canopied exit at the east side of the 1971 addition provides direct egress from a central stairway. This door has some significant rust in the bottom member of sidelight framing and related rust in the canopy framing. This rust appears to have resulted from a flashing failure at the canopy.

*Rusted Sidelight Frame at East Exit of 1971 Addition;
See Rusted Roof Canopy Steel Above on Page A-10*

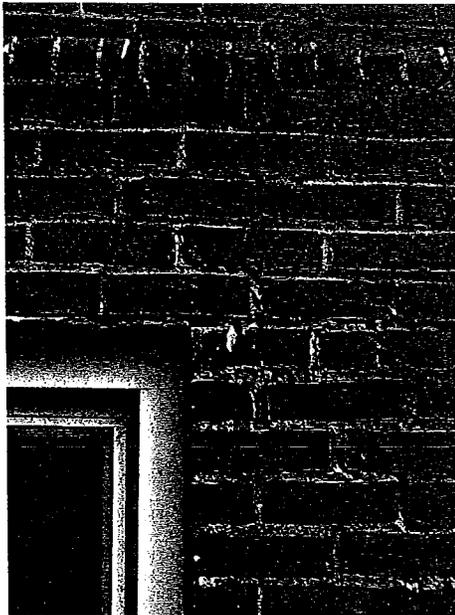
P1010389.JPG

*Missing Mortar at Water Table Brick Coursing of 1931 Addition;
Rusted Lintel Over First Floor Window Opening*

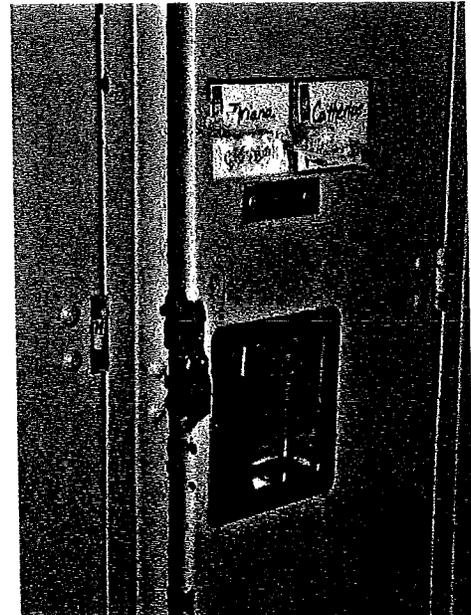
P1010091.JPG

Damaged Lock Area of Corridor Lockers

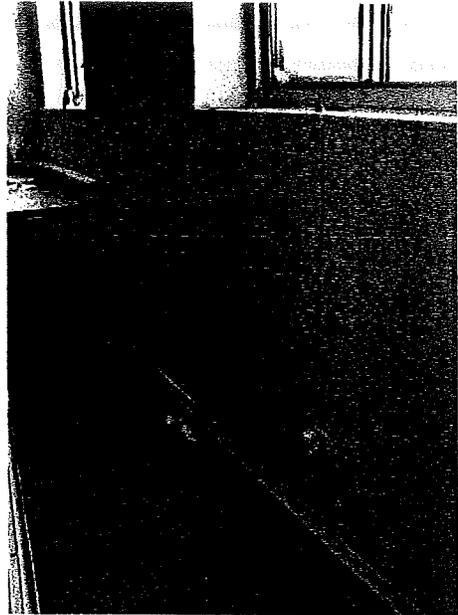
P1010101.JPG

Crack in First Floor East Wall of Art Room in 1931 Addition

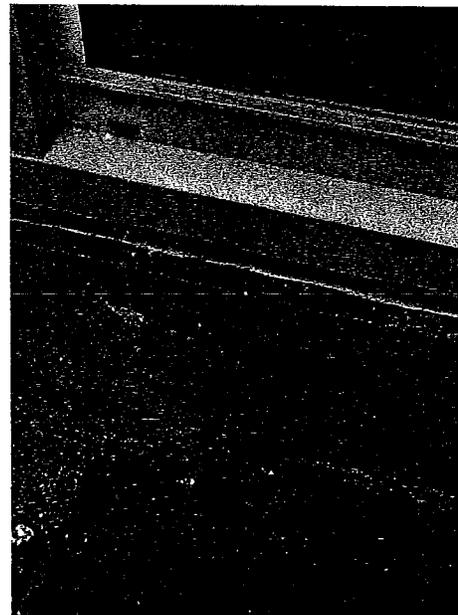
P1010336.JPG

*Exterior of Crack in East Concrete Foundation Wall
of 1931 Addition; Aluminum Replacement Window*

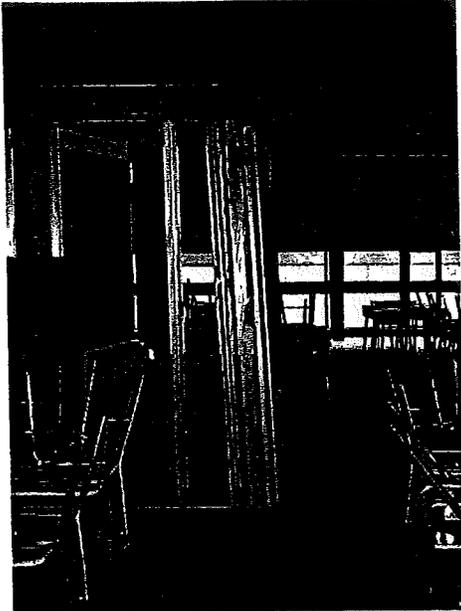
P1010380.JPG

Some operable partitions or "folding walls" are located in various classrooms in order to provide some flexibility in the subdivision of space. It was noted, however, that some of these "flexible" walls have been stationary for some time since rigidly installed conduit has been placed at the floor alongside the base of the walls for the provision of electrical outlets. The condition of the folding walls is poor as evidenced by peeling finishes and damaged end

plates. Some of the walls are leaning and do not appear to be easily movable. All of the walls incorporate sliding tracks at the top and bottom, the latter of which creates a tripping hazard at the floor level when the walls are open or wherever passage doors are located.

Deteriorated & Leaning Folding Partition at Second Floor of 1971 Addition

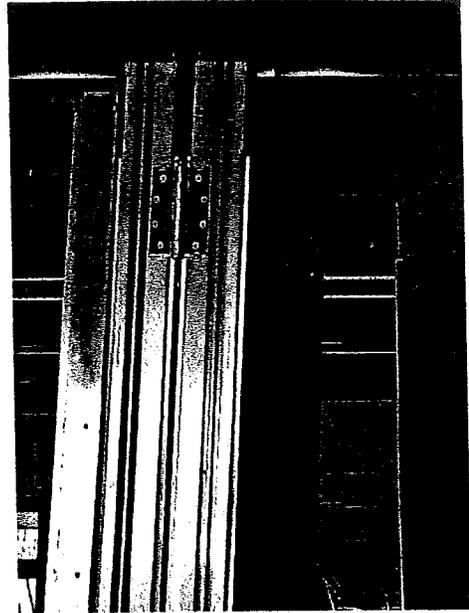
P1010138.JPG

Deteriorated & Leaning Folding Partition at Second Floor of 1971 Addition

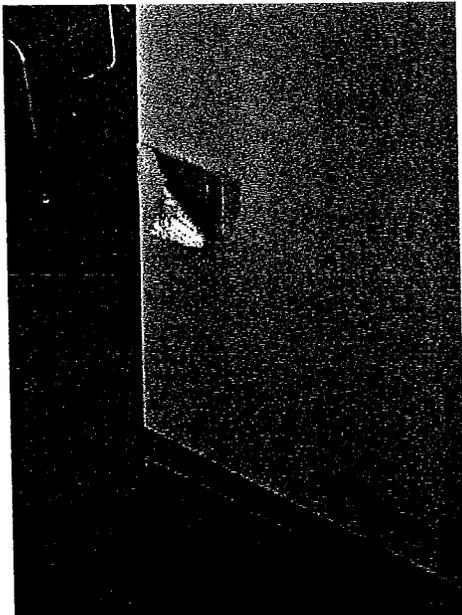
P1010137.JPG

Damaged Surface of Folding Partition in 1971 Addition

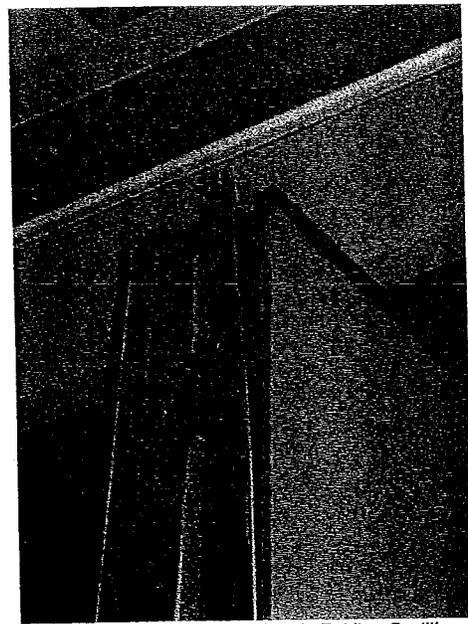
P1010079.JPG

Damaged Panel Closure Plate in Folding Partition of Classroom in 1931 Addition

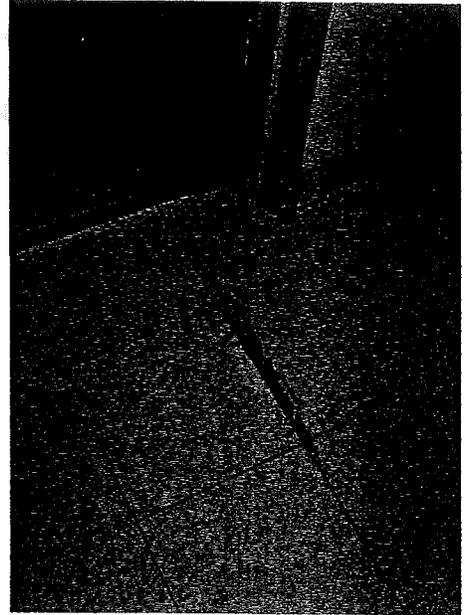
P1010122.JPG

*Detail of Damaged Joint in Vinyl Composition Tile
at Hump in Corridor Floor Level*

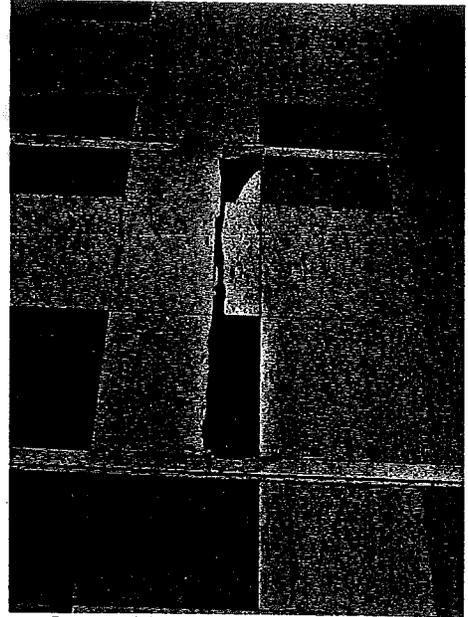
P1010384.JPG

*Damaged Area of Vinyl Composition Tile
in Corridor Cover Plate*

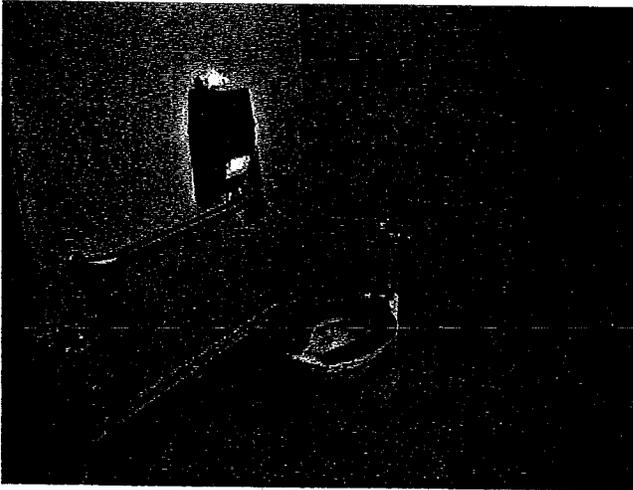
P1010109.JPG

*"Accessible" Toilet Stall in Girl's Toilet Room of 1931 Addition;
Only One Grab Bar in Stall*

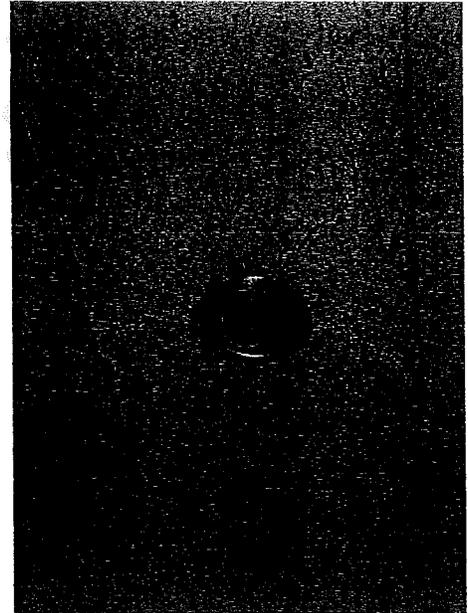
P1010131.JPG

Cracked 12" x 12" Concealed Spline Ceiling Tile

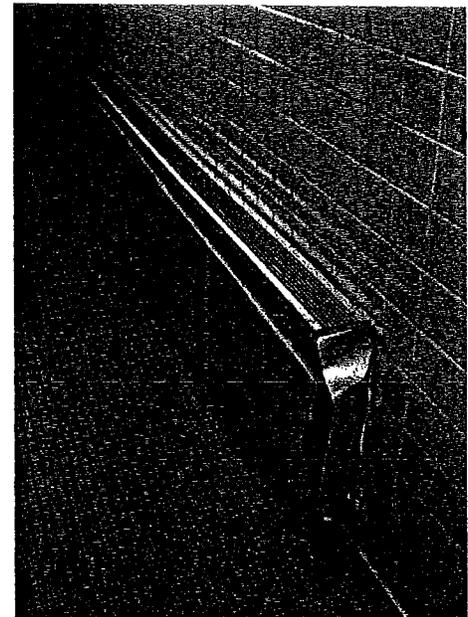
P1010121.JPG

Damaged Radiator Cover in Toilet Room
