**DOVER CARYL COMMUNITY CENTER
ACCESSIBILITY STUDY**

4 Springdale Avenue
Dover MA

Mills Whitaker Architects LLC
30 June 2016

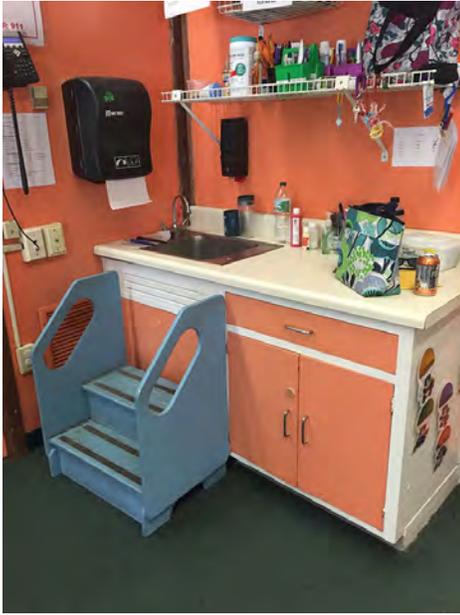
160609-IMG_4827.jpg

Typical Sink and Counter Area in Pre-School Classroom Not Accessible (Knee Space; Counter Ht; Sink Depth)

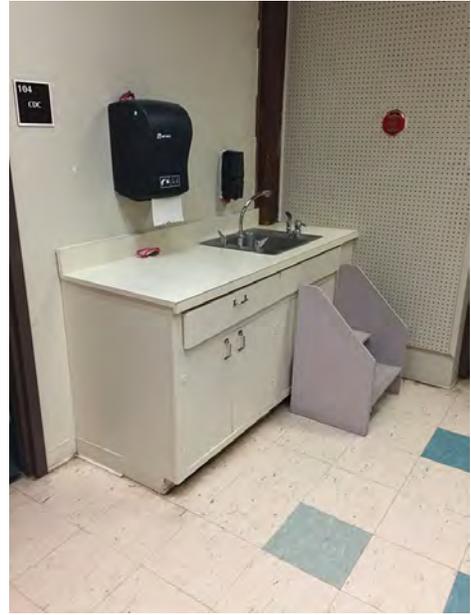
160609-IMG_4855.jpg

Sink and Counter in Pre-School Hallway Not Accessible (Knee Space and Sink Depth)

1. *Remove the non-accessible sinks/counters in the CDC corridor areas in two locations. These should not be located in the path of egress per the building code and are redundant given that each CDC classroom also has a sink and counter.*
2. *In the other S1 locations, replace the existing sink, counter and base cabinet with accessible versions of the same (34" counter maximum height, clear knee space with correct piping array).*
3. *Sinks in the S2 locations can remain as-is unless they are renovated into public use spaces.*

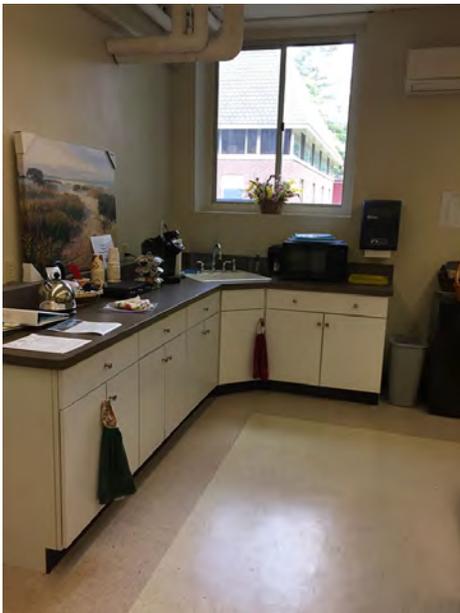
160609-IMG_4858.jpg

No Knee Space and Insufficient Clearance Width at Council on Aging Lavatory in Counter Area

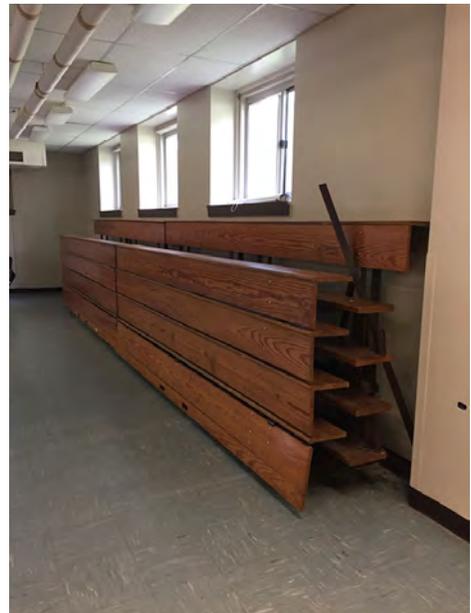
160609-IMG_4848.jpg

Bleachers in Dining Room - No Rails & Guards

- 1. Provide vertical access to the Gymnasium as explained elsewhere in this narrative.*
- 2. Provide an accessible route to and within the surrounding of the exterior playground.*
- 3. Note that the existing bleachers in the Dining Room do not conform to accessibility regulations, and the drawings indicate that these should be removed rather than be replaced.*

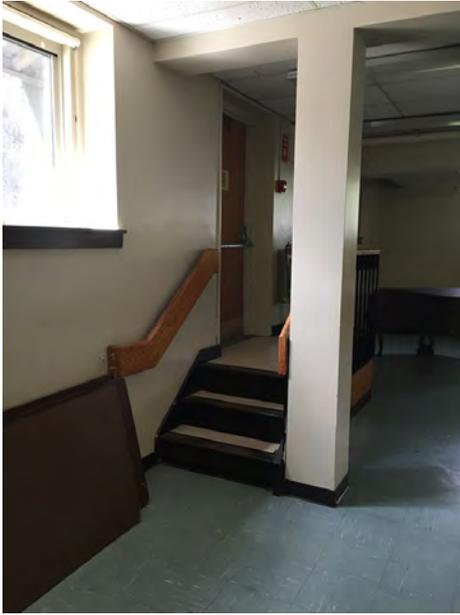
160609-IMG_4845.jpg

Inaccessible Second Exit from Dining Area Leads to Deteriorated Exterior Areaway

- e. *Dining Room Exit: delete this exit and create safe second means of egress via adjacent Blue Room as recommended in a separate study issued on 10/22/2015 and 2/26/2016.*

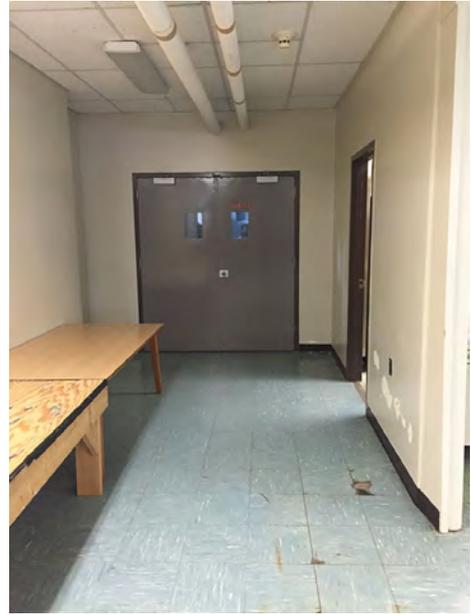
160609-IMG_4846.jpg

Locked Doorway to Blue Room Could Serve as Accessible Second Exit from Dining Room if Modified to be Double Egress Opening

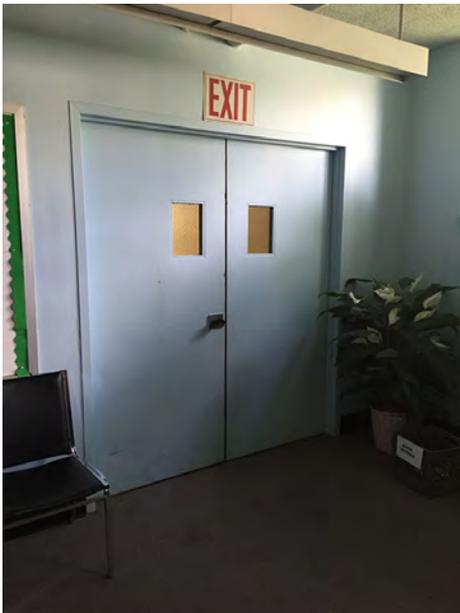
160609-IMG_4853.jpg

Exit from Blue Room to Dining Does Not Allow Exit from Dining Room into Blue Room

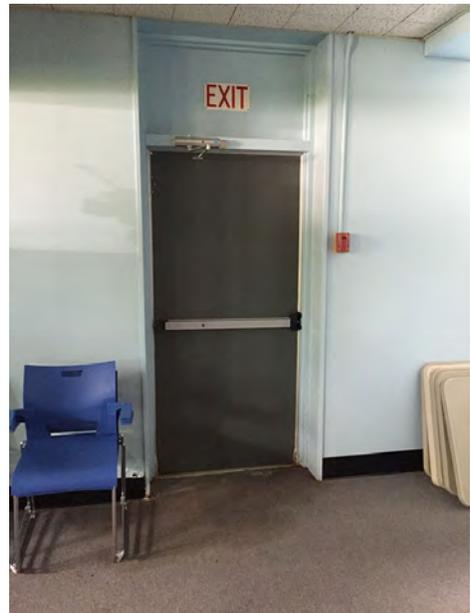
160609-IMG_4854.jpg

Exit from Blue Room Direct to Exterior; Non-Illuminated Exit Sign; Steeply Sloping Walkway Beyond

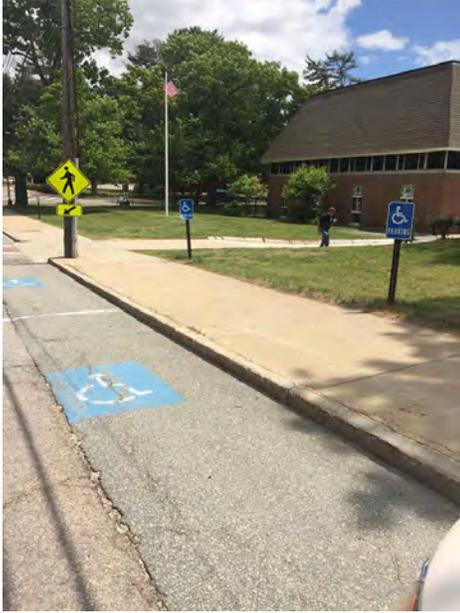
160609-IMG_4822.jpg

*Two Street Parking Spaces Marked Accessible
But Not Compliant with Regulations*

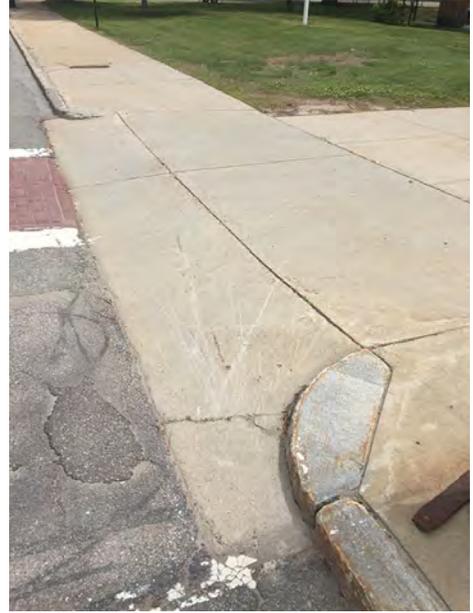
160609-IMG_4823.jpg

*Curb Cut at Street to Front Walkway
Serving as Driveway to Accessible Parking
Spaces at Front Entrance*

1. *Delete the two accessible spaces at the front walkway and entrance area (hazardous, awkward).*
2. *Provide two van-accessible spaces at the rear entrance area in the currently unmarked space adjacent to the back entrance (see recommendations for accessible entrance at back). Provide a shared access aisle (8' wide) with cars parked between the back entrance and back play area.*
3. *Provide one or two additional accessible spaces in the parking area near the back entrance.*
4. *Existing "accessible" parallel spaces at the street are not relevant for building compliance.*

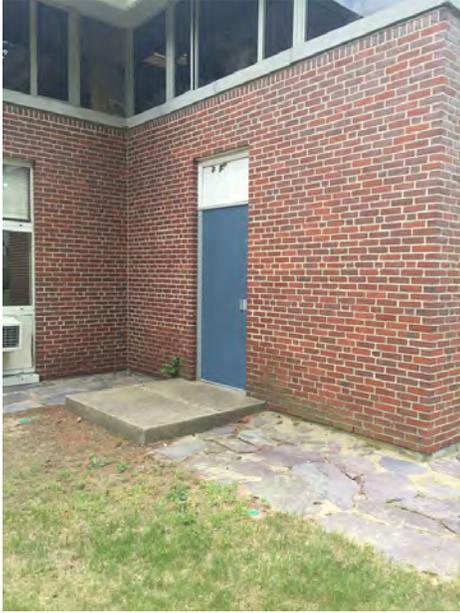
160609-IMG_4816.jpg

Redundant Exit from S.W. Corner CDC Classroom

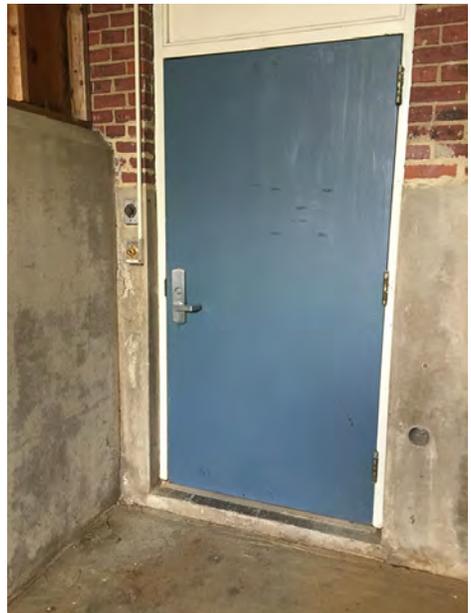
160609-IMG_4806.jpg

Door at Side Entrance Not Accessible Due to Limited Pull Side Clearance and Step Up at Door

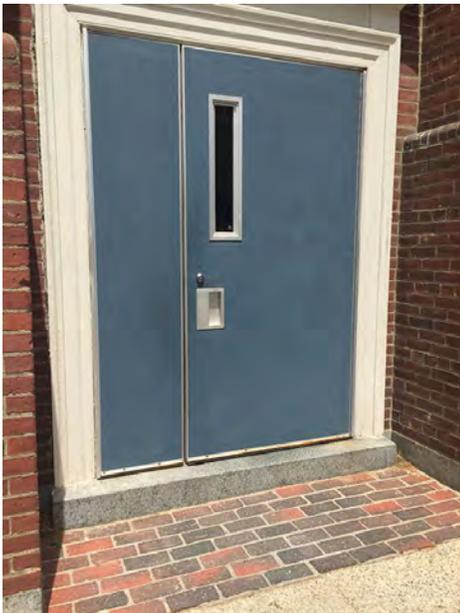
160609-IMG_4815.jpg

Step Up at Back Entrance Door

1. *Make the back entrance accessible by providing an exterior ramp to a raised landing platform and eliminate the step up at the threshold. Refer to recommendations for Stairs (521 CMR 27) and Elevators (521 CMR 28) for interior modifications to provide access from the back entry interior landing to the gym, first and second floor levels.*

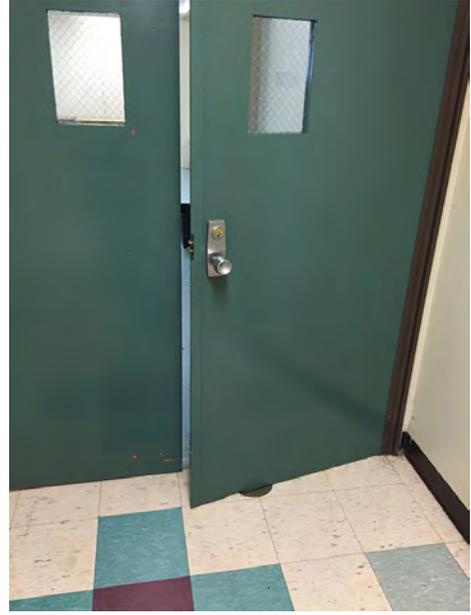
160609-IMG_4850.jpg

Typical Paired Opening with Knob Set at Active Leaf & No Pull at Passive Leaf

1. *Upgrade hardware for 70 existing doors at accessible routes from knob sets to latch sets.*
2. *Improve maneuverability clearances at 9 openings as noted in the drawings (Legend Item 2).*

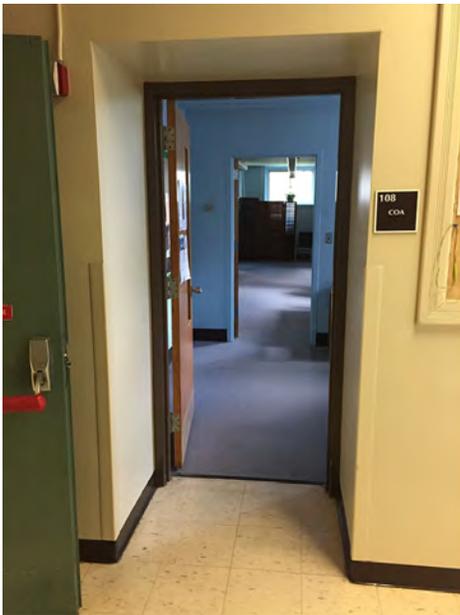
160609-IMG_4857.jpg

Deep Recess in Masonry Wall at Doorway into COA's Blue Room on First Floor

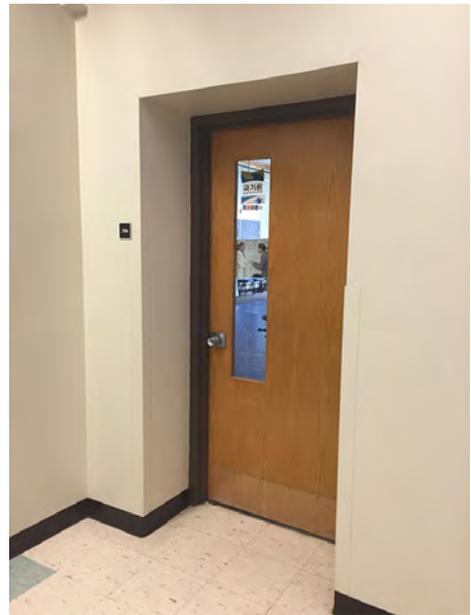
160609-IMG_4799.jpg

Deep Recess in Masonry Wall at Doorway into Classroom at Second Floor (above Blue Room)

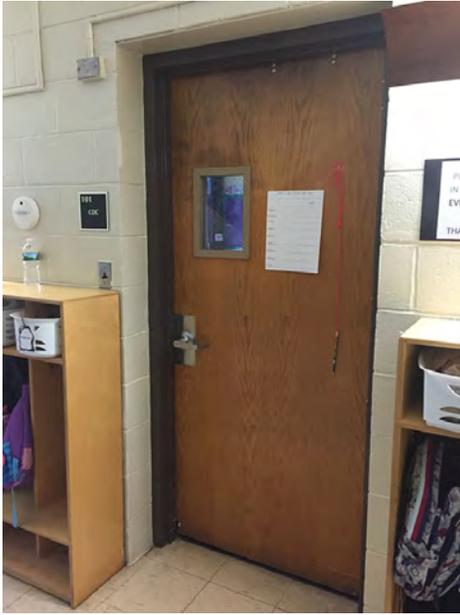
160609-IMG_4828.jpg

Lever Handle on Door with Furniture Obstruction on Push Side of Door & Set > 6" from Wall Plane

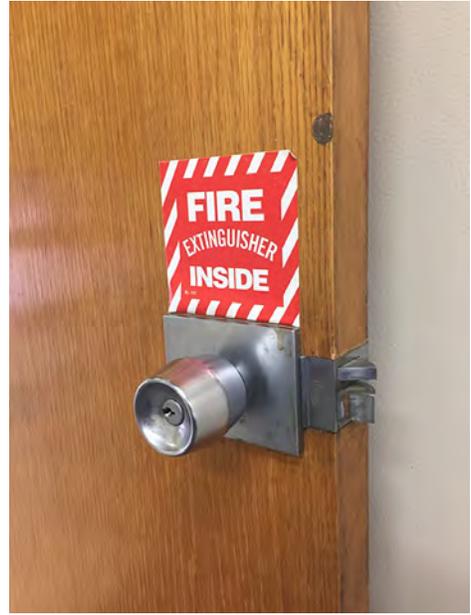
160609-IMG_4797.jpg

Typical Knob Set Hardware

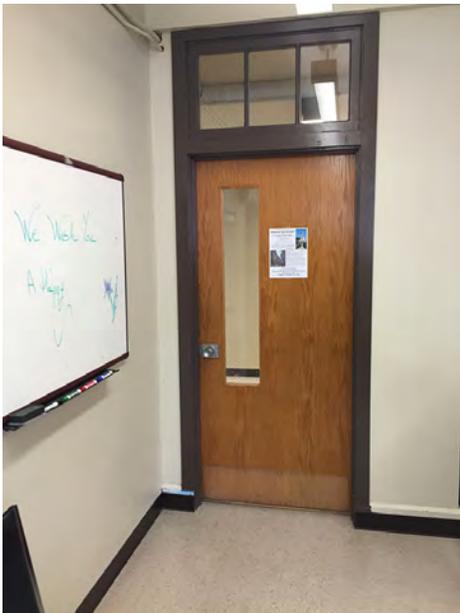
160609-IMG_4859.jpg

Limited Push Side Clearance at Door to Hallway

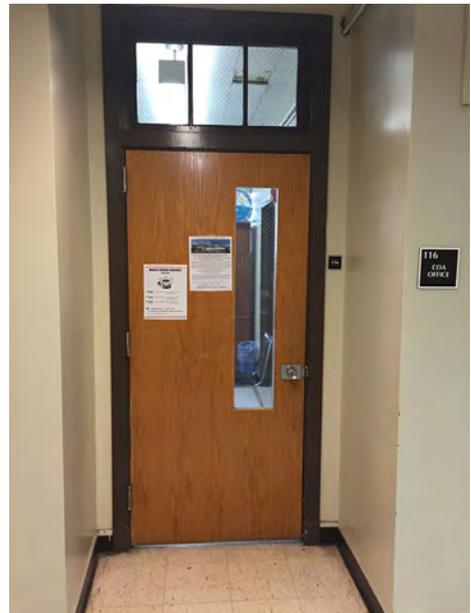
160609-IMG_4861.jpg

Limited Pull Side Clearance at Door into Activity Area

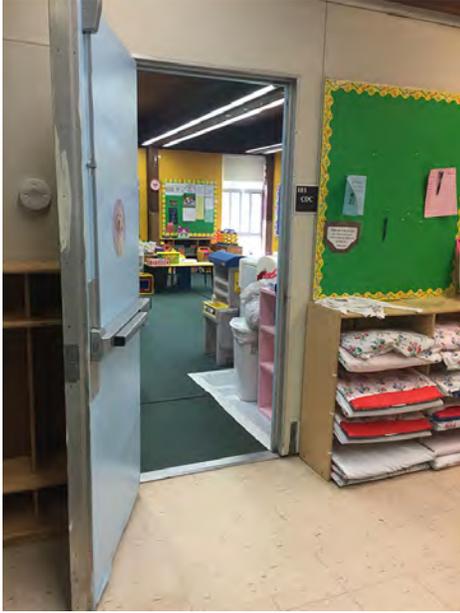
160609-IMG_4825.jpg

Furniture Obstruction Within 18" of Pull Side at Door

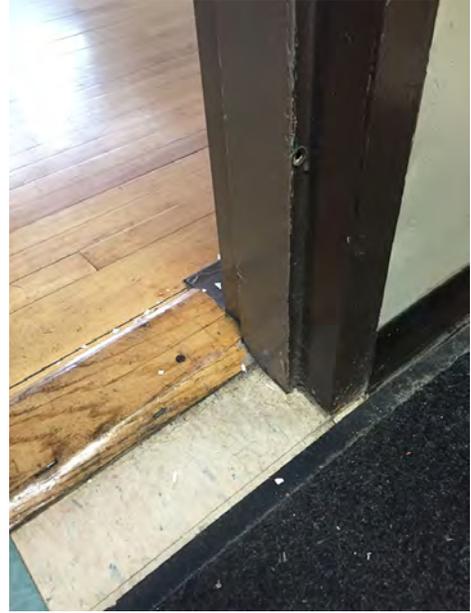
160609-IMG_4867.jpg

Raised Threshold into Gym from Back Stairway

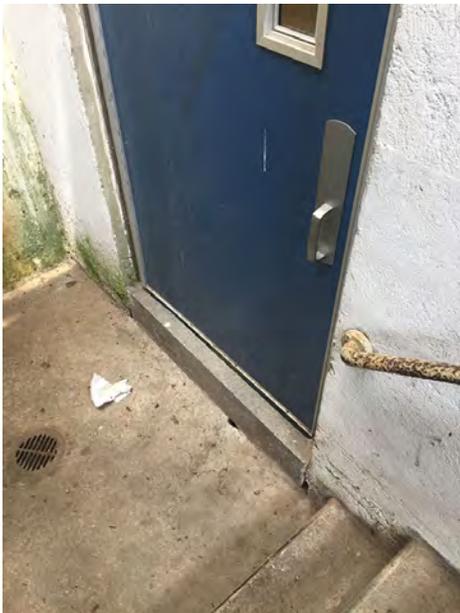
160609-IMG_4812.jpg

Step at Areaway Exit from Gym

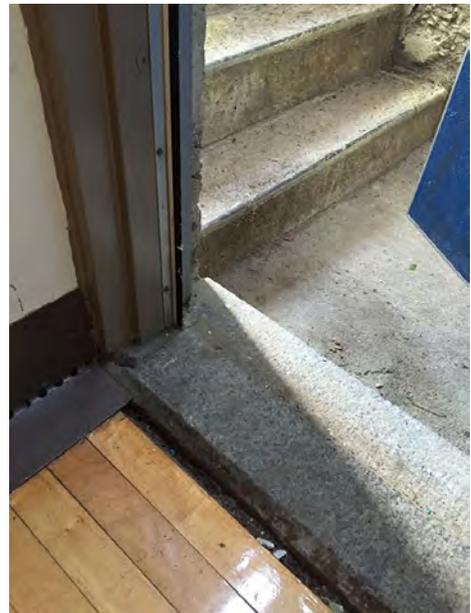
160609-IMG_4868.jpg

Threshold Gap and Step Down at Gym Exit

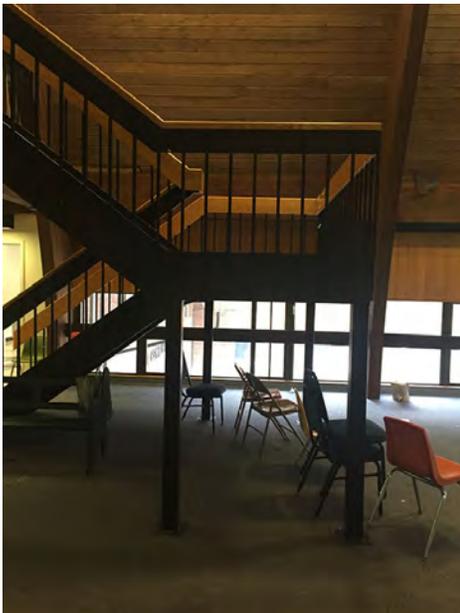
160609-IMG_4834.jpg

*Landing at Library Mezzanine Stairway
Requires Headroom Protection (Cane Guard)*

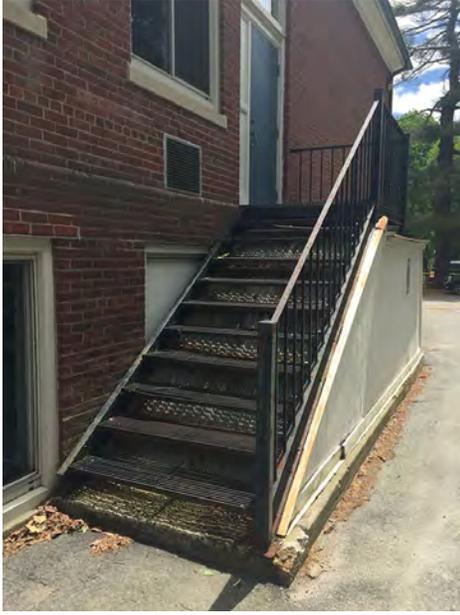
160609-IMG_4808.jpg

*Unnecessary Exit Stair from Erin's Dance Studio
Above Needed Gym Stairway Below*

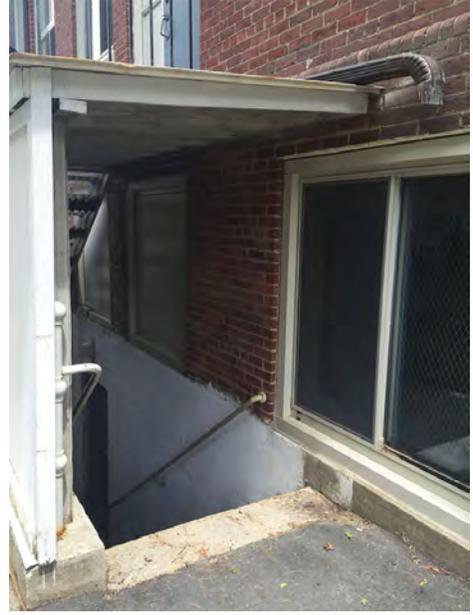
160609-IMG_4809.jpg

Gym Stair with Incomplete Railing Extensions

- 5. Replace handrails at exterior gym exit stairs for compliance. Refer to Doors (521 CMR 26) for additional comments regarding accessibility issues at the gym exit.*

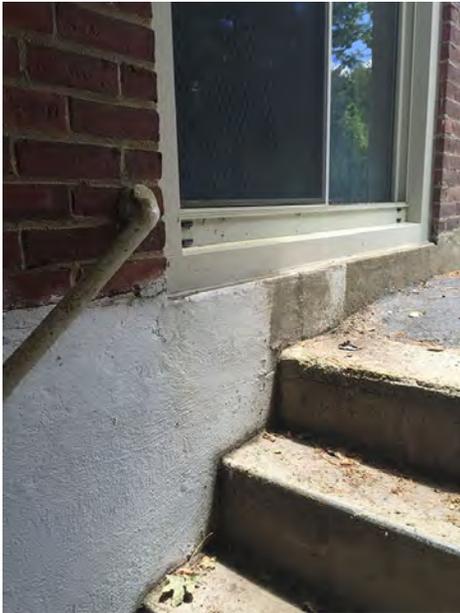
160609-IMG_4810.jpg

Incomplete Railing Extension at Gym Exit Areaway

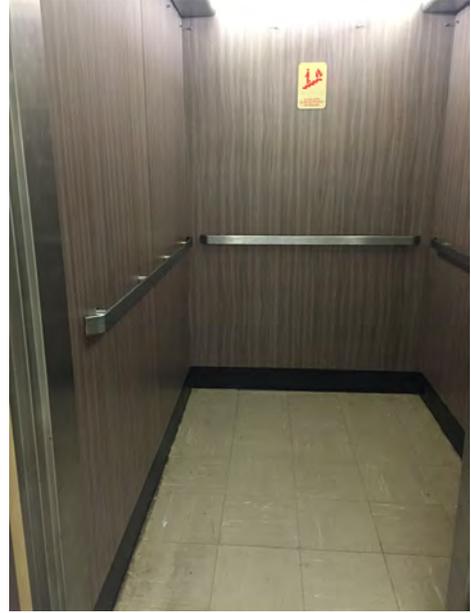
160609-IMG_4801.jpg

Handrails in Passenger Elevator Cab Mounted 4" Higher Than Currently Mandated

1. *Upgrade deficiencies of the existing passenger elevator to bring into full compliance:*
 - a. *Provide hall and in-cab lanterns with visual and audible signals.*

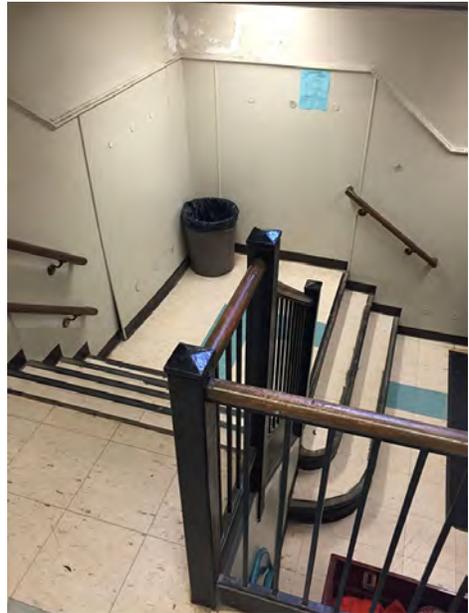
160609-IMG_4864.jpg

*Rebuild Lower Run of Back Stair to
Provide Access to Gym via LU/LA*

2. *Provide a limited use/limited application elevator (LU/LA) in the back stairway area to serve the four floor levels of the stairway. This will add access to the gym level and provide a second public accessible entrance as noted in the narrative for Entrances (521 CMR 25). Installation of a LU/LA, which will require a variance, is much less expensive than the cost of a full passenger elevator.*

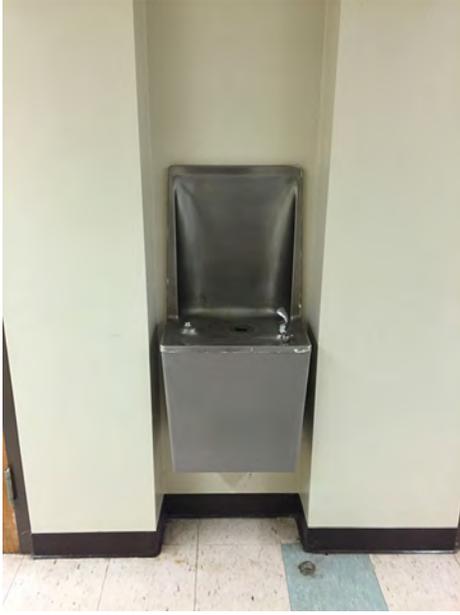
160609-IMG_4863.jpg

Inaccessible Drinking Fountain in Hallway

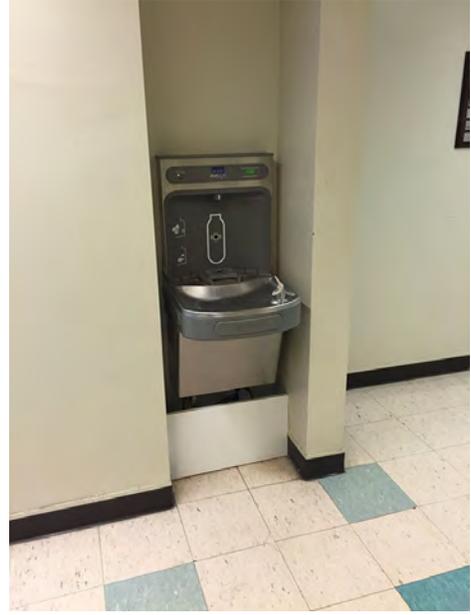
160609-IMG_4862.jpg

Accessible Drinking Fountain, but in an Inaccessible Recess in Wall (<30" Wide)
