June 16, 2017

RE: Dover Caryl Community Center
Study for Required Improvements

**DOVER CARYL COMMUNITY CENTER
STUDY for REQUIRED IMPROVEMENTS**

4 Springdale Avenue
Dover MA

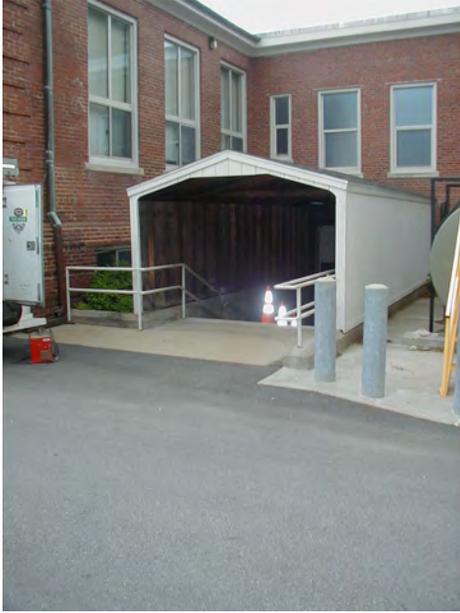
170511-P1010061.JPG

*West Side Covered Areaway Entrance;
Water Infiltration at Foundation Wall of Link*

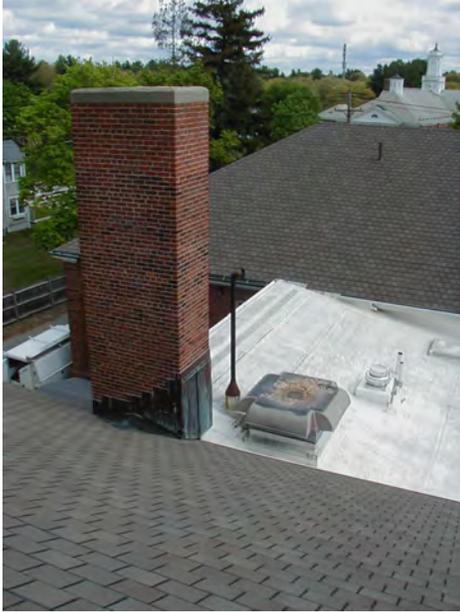
170511-P1010011.JPG

*Boiler Chimney Repaired in 2009;
All Roofing Replaced in 2008*

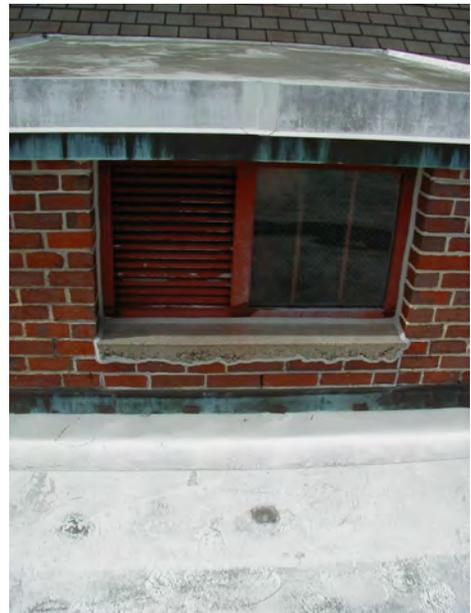
170511-P1010005.JPG

*Replace Glass & Louver for Elevator Venting with
Louver and Motorized Damper for Energy Efficiency;
Upgrade as Mech/Elect/Fire Alarm Improvements*

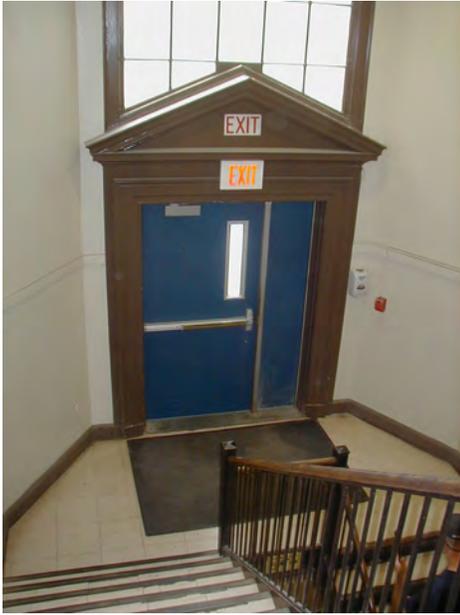
170511-P1010021.JPG

*Back Entrance to Stair Landing of 1931 Addition;
4-Stop LU/LA to be Installed to Left of Stair*

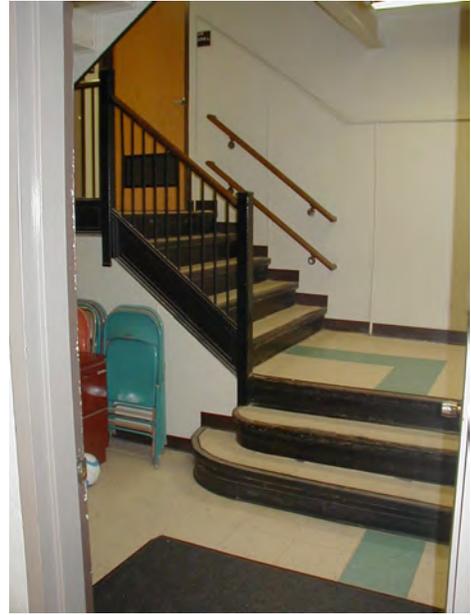
170511-P1010052.JPG

*Bottom Landing of 1931 Stair at Gym Level;
Lower Run to be Rebuilt for Access to LU/LA Beyond*

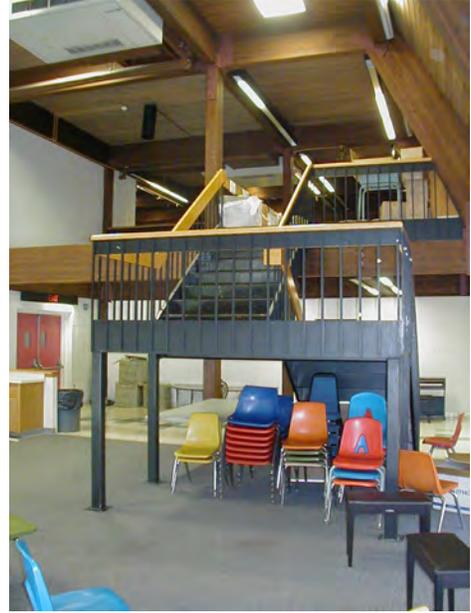
170511-P1010073.JPG

Mezzanine Level Above Former Library; Refer to Accessibility Info for Vertical Wheelchair Lift

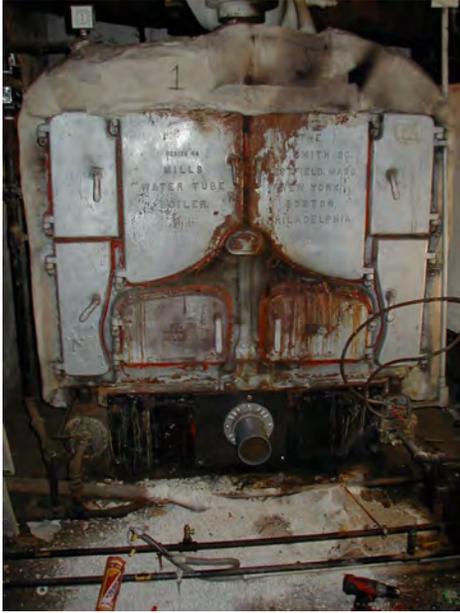
170511-P1010044.JPG

The existing pair of boilers, along with all associated piping, controls and distribution equipment (radiation and unit ventilators) are antiquated and well beyond their useful life. There was an HVAC study done in 2014 to outline recommendations for improvements, and just recently a peer review was performed that modified some of the recommendations and expanded upon certain aspects of the future project. The intent of the mechanical improvements will be to perform them in such a way that the ongoing use of the building can be maintained, so a sequential work program will need to be established by the contractor.

*Antiquated Cast Iron Steam Fired Boiler;
Oil Burner Replacement in Process*

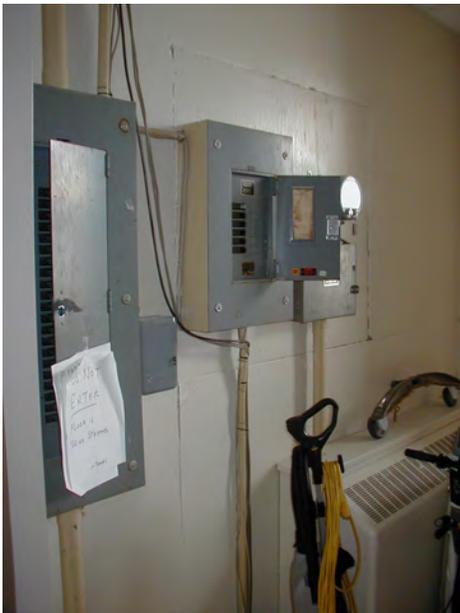
170511-P1010018.JPG

Existing electrical switchgear and panels date from the 1971 work and consist of products from a company that is no longer in business (Empire), making repairs and maintenance infeasible. This was noted in 2003, and reiterated in the 2017 review by the Electrical Engineer. Replacement of primary equipment is recommended as noted in the report. Also, replacement of the fire alarm system in its entirety, along with upgrading of corridor lighting, is recommended to be included.

Empire Panels on Second Floor in Janitor's Closet; One Panel Previously Damaged from Roof Leak

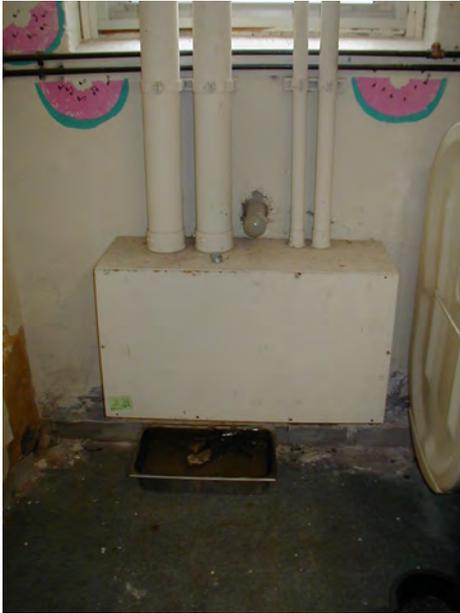
170511-P1010023.JPG

Pull Box at Incoming Electrical Service Cable; Water Infiltration Due to Inappropriate Weather Head Treatment at Utility Pole

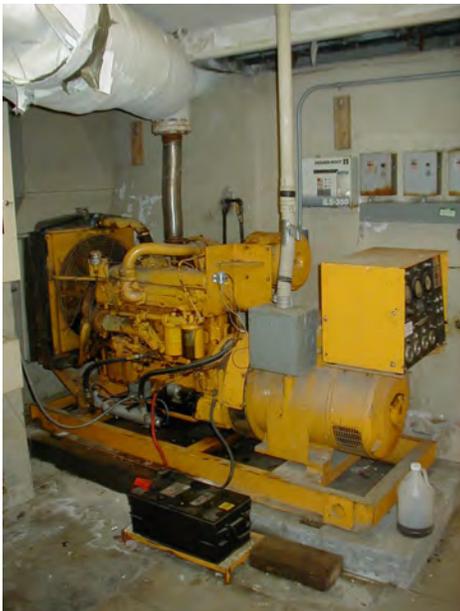
170511-P1010027.JPG

Antiquated Emergency Generator to be Replaced with Outdoor Unit per Electrical Report

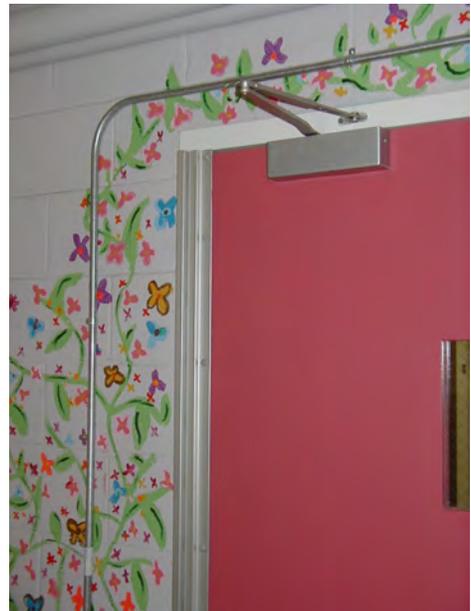
170511-P1010076.JPG

Delete Floor-Mounted Magnetic Hold-Open Device During Fire Alarm System Improvements & Replace Closer with Life Safety Type with Built-In Hold-Open and Fire Alarm Relay

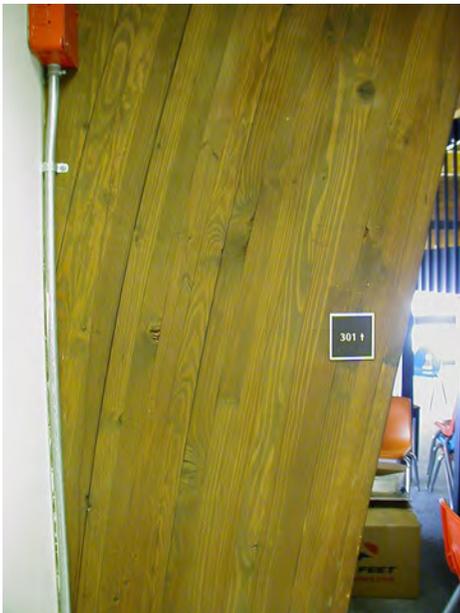
170511-P1010067.JPG

*Detail of Laminations with Slight Cracking
Indicative of Wood Shrinkage Between Members*

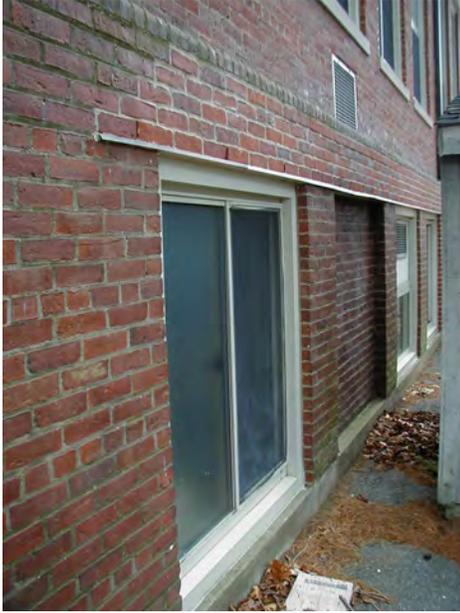
170511-P1010077.JPG

2009 Replacement Brickwork, Lintels and Flashing at East Facade of 1931 Addition; Watertable Above Requires Attention per Structural Info

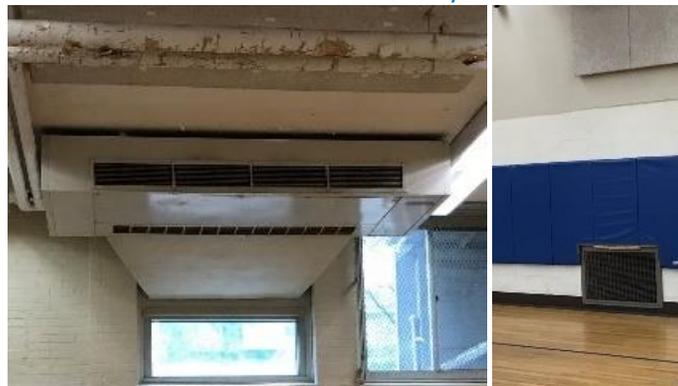
L- One of the two ceiling hung UV serving the Gym, with outside air ducted to louver above window; Note the damaged pipe insulation from activities. R- low exhaust grille.

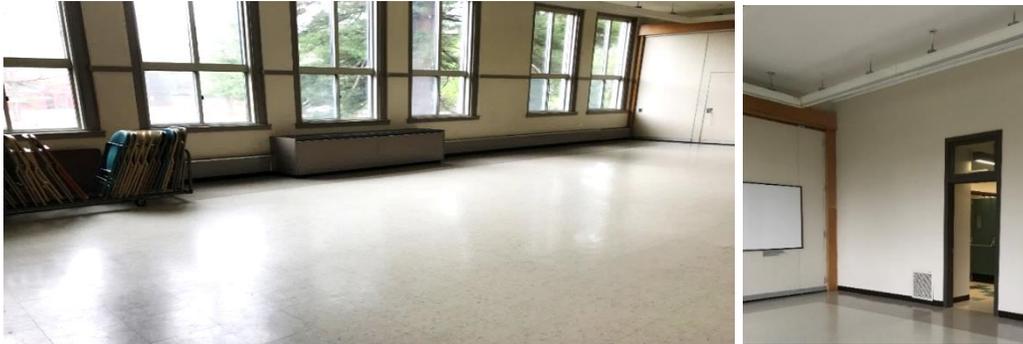
Spaces that used to be classrooms are served by UVs plus low exhaust on opposite wall. UVs are heating, but its ventilation function likely is not working, and none of the exhaust grilles show any draw, suggesting that associated exhaust fans have long failed.

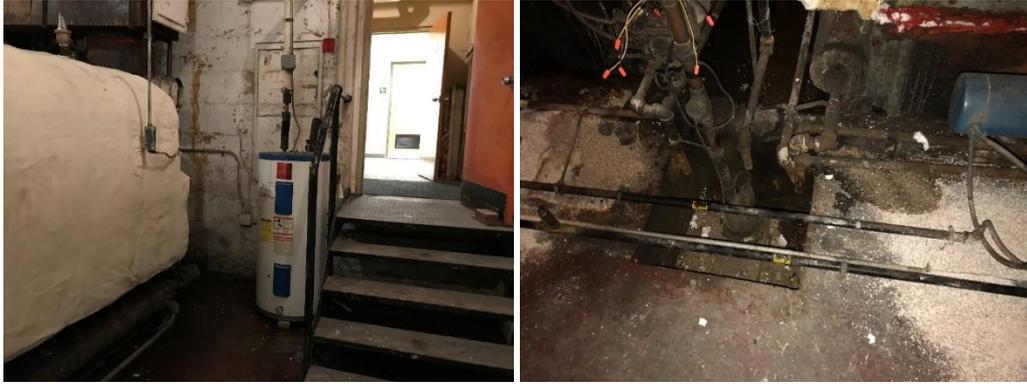
L- electric domestic hot water heater in boiler room. R- see the boiler room sump pump; leaking fuel oil was observed as evidenced by absorbent spreads; sump is manually operated to avoid potentially contaminating the septic system.

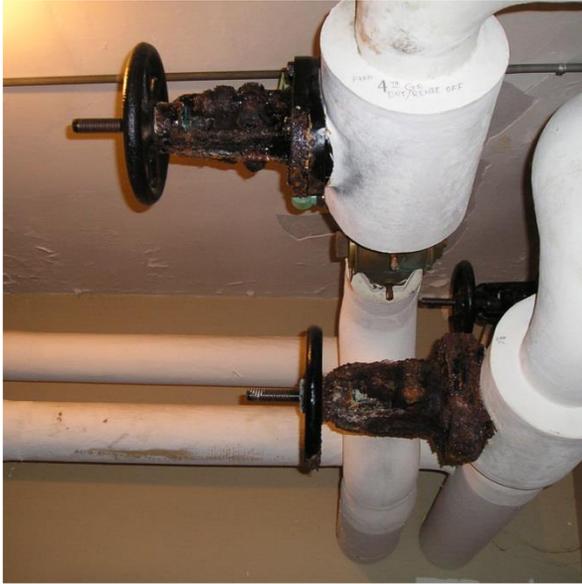
Heavily corroded existing valves

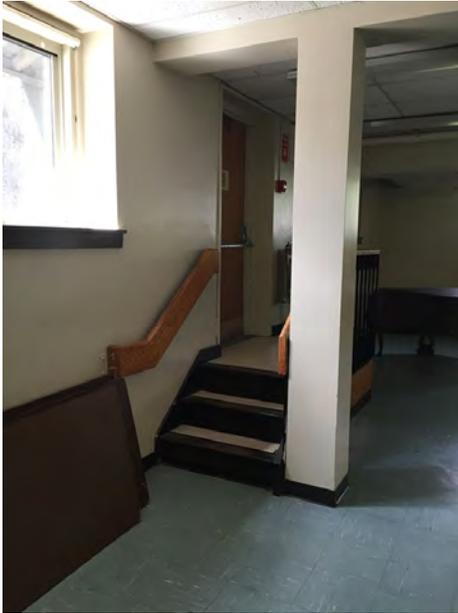
160609-IMG_4845.jpg

Inaccessible Second Exit from Dining Area Leads to Deteriorated Exterior Areaway

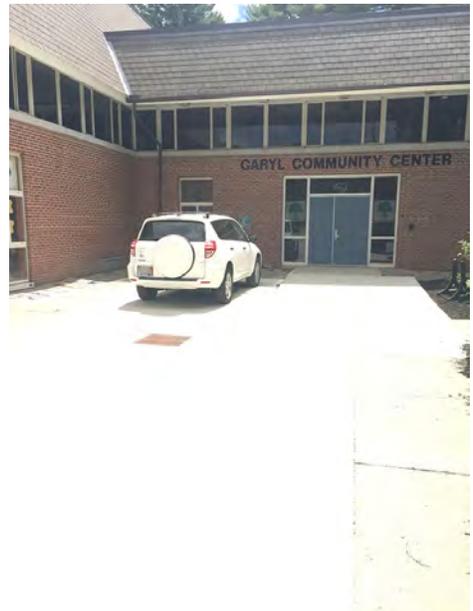
160609-IMG_4820.jpg

*Accessible Parking Space Adjacent to Front Entrance;
Both Spaces at Entry Creates Pedestrian Hazard*

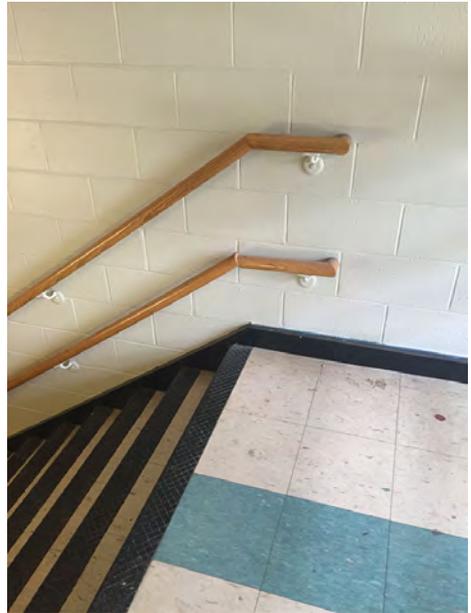
160609-IMG_4829.jpg

Dual Handrails with Deteriorated Joinery

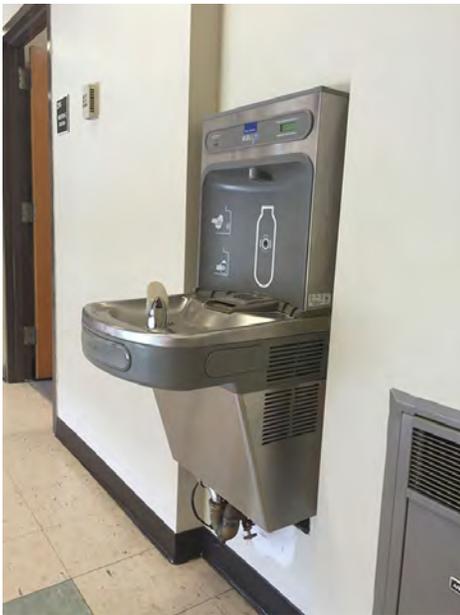
160609-IMG_4798.jpg

Accessible Drinking Fountain, But Protruding >4" Into Accessible Route, Creating an Egress Hazard
