Property Condition Assessment

Caryl Community Center

Dover, MA
August 21, 2019

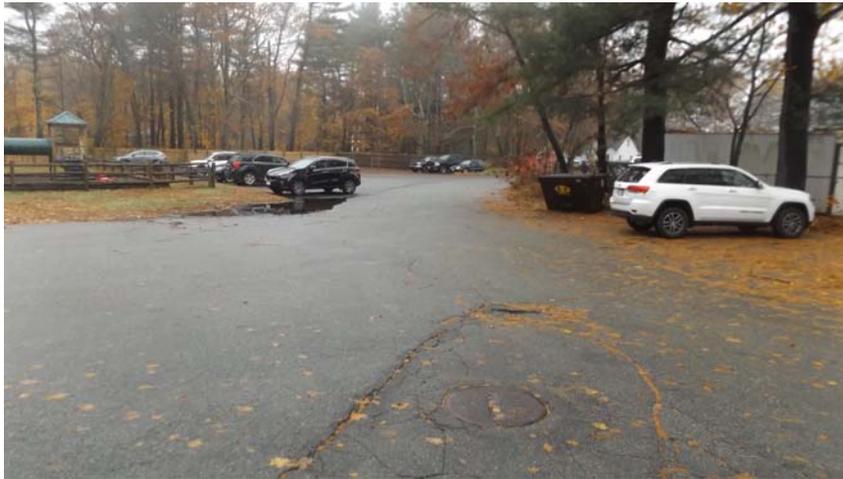
- 1. Costs for the development's site related elements total \$491,614 or \$13.33 per GSF in inflated dollars.**
2. The older asphalt-paved surfaces are in fair condition with some age-related cracks and wear evident; future costs to scarify and resurface this pavement are shown in Year 5. Interim and subsequent allowances for routine surface maintenance (crackfilling, sealcoating, and striping) cycles are shown in Year 1, 10, 15, and 20.

View of asphalt-paved access drive looking southwesterly from near rear of building

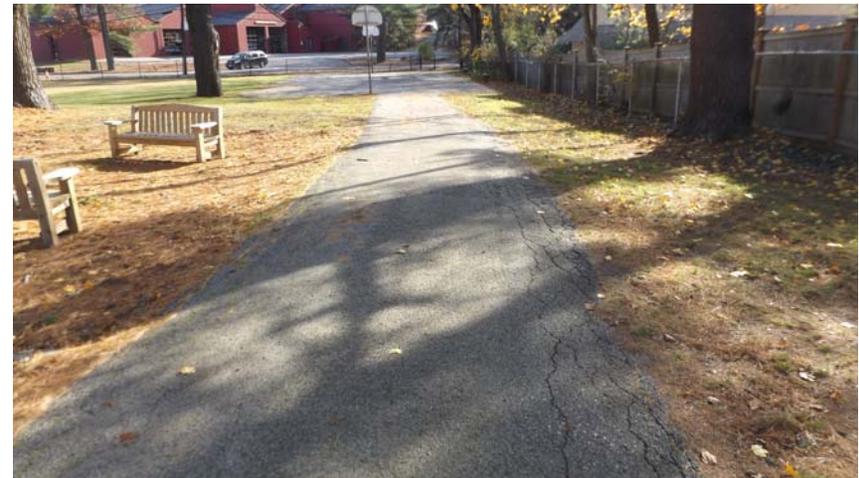
Asphalt-paved walkway leading to play court at rear of building – Note older chain link fencing along property line that is now adjacent to abutter's wood fencing

4. Allowances for potential future sectional repair and/or replacement needs related to the concrete pedestrian walkway are shown in Years 4, 12, and 20. Resurfacing of the asphalt-paved pedestrian walkway and play court surface is shown in Year 5, concurrent with the anticipated resurfacing of the older access drive and parking area asphalt surfaces.

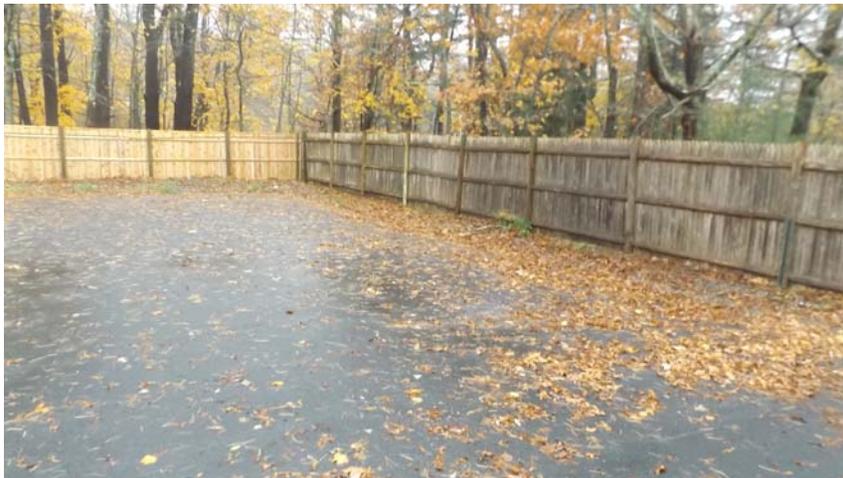
5. The fencing is of varying ages and conditions at the present time; replacement allowances are shown based on observed conditions, current estimated ages, and anticipated remaining useful service lives.

Wood stockade fencing varies in age as seen along sides of newer asphalt-paved parking area at southwesterly corner of site

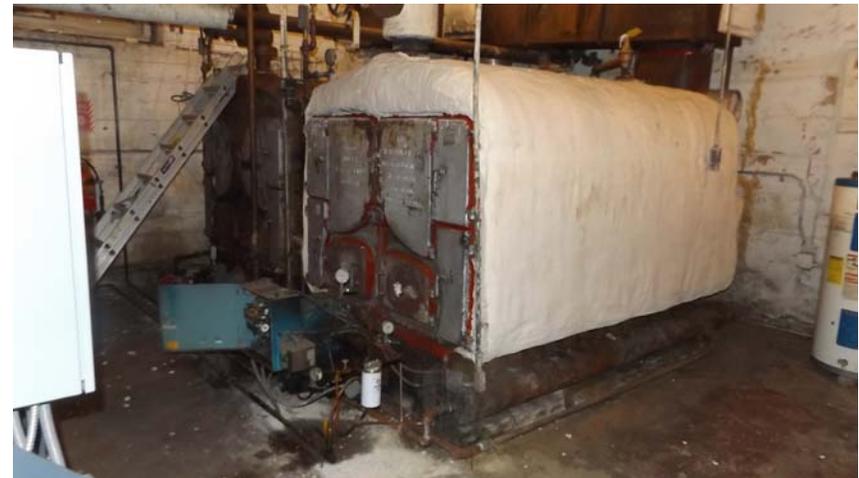
10. The boilers are operable but they have significantly surpassed their expected useful service lives. Payback in the form of increased operating or service life for any major repair work done on the boilers at this point in time is seen as limited. Based on the current age of the boilers and expected useful service life, replacement is shown in Year 1. Prior to the commencement of any replacement work, consultation with a qualified mechanical engineer is recommended in order to identify potential opportunities for energy savings and increased interior comfort for staff and visitors.

Hydronic heat for the facility is produced by two circa 1930s HB Smith oil-fired water tube boilers with newer burners in place – Note the boiler in the background is offline and awaiting completion of repairs

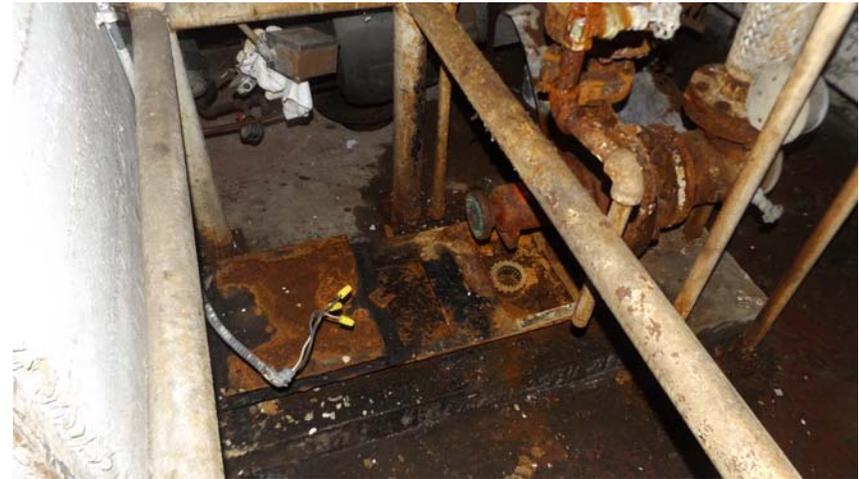
A second pump for circulation of hydronic heat was out of service and removed from the base-mount at the time of the assessment

11. Replacement of the missing/offline circulating pump is shown in Year 1; future replacement of the existing pump is shown in Year 10.

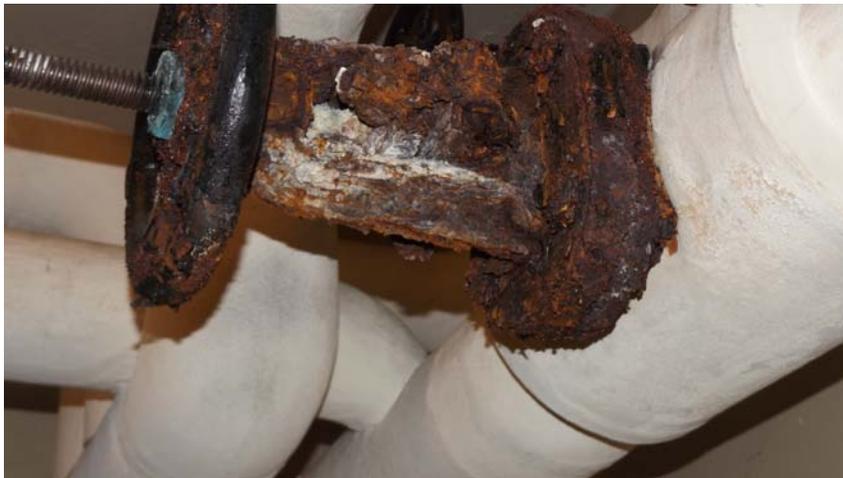
15. The existing distribution piping for the heating system exhibits heavy levels of age-related rust and corrosion, most notably in and around the outside stem and yoke (OS&Y) valve assemblies. Based on observations and discussion with Town staff, the existing conditions are prohibitive with regards to being able to isolate portions of the system

Example of significant rust/corrosion noted on an OS&Y valve assembly serving the heating system – Similar conditions widespread

for servicing/repairs and/or emergencies. A significant allowance for replacement of the distribution piping serving the heating system is shown in Year 1.

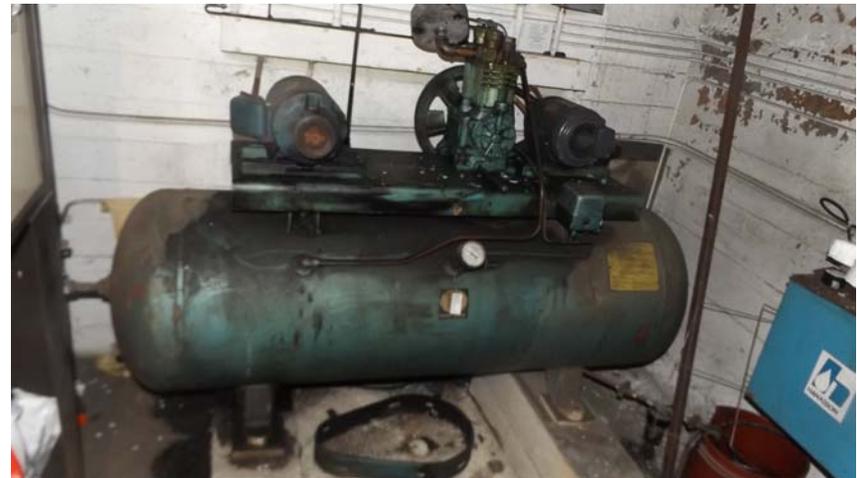
17. At present, the facility's heating system utilizes pneumatic controls to help regulate/govern temperature levels within the building. A duplex-type compressor, located in the central mechanical room, provides pressurized air for the system. The equipment is older, and during the assessment, it was noted that one of the two compressors was offline and not in service. Costs to replace the compressor are shown in Year 1. Replacement allowances for the electric air dryer unit that augments the system are shown in Years 1 and 16.

View of duplex-style compressor that serves pneumatic control devices that are part of heating system – Note one compressor motor is offline at the present time

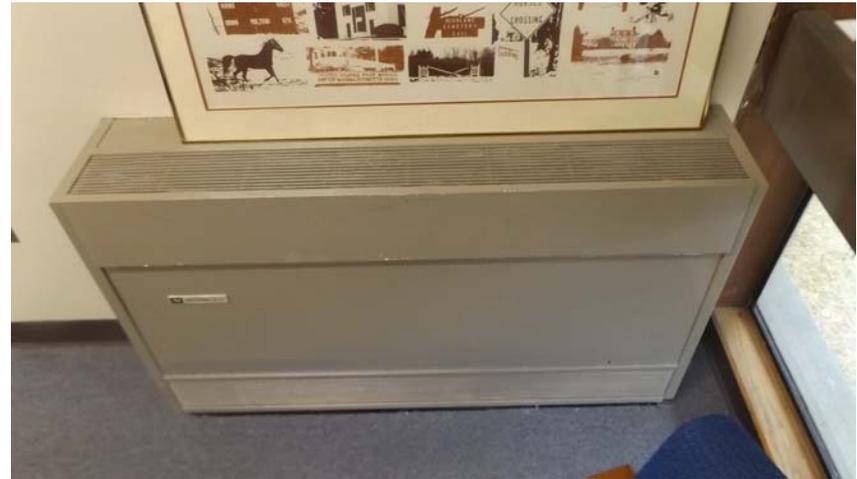
18. The cabinet unit ventilators that are present in the majority of the original 'classroom' spaces and other select locations are older models. Operational problems were reported to be widespread with several of the units either being offline or providing only marginal service. Based on reported conditions, current equipment age and expected useful service life; replacement costs for the ventilator units are shown in Year 1. An allowance to service/replace the coils within the cabinet unit heaters is shown on a concurrent schedule.

Typical cabinet-style ventilator unit present in most original 'classroom' spaces – Most of the ventilators perform poorly or are inoperable

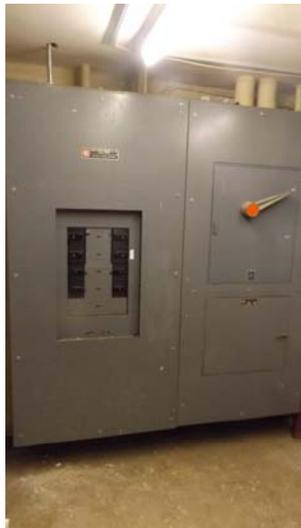
20. During the assessment, it was reported that service/maintenance parts for the electric switchgear and disconnect equipment are no longer commercially available. Based on this information and current equipment age; an allowance for replacement is shown in Year 1.

Original 'Empire' electrical switchgear and disconnect equipment – Service/maintenance parts are reportedly no longer commercially available

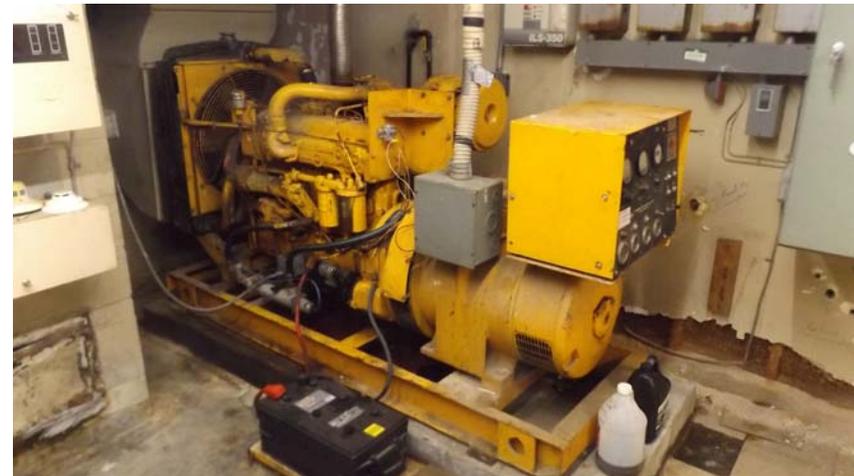
21. The emergency generator dates to the time of the 1971 addition, and although operable, it has surpassed its expected useful service life. An allowance to replace the unit with a larger unit capable of powering additional elements within the facility in the event of a power failure is shown in Year 1.

Emergency power for select building systems in the event of a power failure is provided by a circa 1971 diesel-powered generator

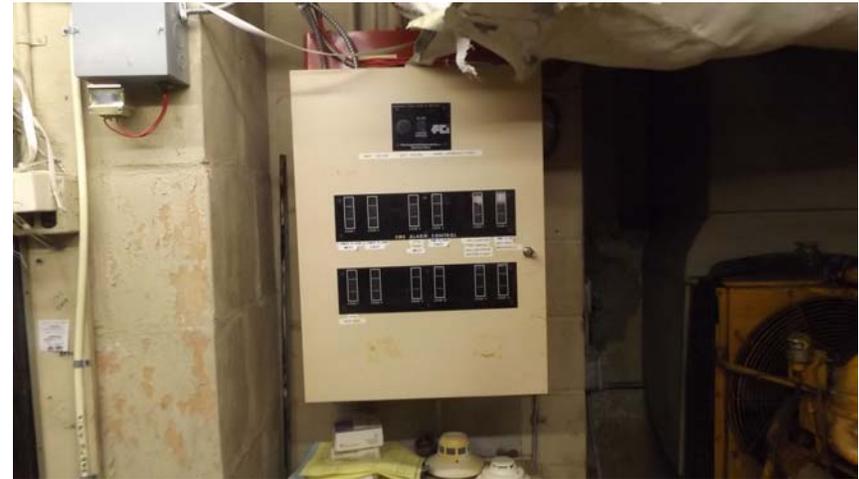
22. The smoke/fire detection system serving the facility is believed to date to 1971. Like many other components at the facility, it is operable, but considerably beyond its expected useful service life. As a life safety system, replacement/upgrade is seen as a near-term need. An allowance to complete this work is shown in Year 1.

Hardwired smoke/fire detection devices at the facility are monitored and supervised by an older FCI zone-type fire alarm control panel

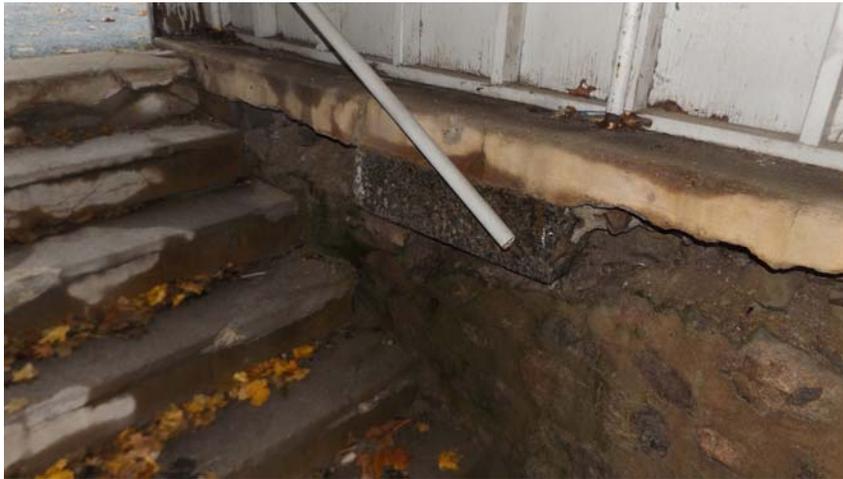
26. During the assessment, areas of peeling/flaking plaster and paint were noted at the outside wall of the stairway leading to the gymnasium and the outside wall at the cafeteria area. Deterioration of the wall around the exterior stairs leading up to the access drive level from the cafeteria was also noted. An allowance to excavate along the foundation at the exterior of these locations and coat/moisture proof the foundation and backfill is shown in Year 1. Included with the allowance is reconstruction of the stairs leading to the cafeteria.

View of deteriorated treads and support wall at exterior stairs leading to cafeteria area from westerly elevation

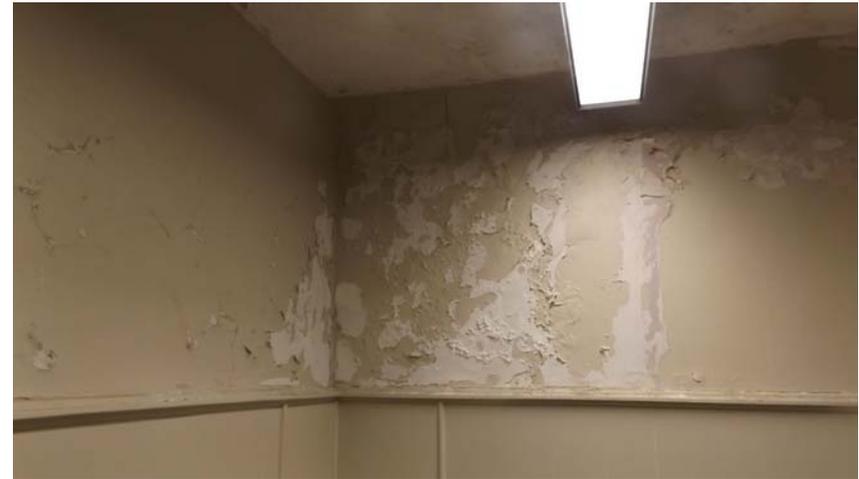
View of peeling paint/plaster noted at outside wall section of stairway leading to gymnasium

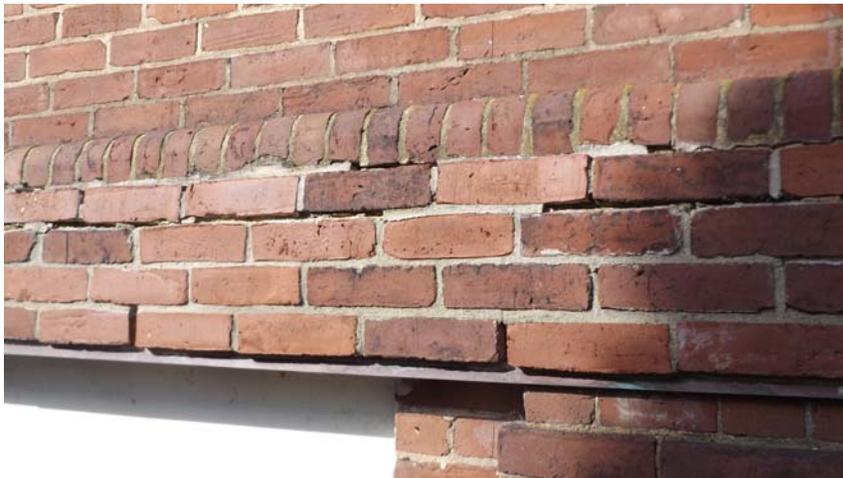
28. Overall, the exterior brickwork is generally good condition at the present time. Isolated areas or mortar loss were noted during the assessment with the most pronounced wear/damage present above the entry Springdale Avenue

View of mortar loss within brick masonry in area above Springdale Avenue entrance to COA multi-purpose room

entrance to the COA's multi-purpose room. Allowances for as-needed selective repair/re-pointing of the exterior masonry wall surfaces are shown in Years 1 and 11.

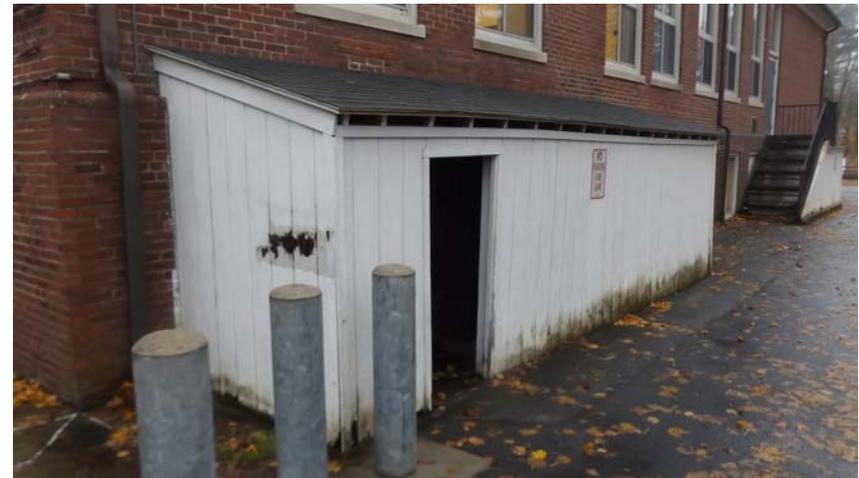
29. The T1-11 plywood siding on the 'sheds' over the westerly elevation stairs exhibits age-related wear and damage from water wicking. Replacement of the siding is shown in Year 1; subsequent allowances for routine surface prep and painting cycles are shown every five years, starting in Year 6.

Typical 'shed' with T1-11 siding located over stairway along westerly side of building – Note the T1-11 siding exhibits age-related wear and evidence of moisture wicking

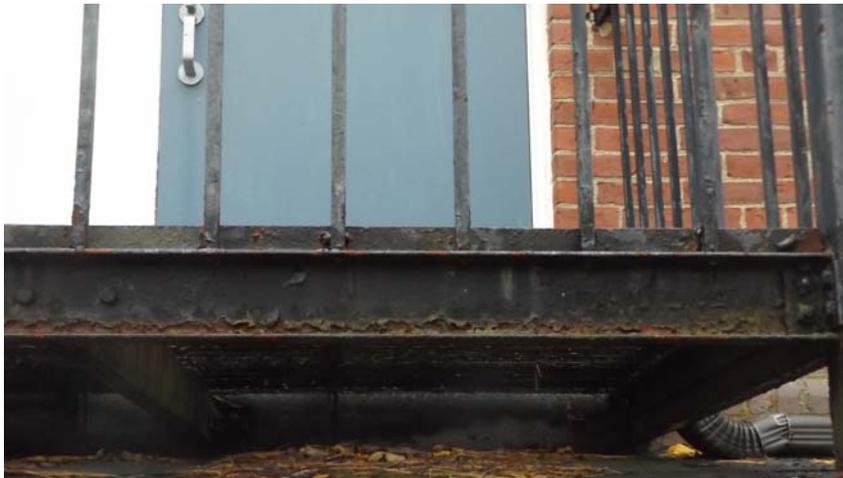
Steel egress stair set leading to Erin's Dance Studio at westerly elevation of building is in need of surface prep and painting

27. No problems related to the remaining concrete stair sets located along the westerly elevation were noted; allowances for potential future repair needs are shown in Years 7, 12, and 15. Surface prep and painting allowances for the steel emergency egress stairs leading to Erin's Dance Studio are shown every five years, starting in Year 1.

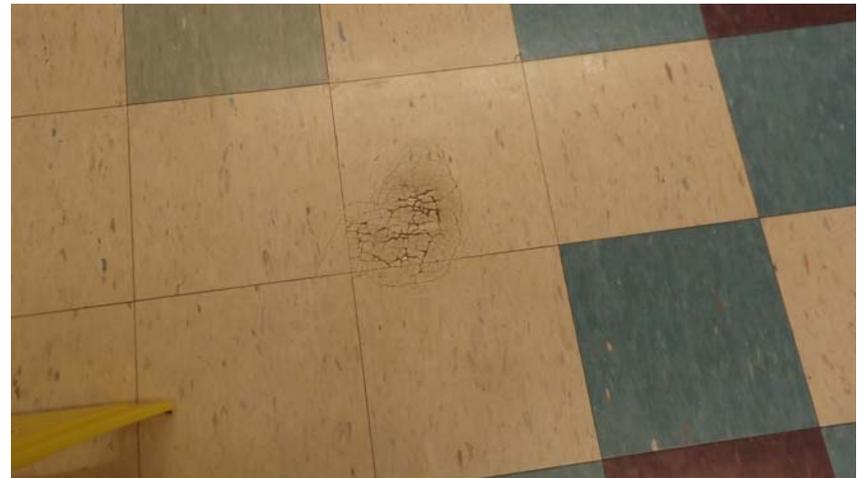
33. The (non-licensed) interior space finishes are in fair to good overall condition; the floor coverings exhibit the most significant levels of age-related wear. An initial cycle of painting and floor covering replacement at most locations is shown in Year 1. Subsequent painting and floor covering replacement allowances are shown based upon material type and respective expected useful service lives.

Example of wear/damage noted at vinyl composition tile (VCT) flooring in the hallways

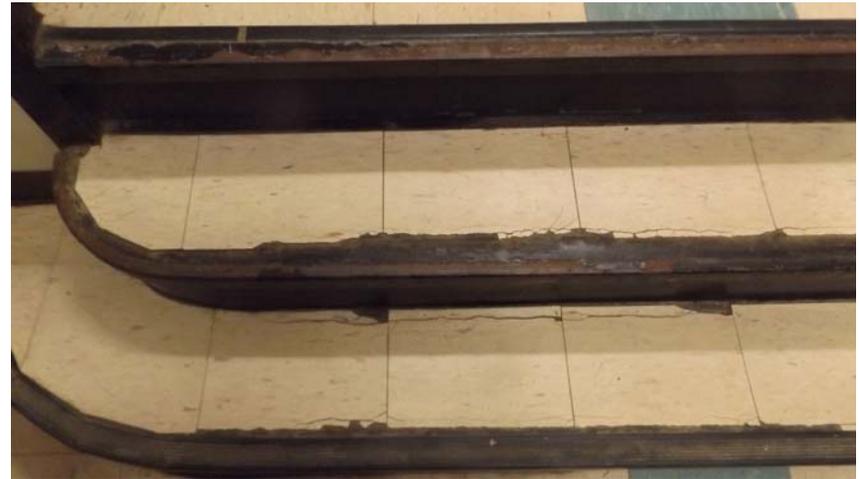
View of worn/damaged VCT noted on stair treads
