DEFERRED MAINTENANCE STUDY

Caryl School

Dover, Massachusetts

30 April 2003

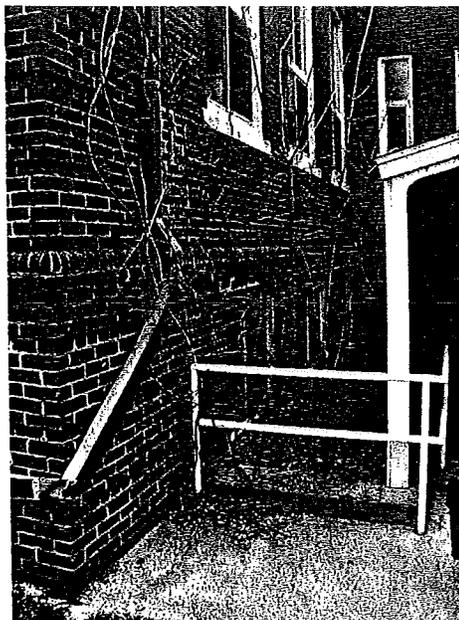
P1010348.JPG

*Southwest Corner of 1910 Original Building;
Overgrown Vegetation in Link Yard Area*

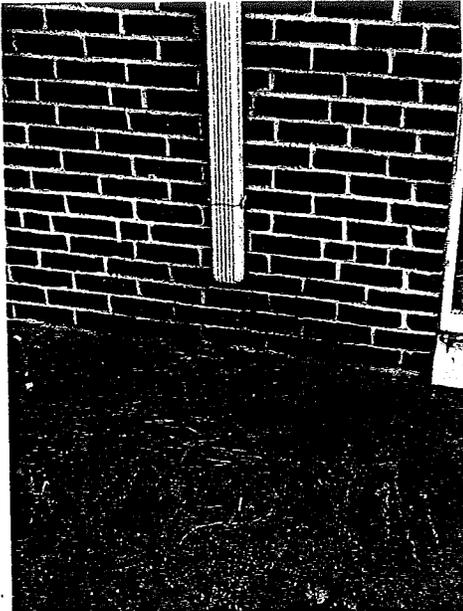
P1010325.JPG

*Corrugated Aluminum Downspout at North Wall of 1971 Addition;
Note Algae Growth at Base of Downspout*

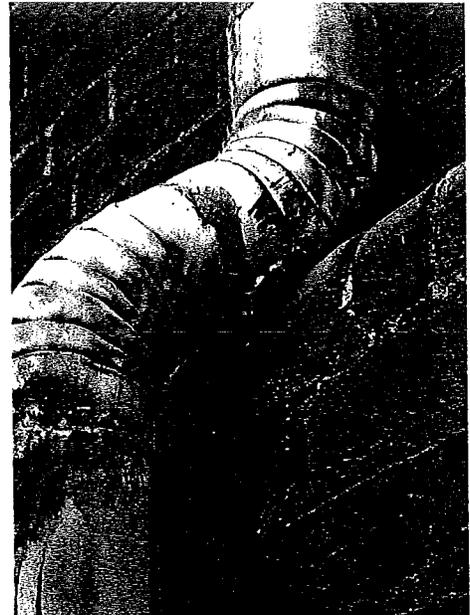
P1010338.JPG

Detail of Water Table at 1931 Addition; Copper Downspout Has Large Hole in Bottom of Offset

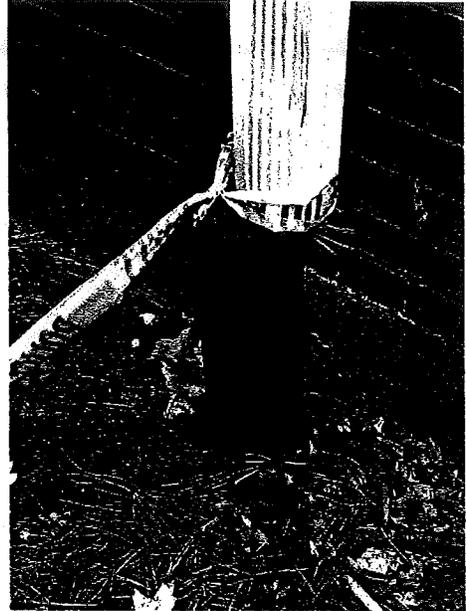
P1010341.JPG

White Corrugated Aluminum Not Seated Into Cast Iron Boot at East Wall of 1931 Addition

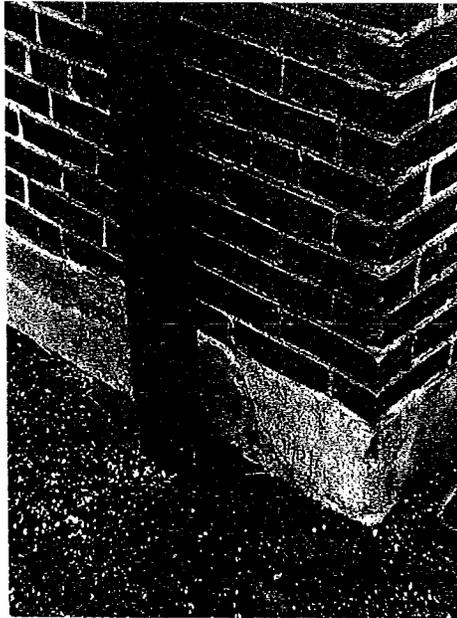
P1010343.JPG

Brown Corrugated Aluminum Downspout at SW Corner of 1931 Addition Penetrates Pavement; No Visible Cast Iron Boot

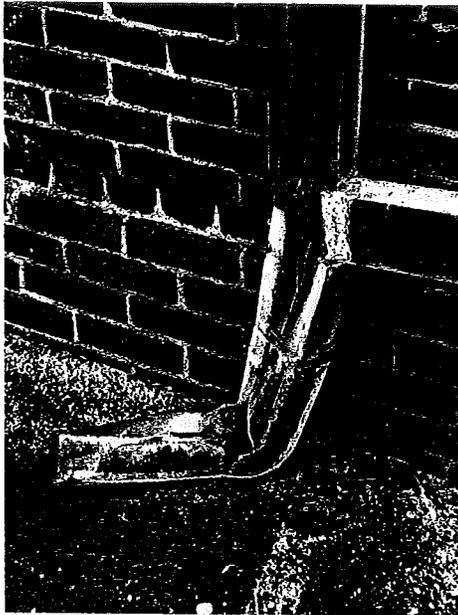
P1010349.JPG

*Crushed Rectangular Copper Downspout
at SW Corner of 1910 Original Building*

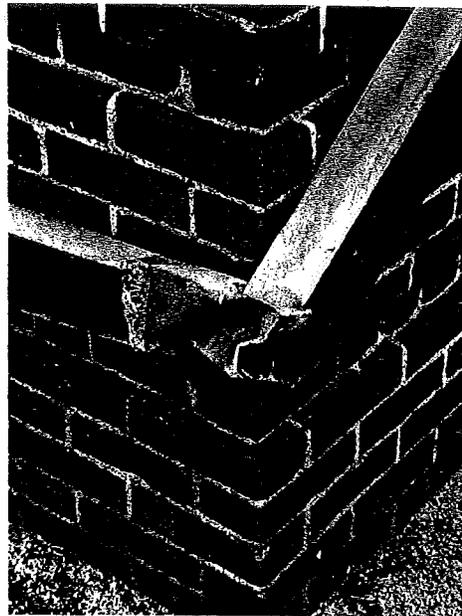
P1010350.JPG

*Crushed Rectangular Copper Downspout
at SW Corner of 1910 Original Building*

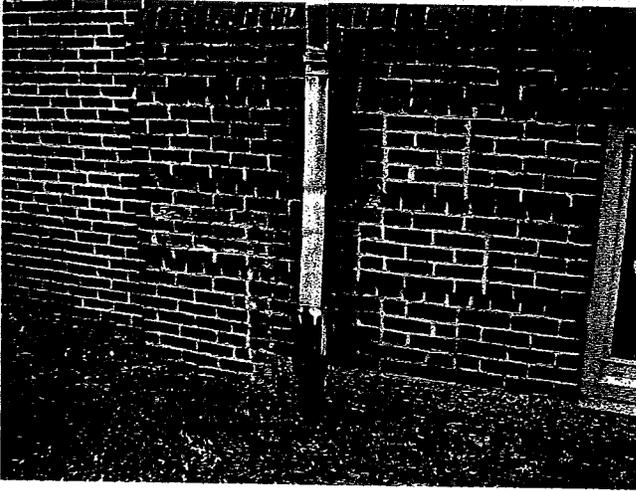
P1010317.JPG

Infilled Masonry at Original School Entrance on North Wall

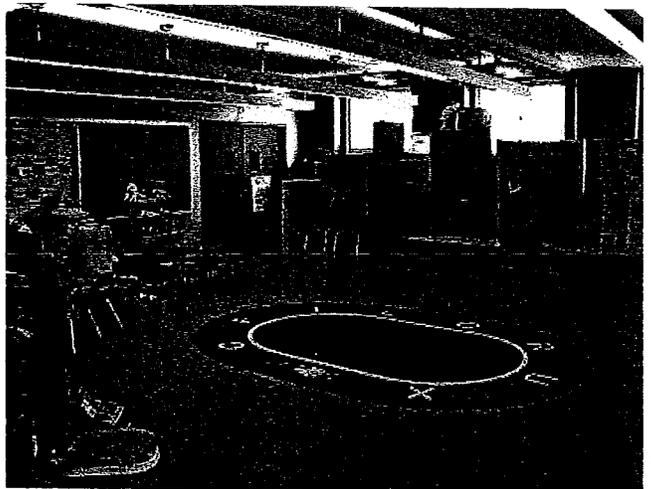
P1010116.JPG

First Floor Classroom Adjacent to Cafetorium in 1910 Building

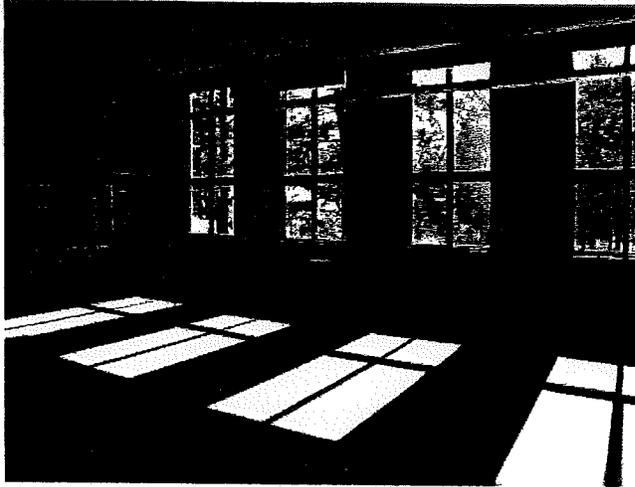
P1010086.JPG

South-Facing Classroom Above Gym in 1931 Addition

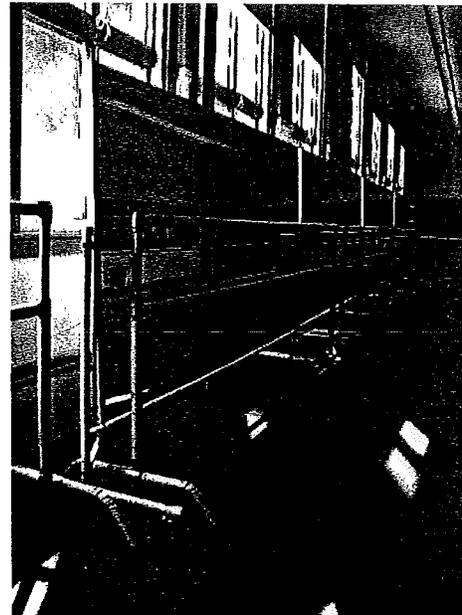
P1010081.JPG

*Dance Studio Currently Using East Classroom;
Vinyl Mats Cover Carpet; Moveable Bars & Mirrors*

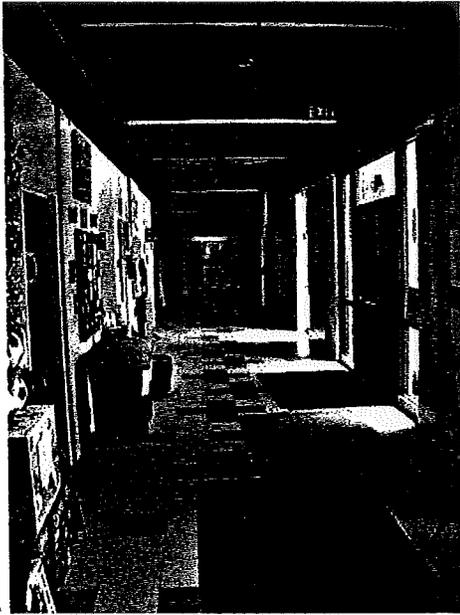
P1010155.JPG

Looking West in First Floor Corridor of 1971 Link;
Vinyl Composition Tile Flooring; Stained Wood Deck Ceiling

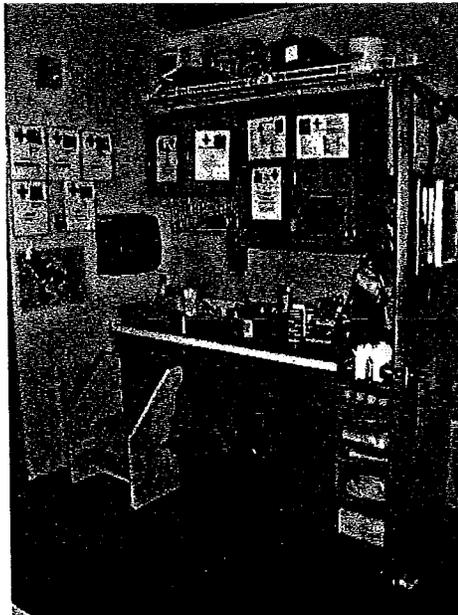
P1010151.JPG

Sink and Cabinet Area of First Floor in 1971 Addition

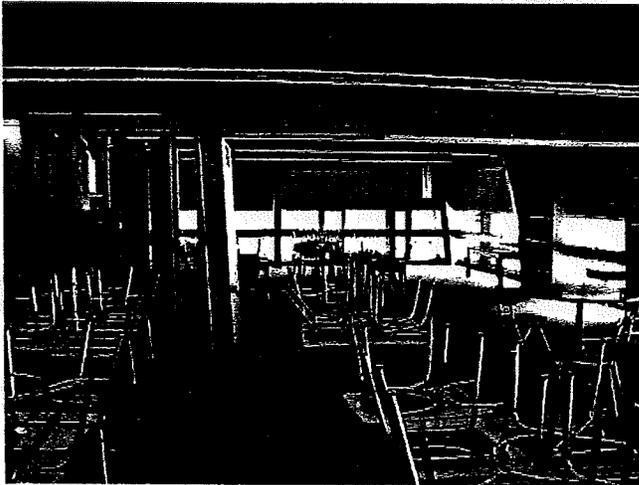
P1010136.JPG

*Southern Portion of Second Floor at 1971 Addition;
Folding Partition Subdivides Space into Two Classrooms*

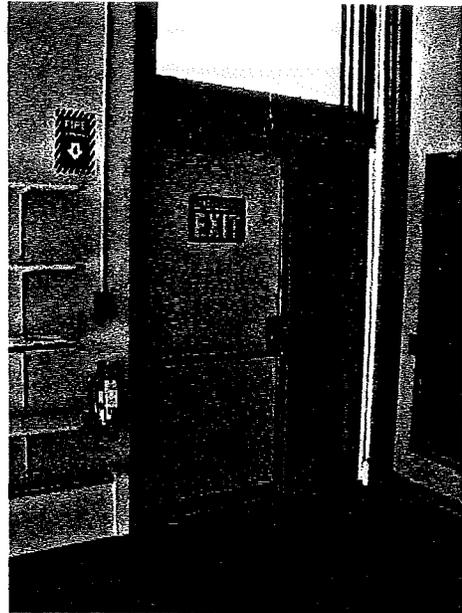
P1010096.JPG

Exit Door from Second Floor Classroom at West Wall of 1931 Addition

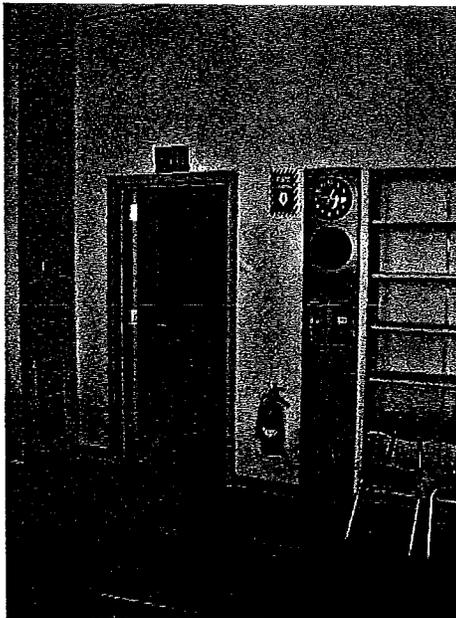
P1010085.JPG

Classroom Door to Corridor in 1931 Addition; Master Clock System with Phone to Right of Door

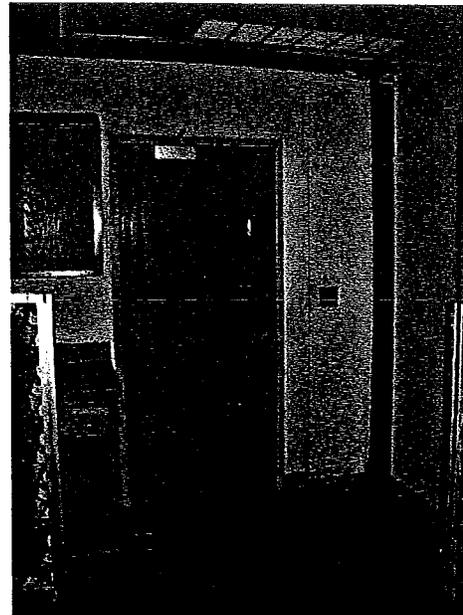
P1010145.JPG

Door from Loft to East Stair in 1971 Addition

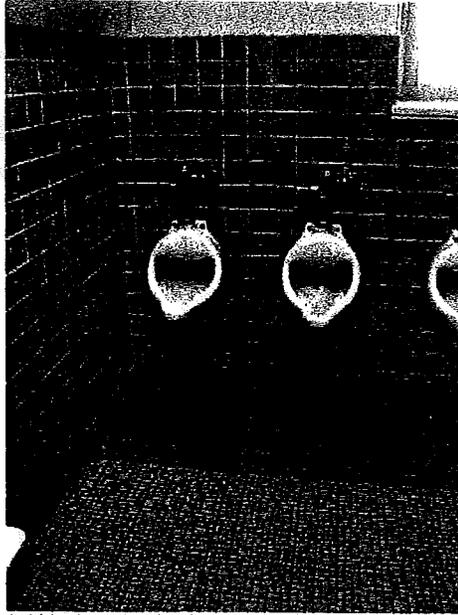
P1010098.JPG

Boy's Urinals in 1931 Addition; Wooden Platform Installed to Temporarily Lower the Effective Mounting Height
