**DOVER CARYL COMMUNITY CENTER
ACCESSIBILITY STUDY**

4 Springdale Avenue
Dover MA

Mills Whitaker Architects LLC
30 June 2016

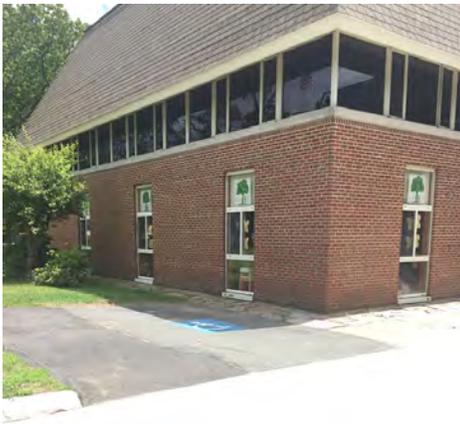
160609-IMG_4821.jpg

Accessible Parking Space to Left of Entrance

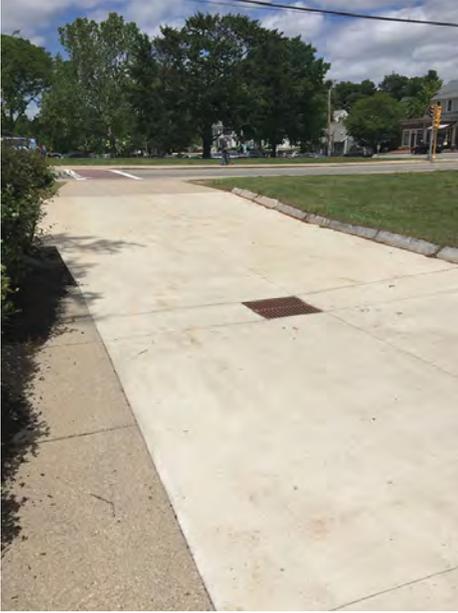
160609-IMG_4819.jpg

*Drain at Front Walkway in Steeply Sloping Portion of Walk;
Requires Re-grading or Construction of Ramp with Rails*

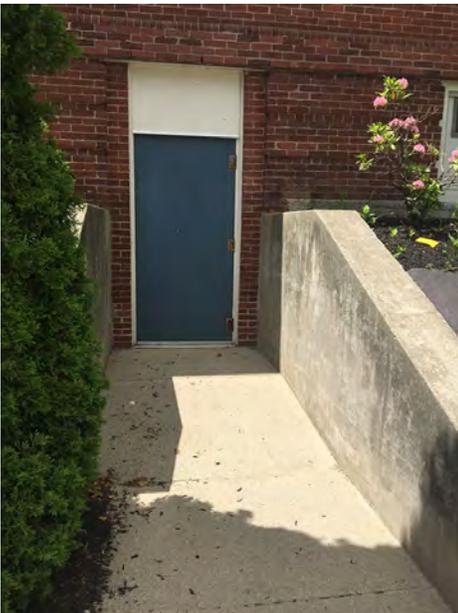
160609-IMG_4818.jpg

Steeply Sloping Walk at Blue Room Exit

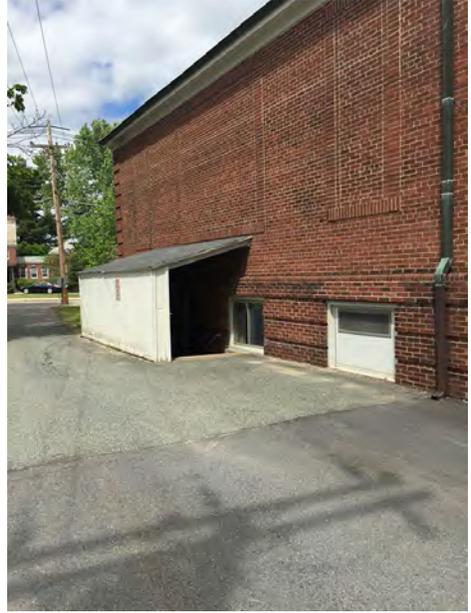
160609-IMG_4836.jpg

Dining Room Exit Shed Enclosure at Driveway

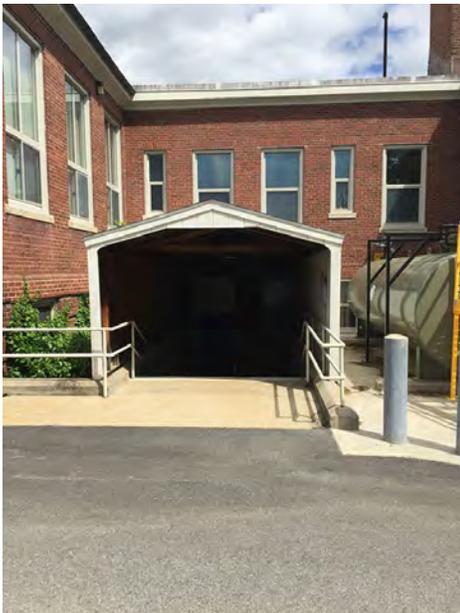
160609-IMG_4837.jpg

Side Entrance Roof Canopy at Stairs Down to First Floor

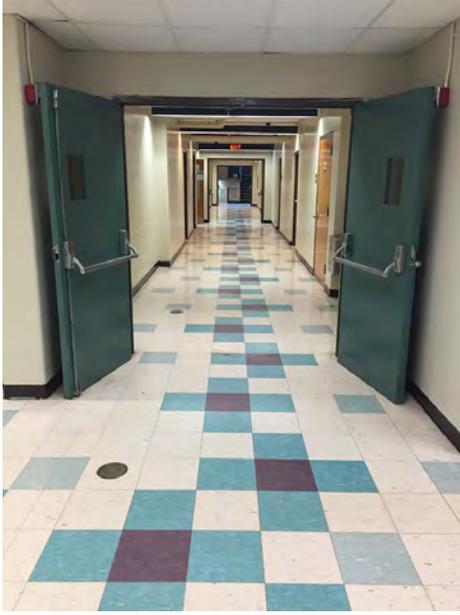
160609-IMG_4840.jpg

Typical Corridor Paired Opening with Magnetic Hold-Open Devices

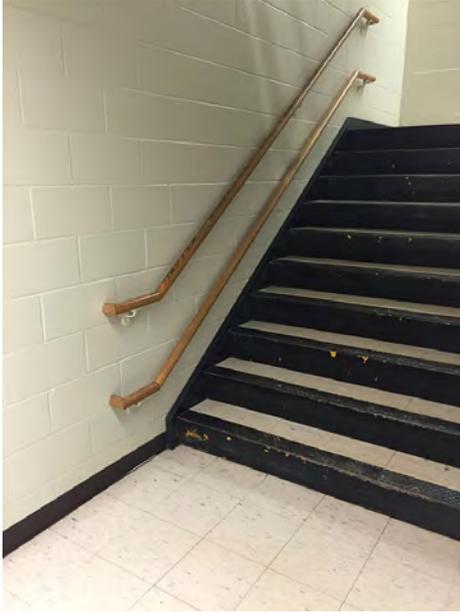
160609-IMG_4851.jpg

Dual Handrails at Central Stair

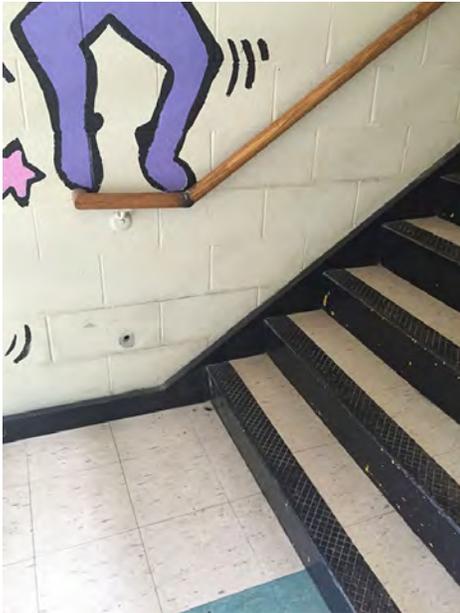
160609-IMG_4830.jpg

Single Handrail at CDC (East) Stairway

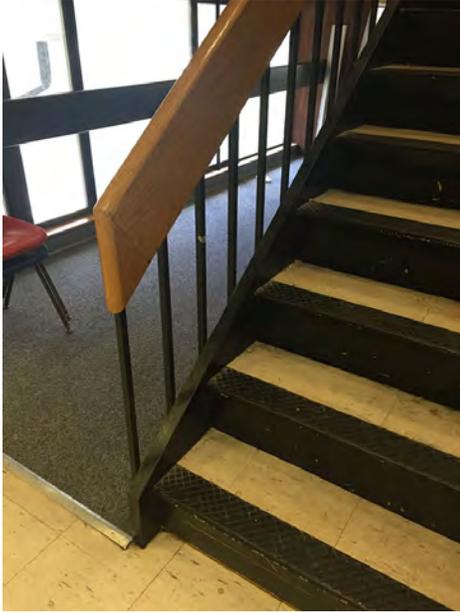
160609-IMG_4832.jpg

Guardrail at Library Mezzanine Stairway

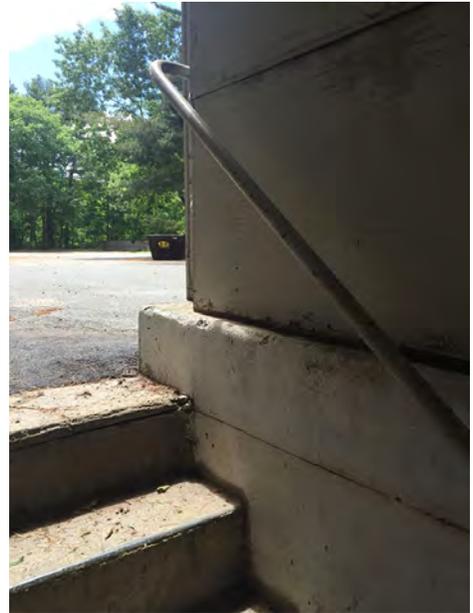
160609-IMG_4811.jpg

Opposite Side of Gym Exit Areaway Stair

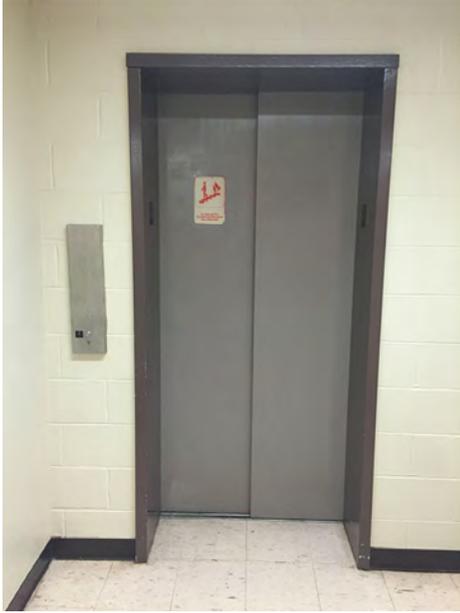
160609-IMG_4800.jpg

Passenger Elevator with Hall Call Button

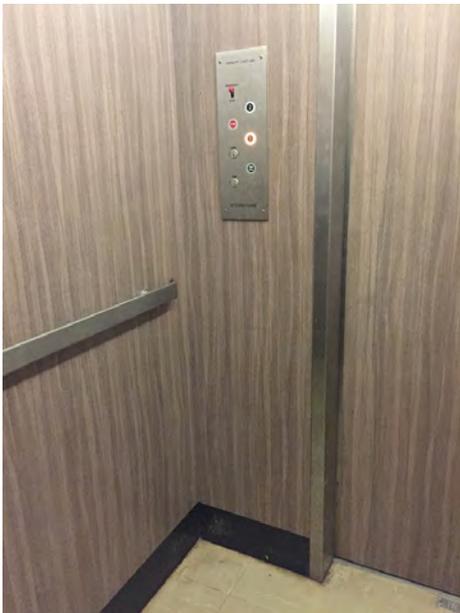
160609-IMG_4802.jpg

Cab Call Buttons Not in Compliance

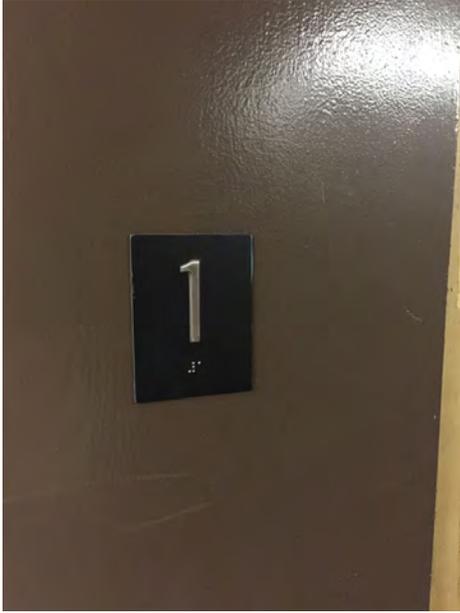
160609-IMG_4804.jpg

Jamb Markings at Elevator Frame

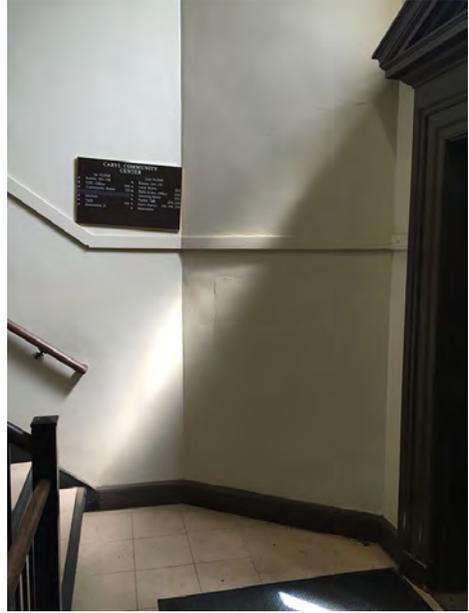
160609-IMG_4870.jpg

*Entrance Landing Level at Back Door;
Proposed LU/LA at Wall Beyond*

2. *Provide a limited use/limited application elevator (LU/LA) in the back stairway area to serve the four floor levels of the stairway. This will add access to the gym level and provide a second public accessible entrance as noted in the narrative for Entrances (521 CMR 25). Installation of a LU/LA, which will require a variance, is much less expensive than the cost of a full passenger elevator.*

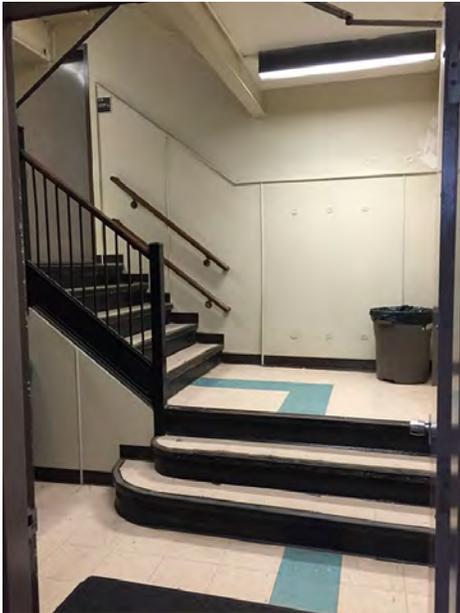
160609-IMG_4869.jpg

*Lower Run of Back Stairs to be Rebuilt;
LU/LA to be at Wall Beyond*

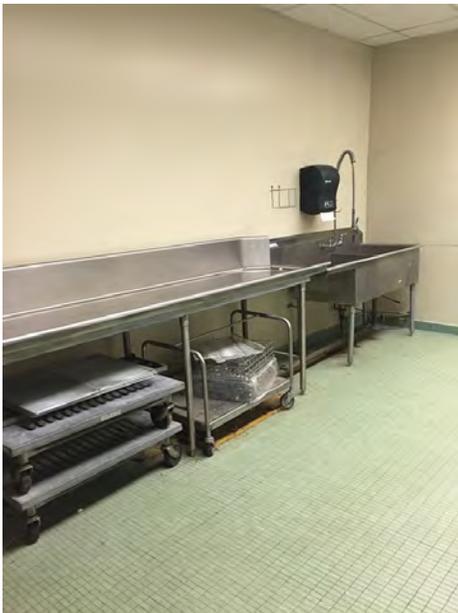
160609-IMG_4842.jpg

Dishwashing Station at Dining Room Kitchen

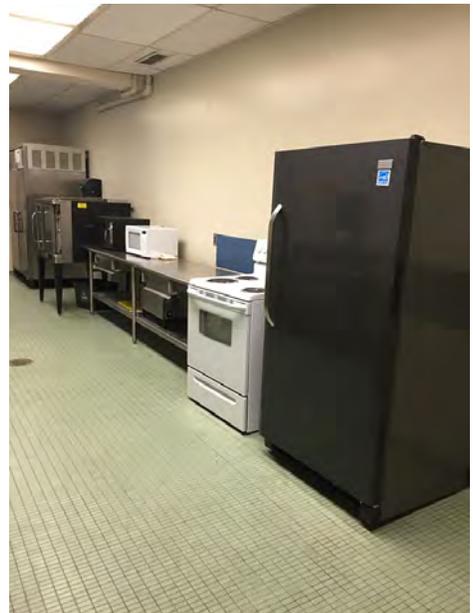
160609-IMG_4841.jpg

Residential Refrigerator & Range at Dining Room Kitchen
