June 16, 2017

RE: Dover Caryl Community Center
Study for Required Improvements

**DOVER CARYL COMMUNITY CENTER
STUDY for REQUIRED IMPROVEMENTS**

4 Springdale Avenue
Dover MA

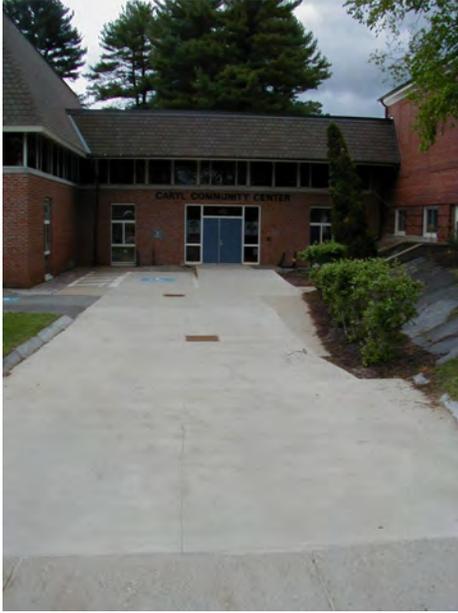
170511-P1010085.JPG

*Main Entrance Walkway from Springdale;
Refer to Accessibility Info for Re-Grading*

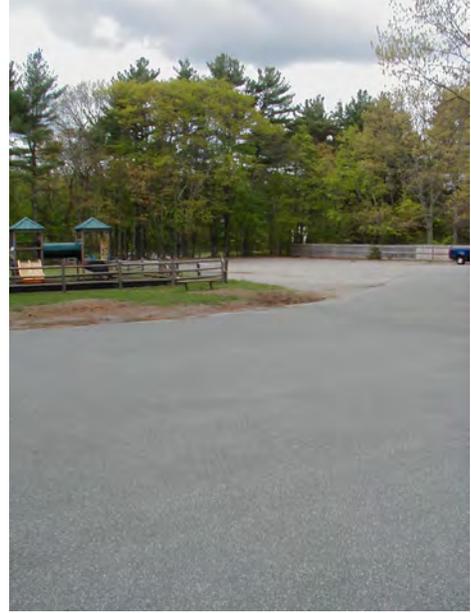
170511-P1010057.JPG

*Back Parking Lot Area;
Refer to Electrical Report for Pole Lighting*

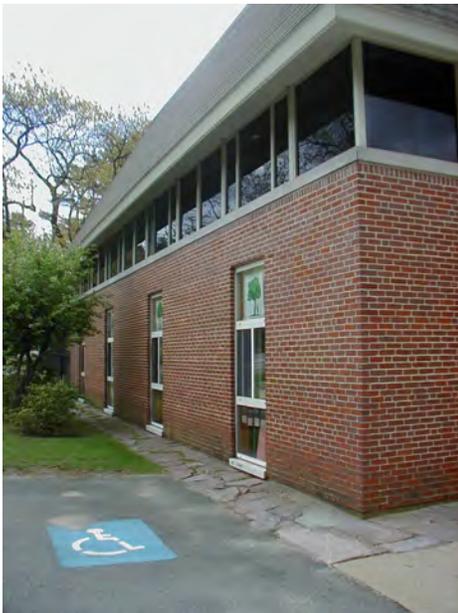
170511-P1010083.JPG

*Front Facade (North) of 1971 Addition;
Refer to Structural Report for Continuous Window Sill*

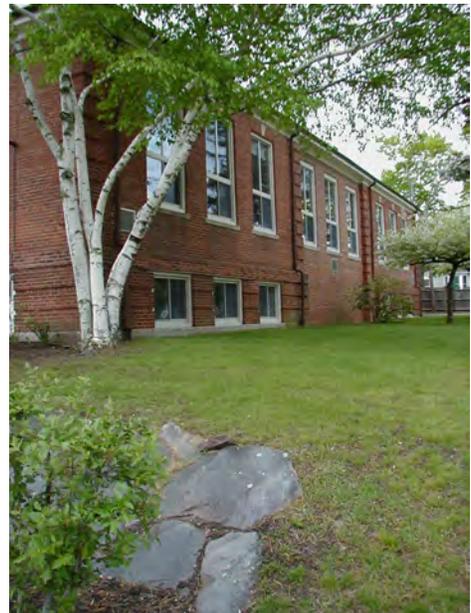
170511-P1010084.JPG

*Front Facade (North) of 1910 Original Building;
Refer to Structural Info for Moss at Watertable*

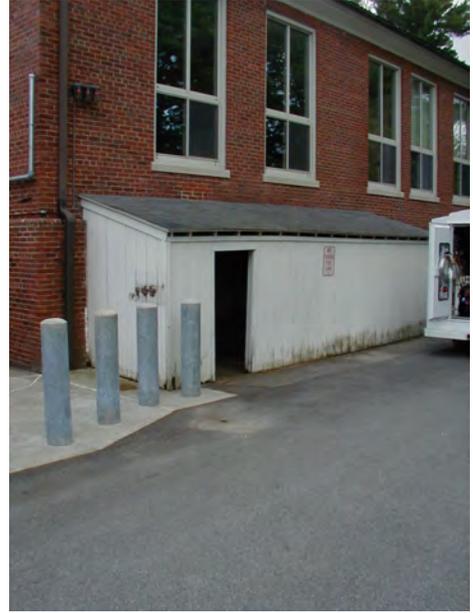
170511-P1010063.JPG

*Covered Areaway Service Stair to Boiler Room;
Requires Re-painting & Re-roofing*

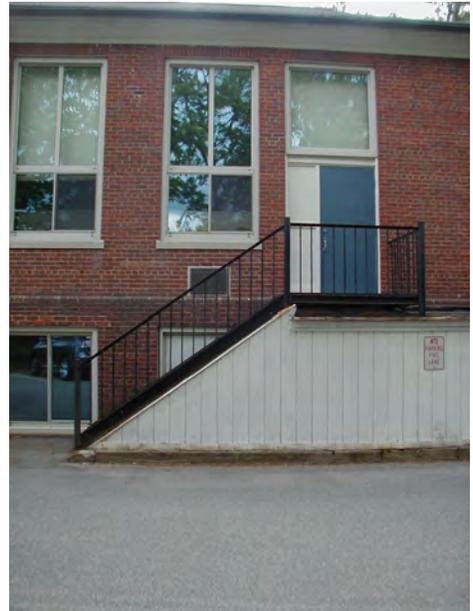
170511-P1010059.JPG

*Remove Unnecessary Exit Stair from Classroom;
Retain Enclosure for Gym Exit Areaway Below &
Re-paint and Re-roof the Enclosure*

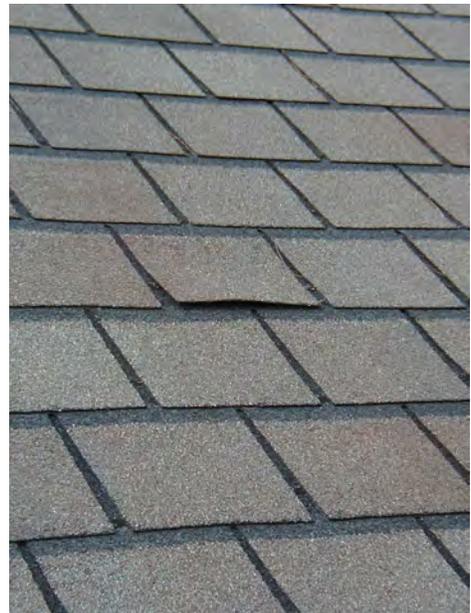
170511-P1010013.JPG

*Popped Nail Head at North Slope of 1931 Roof
Below 2008 Shingle Work*

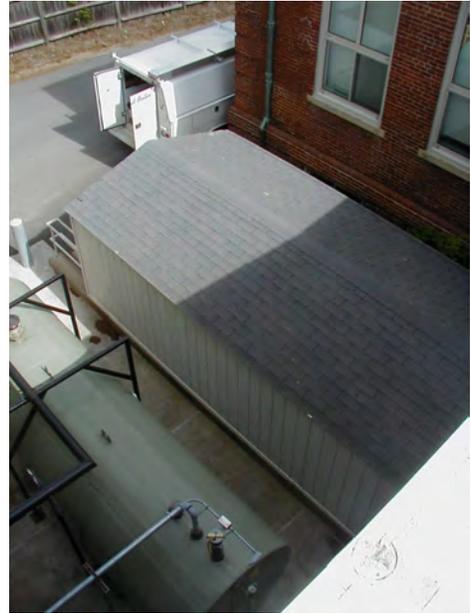
170511-P1010008.JPG

Re-roofing required at Areaway Entrance Canopy

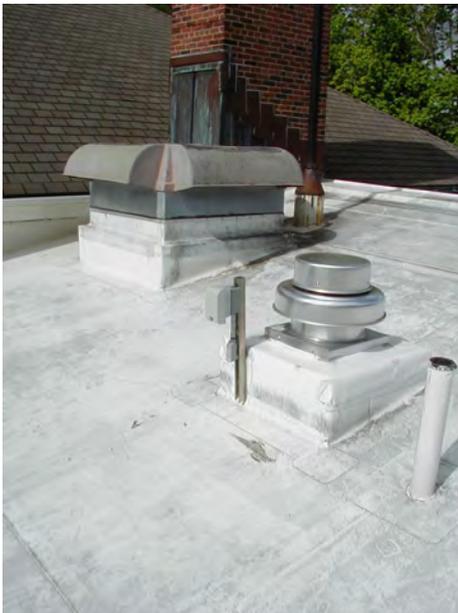
170511-P1010006.JPG

*2016 Toilet Fan for Second Floor Renovated Areas;
Emergency Generator Intake Air Hood & Exhaust,
Remove & Patch Roof per Generator Upgrades*

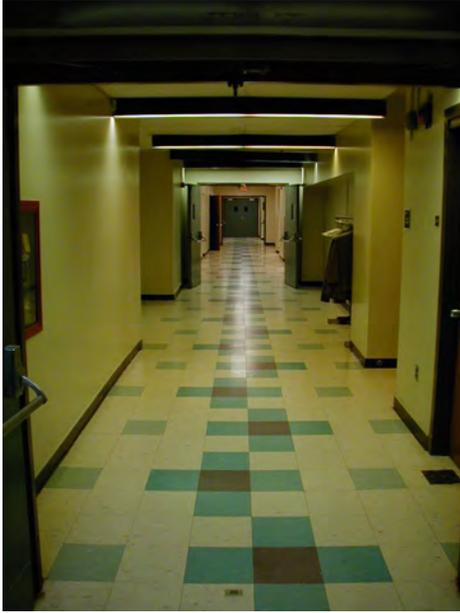
170511-P1010055.JPG

Looking North in First Floor Corridor of 1931 Addition

- Remove VCT at the first floor hallways; level the slab and provide replacement VCT.
- Remove VCT at the second floor hallways; remove underlayment; re-nail subfloors and provide replacement underlayment plywood and replacement VCT.
- Replace VCT at stair treads between riser and abrasive nosing; replace VCT at landings.
- Remove existing linear light fixtures; provide acoustical ceiling tiles (2 x 2 mineral fiber Armstrong “Ultima Vector”); provide recessed LED lay-in lighting fixtures.

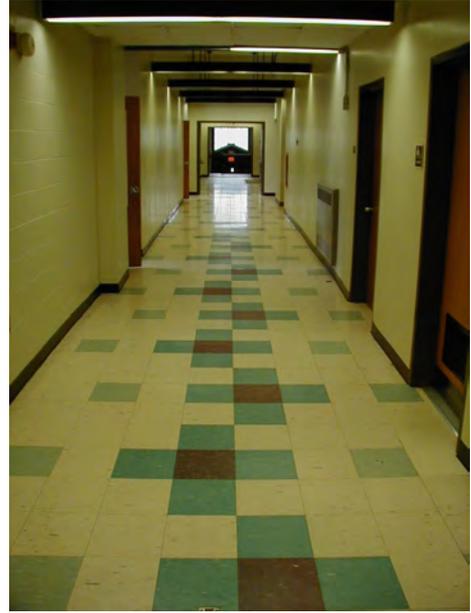
170511-P1010017.JPG

Looking South in Second Floor Corridor of 1931 Addition

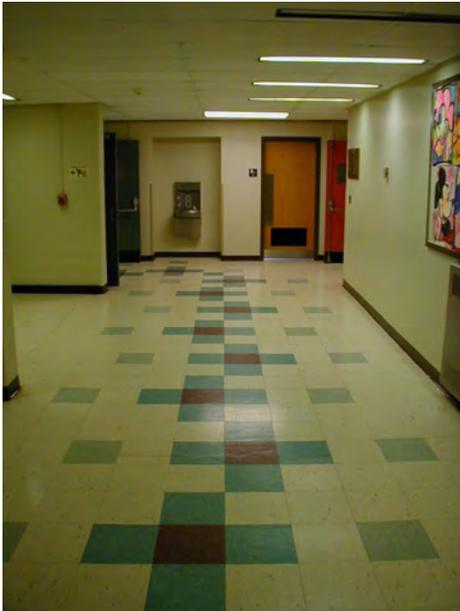
170511-P1010016.JPG

Looking West in Second Floor Corridor of 1971 Link

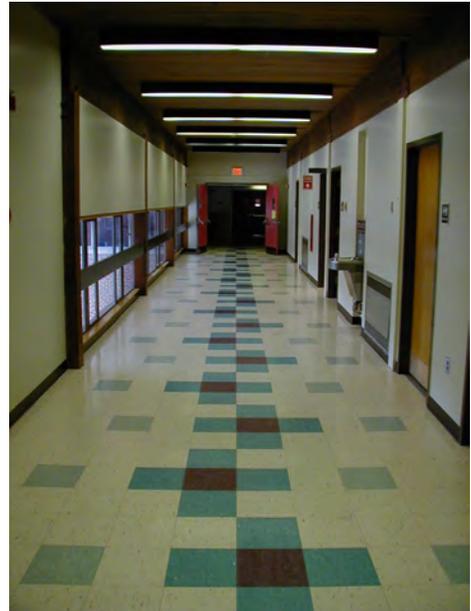
170511-P1010015.JPG

Looking East in Second Floor Corridor of 1971 Link

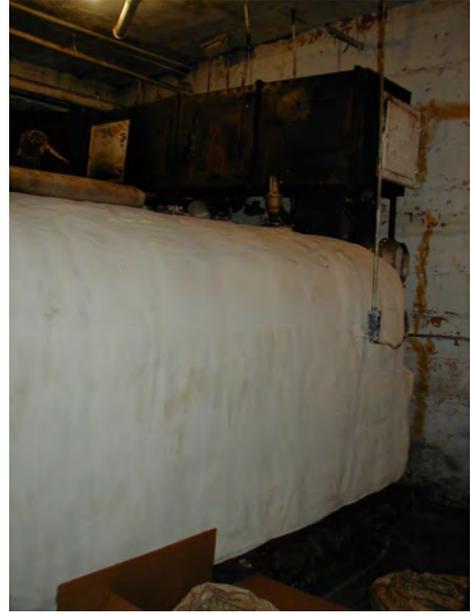
170511-P1010043.JPG

*Insulation Jacketing for Boilers;
Breaching Beyond*

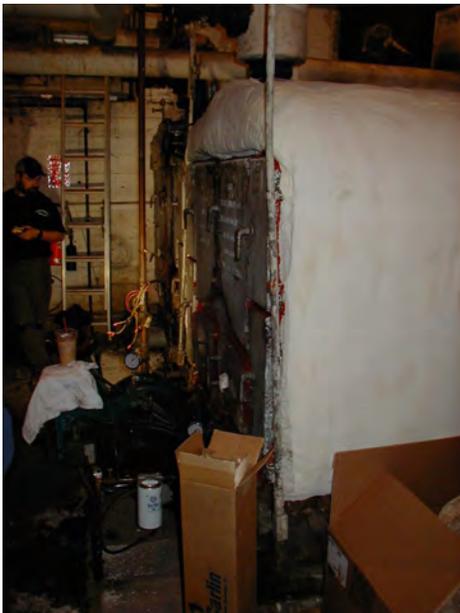
170511-P1010042.JPG

Boiler Burner Replacement in Process

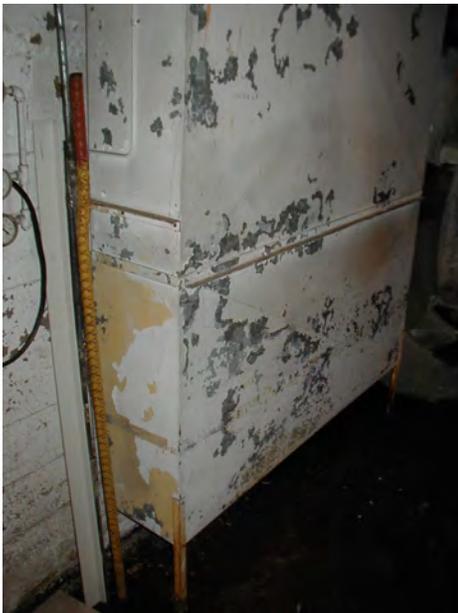
170511-P1010047.JPG

*Duct From Areaway Window to Floor of Boiler Room
Serving as Combustion Air Intake*

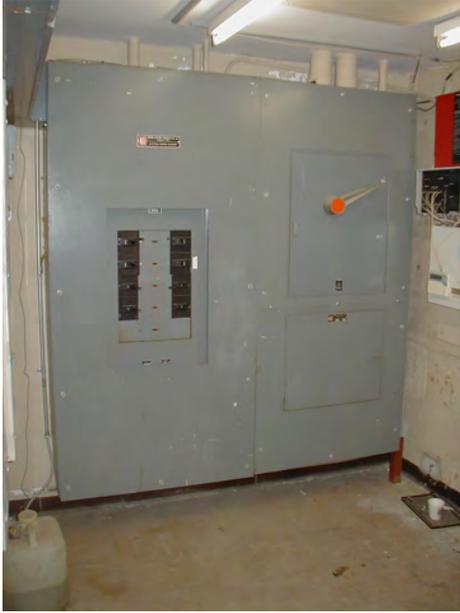
170511-P1010024.JPG

Existing electrical switchgear and panels date from the 1971 work and consist of products from a company that is no longer in business (Empire), making repairs and maintenance infeasible. This was noted in 2003, and reiterated in the 2017 review by the Electrical Engineer. Replacement of primary equipment is recommended as noted in the report. Also, replacement of the fire alarm system in its entirety, along with upgrading of corridor lighting, is recommended to be included.

Empire Switchgear in Existing Electrical Room

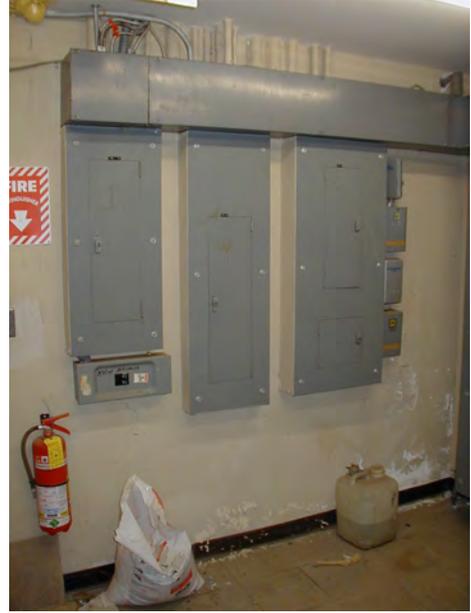
170511-P1010028.JPG

Empire Panel Array in Main Electrical Room

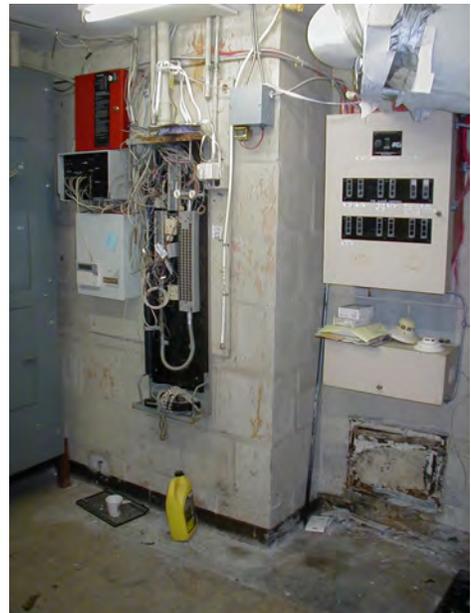
170511-P1010025.JPG

Communications Cabling & Fire Alarm Panel in Existing Electrical Room

Electrical: Replace fire alarm system, electrical panels and emergency generator.

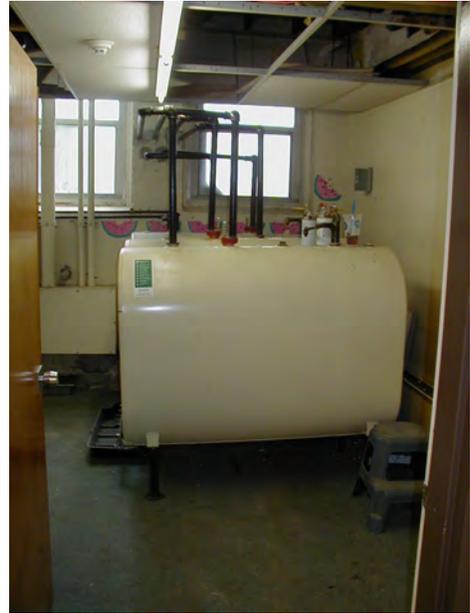
170511-P1010022.JPG

Three Fuel Oil Tanks Used for Temporary Heating Oil During 2011 Removal of Underground Tank; Now Only One in Use for Emergency Generator; This Room to Become New Electrical Room for Upgrades

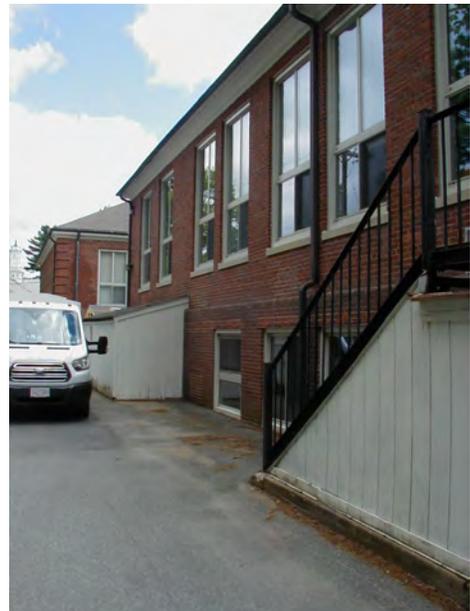
170511-P1010065.JPG

Proposed Outdoor Location for Emergency Generator; Pad Mounted with Sound Enclosure; Fuel Tank as Part of the Unit; Run Exhaust Above Roof Eave

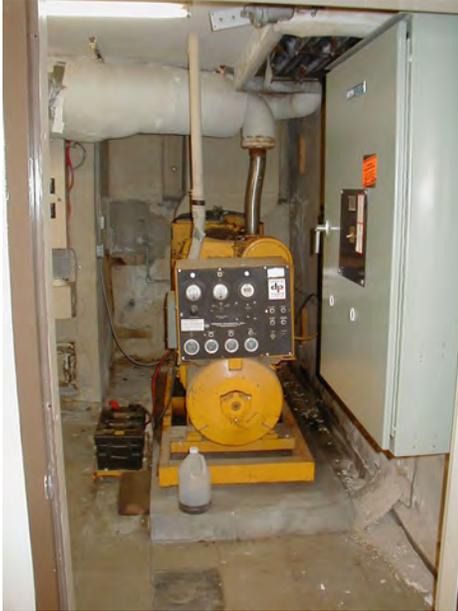
170511-P1010031.JPG

Existing Indoor Generator and Transfer Switch

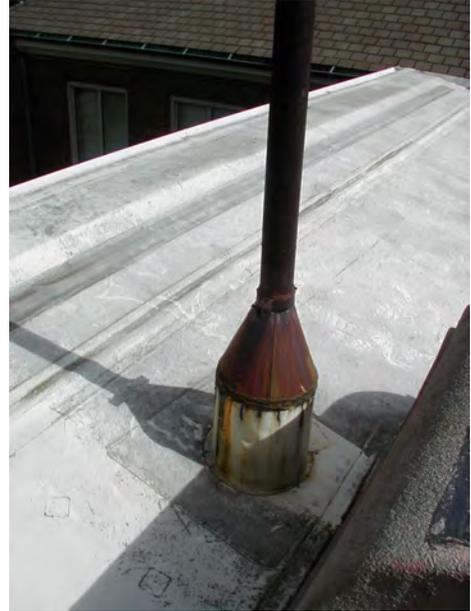
170511-P1010007.JPG

Existing Generator Exhaust at Link Roof; Hood for Combustion Air Intake to Right; Infill Roofing Systems Upon Removal (Sarnafil PVC)

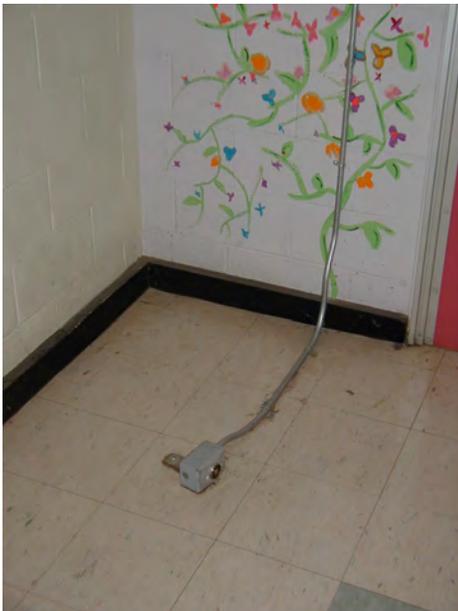
170511-P1010074.JPG

Awkward Floor-Mounted Magnetic Hold-Open Device Stair Doors in 1971 Addition; Remove as Part of Fire Alarm System Improvements

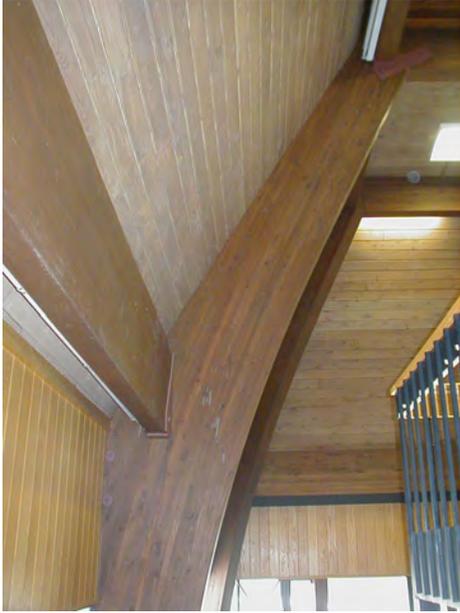
170511-P1010069.JPG

Arched Glue-Laminated Timbers of 1971 Addition

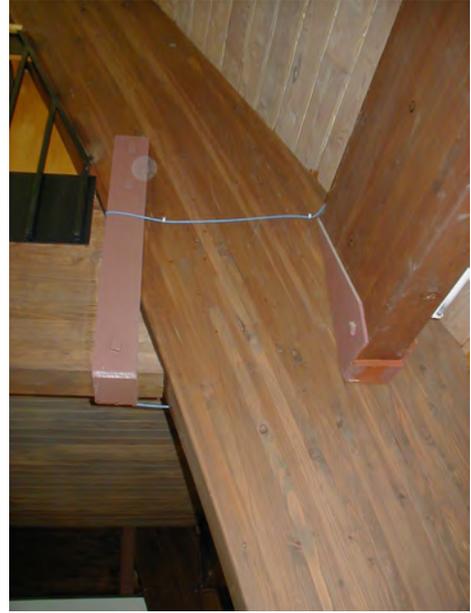
170511-P1010070.JPG

*Perimeter Beam with Hanger at Right of Arch;
Mezzanine Beam with Hanger to Left of Arch*

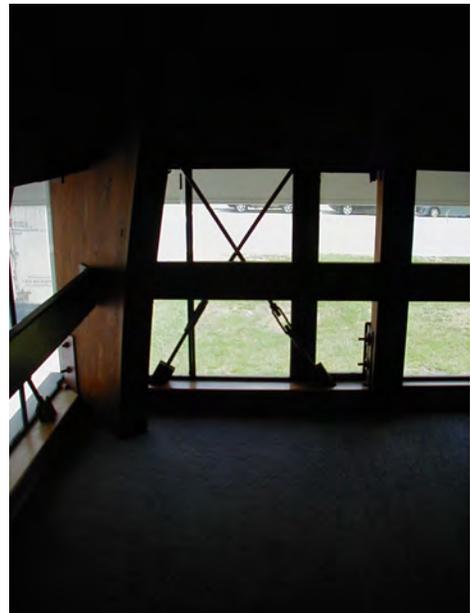
170511-P1010071.JPG

*Structural Reinforcements at Corners of 1971 Addition;
Steel Plates Below X-Bracing are Below Window Sills*

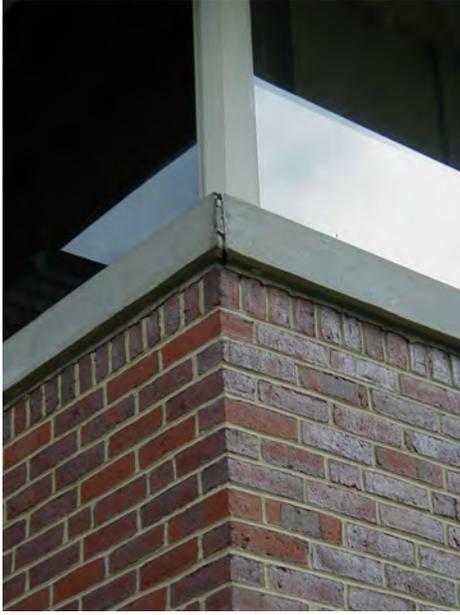
170511-P1010079.JPG

Open Joint in Continuous Window Sill at SW Corner of 1971 Addition; See Structural Info

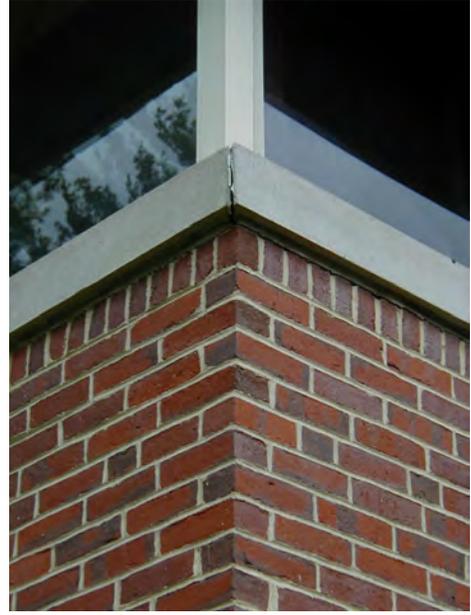
170511-P1010080.JPG

Open Joint in Continuous Window Sill at SE Corner of 1971 Addition; See Structural Info

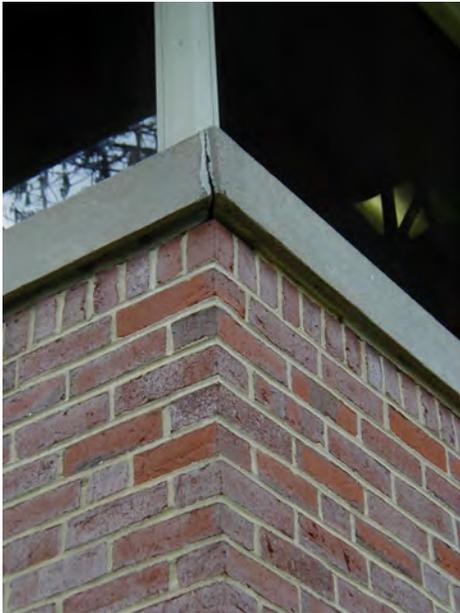
170511-P1010081.JPG

Open Joint in Continuous Window Sill at NE Corner of 1971 Addition; See Structural Info

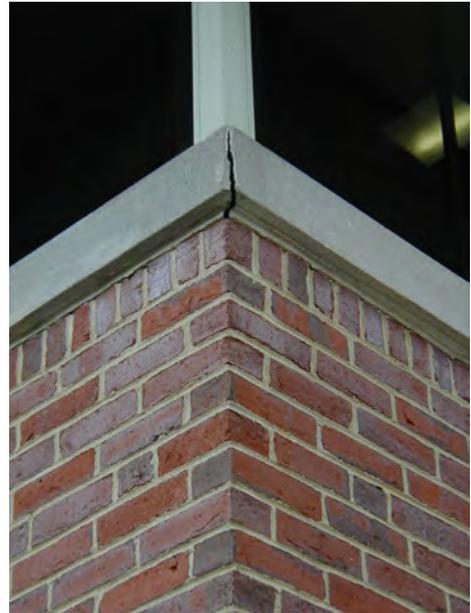
170511-P1010082.JPG

Open Joint in Continuous Window Sill at NW Corner of 1971 Addition; See Structural Info

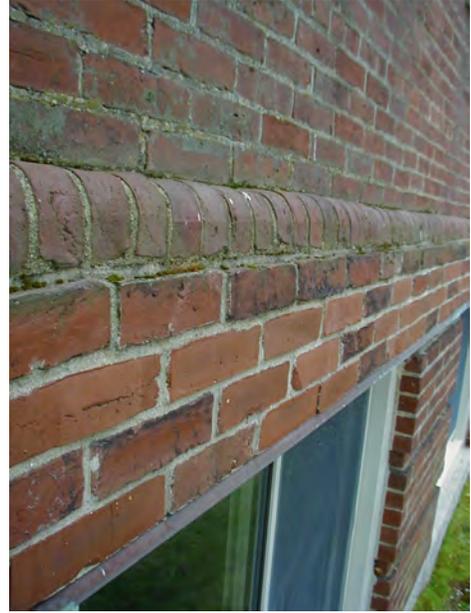
170511-P1010086.JPG

Detail of Watertable Brickwork at Front Facade (North) of 1910 Original School; Rebuilt Brickwork at Window

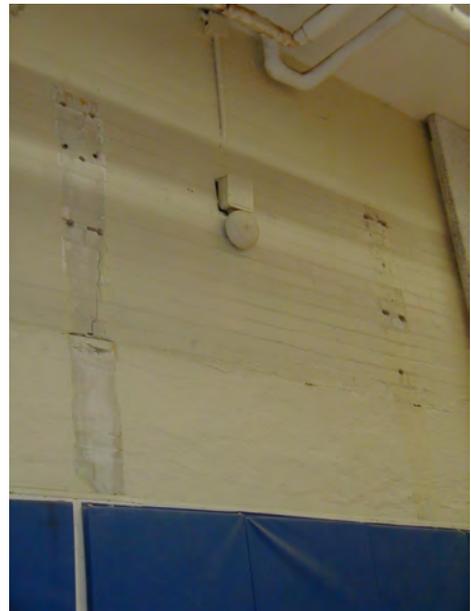
170511-P1010054.JPG

Holes in Masonry at Former Attachments of Basketball Backboard in Gymnasium

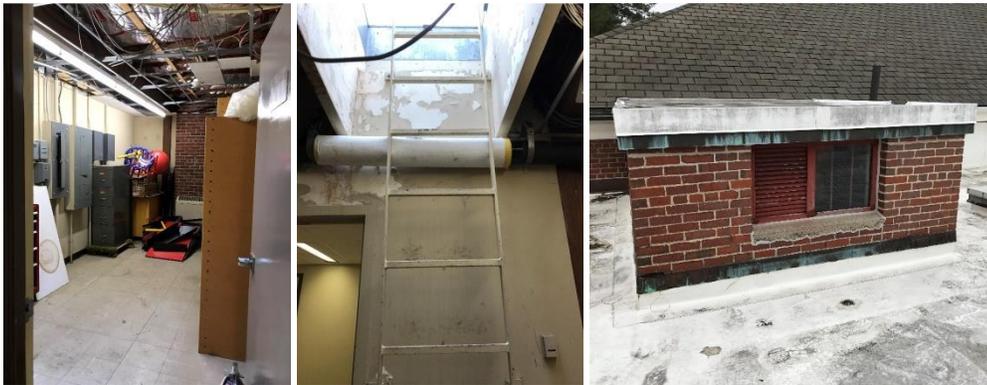
L&C- roof access. R- Elevator penthouse- old louvers and glass, no dampers.

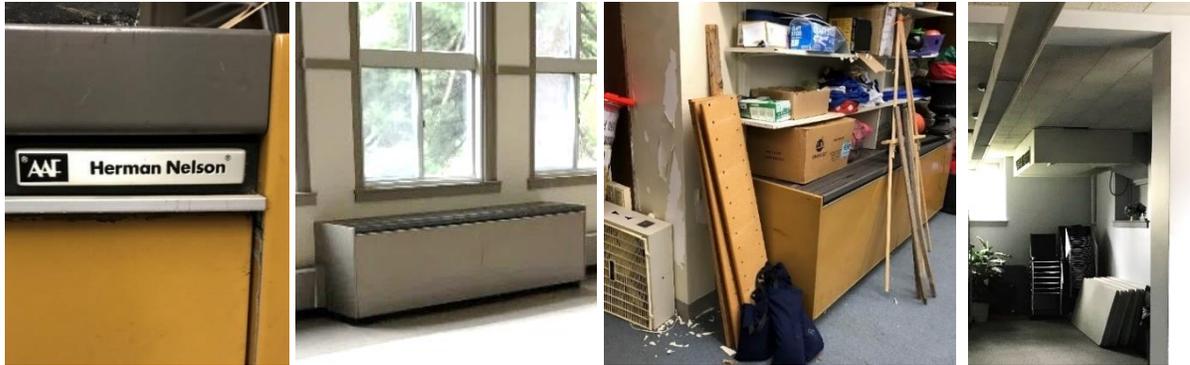
L- All unit ventilators (UV) are AAF Herman Nelson make installed in 1971. There are three basic types used CL- console type along perimeter wall with outside air (OA) louver directly behind, CR- console type in interior wall with OA shaft, and R- horizontal ceiling hung type.

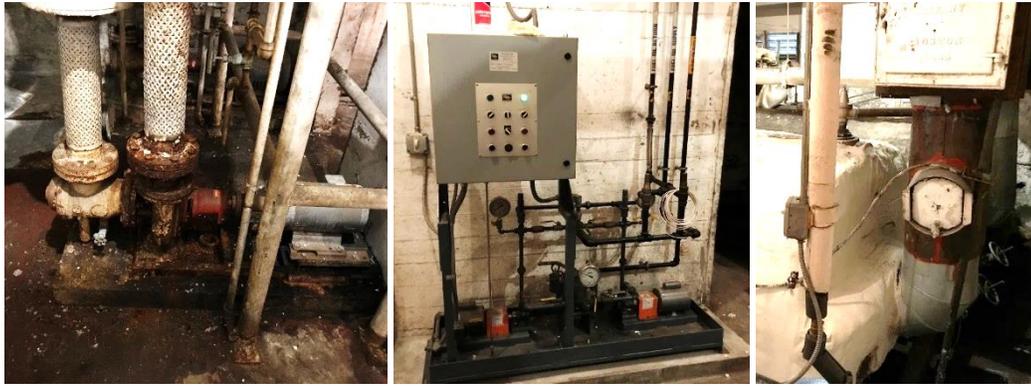
L- Hot water pumps are in very poor shape.
 C- duplex fuel oil transfer pumps appear to be reasonably modern and are in good shape. R- boiler breeching and draft damper looks to be in a fair shape; but this ties into the original 1910 chimney which is likely not lined.

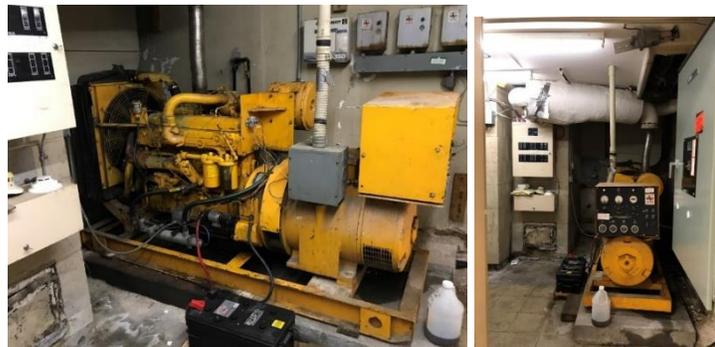
Inside diesel emergency generator with radiator venting and engine exhaust piping.

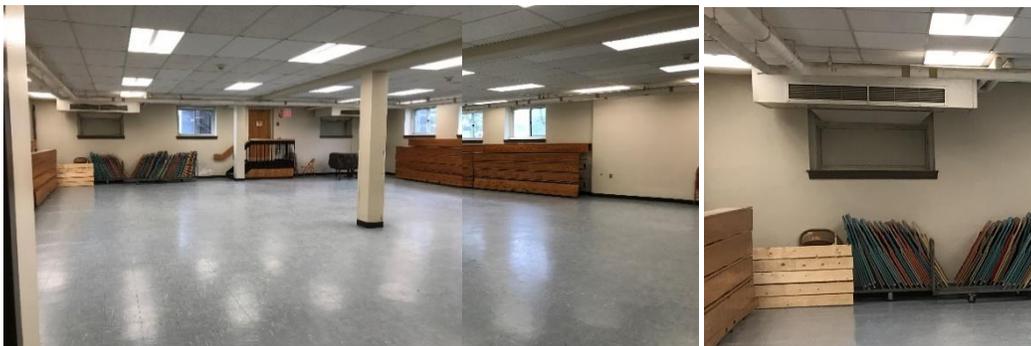
L- Cafeteria with folding bleachers on two sides, and direct exit on far side. R- close up view of the ceiling mounted UV.

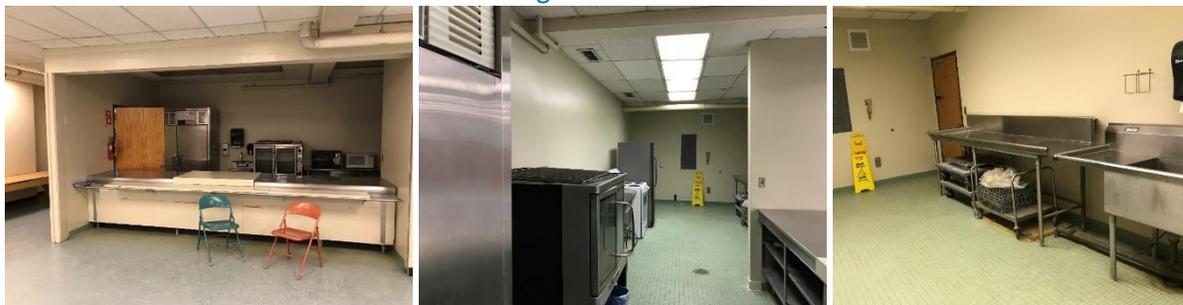
L- Servery to Kitchen. C- not hood over cooking line. R- pot wash station.

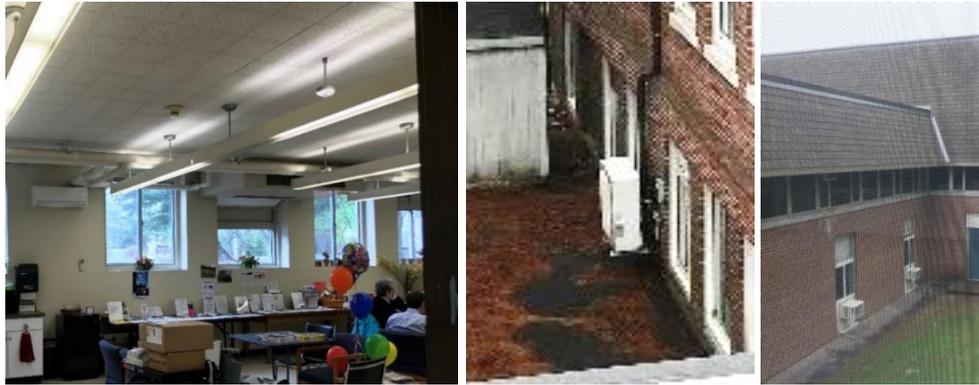
L- this office has a ceiling UV for winter heating, and a wall hung mini-split for summer. C- mini-split outdoor unit is wall hung. R- other offices have window AC units.

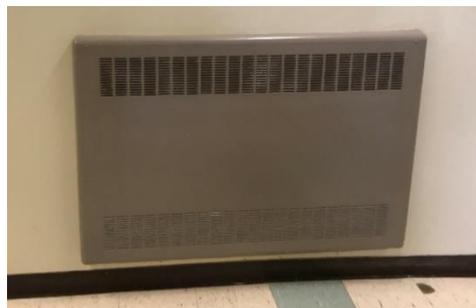
Corridors, offices, and general spaces are heated by convectors or fin tube radiation, and relies on operable windows for ventilation

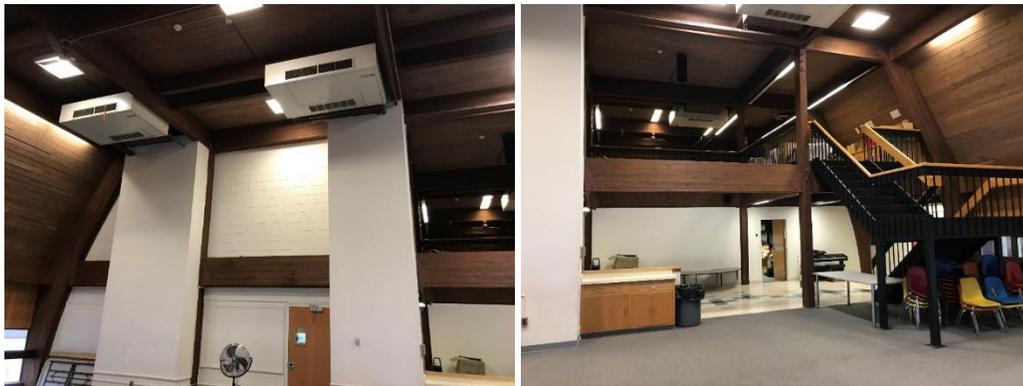
Former Library is served by ceiling hung UVs with OA intakes on roof

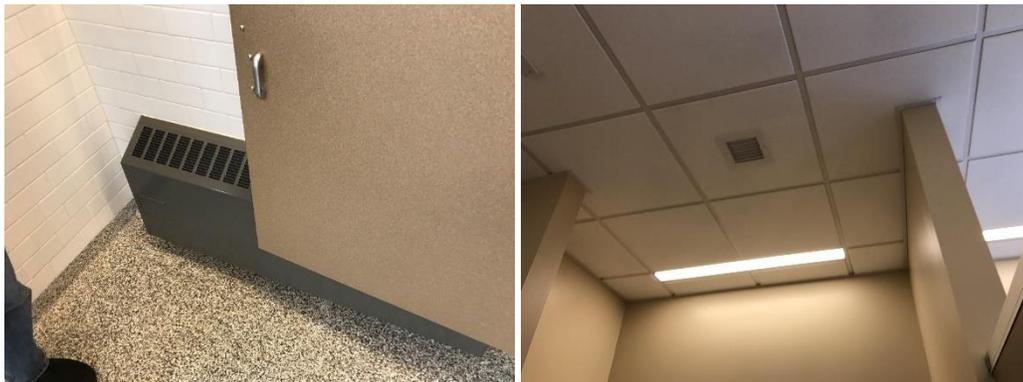
New FTR for heating, and new exhaust grilles are ducted to new roof exhaust fan.

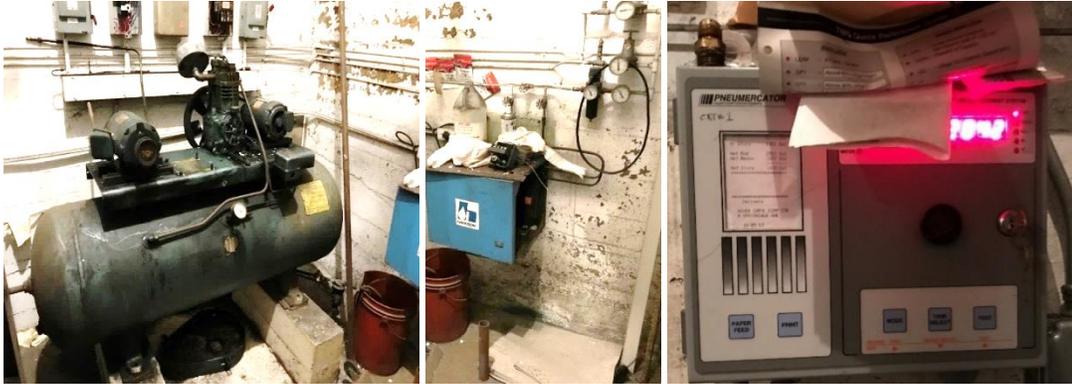
Pneumatic control compressor and dryer located in boiler room; note that one of the compressor has been removed.

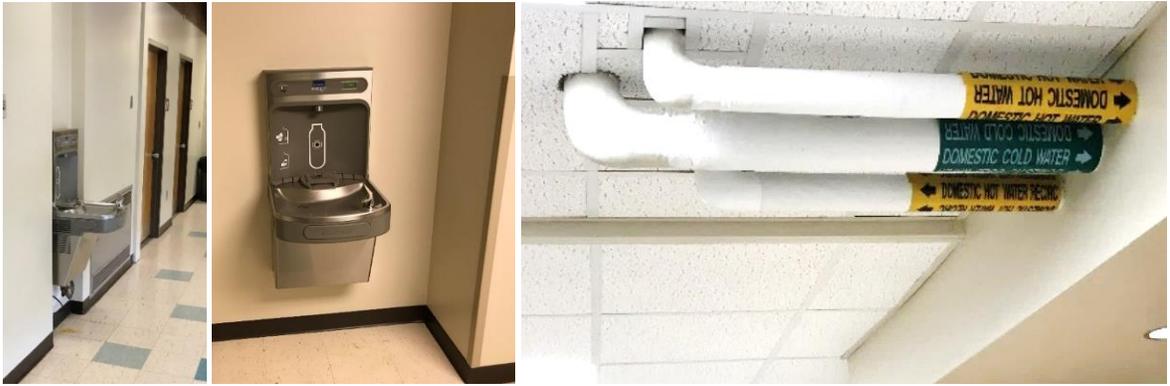
L- Water cooler. C- bottle filler. R- newer looking potable water piping exposed section showing newer insulation and labeling system, possibly suggesting that at least some parts of the piping may have been replaced.

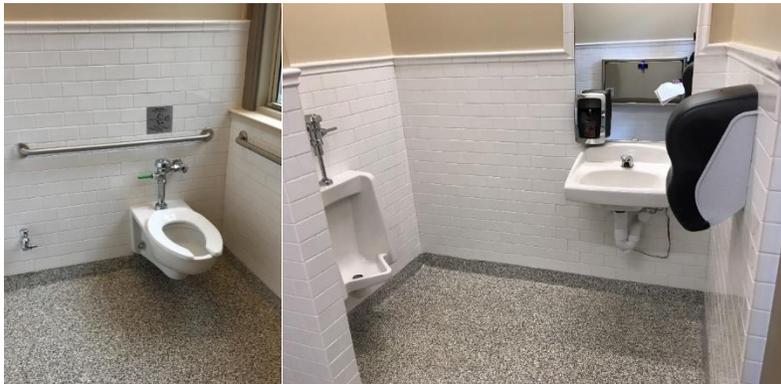
Renovated bathrooms. L- wall hung rear flush WC with dual flush flushometer; note the hose bib. R- urinal and Lavatory.

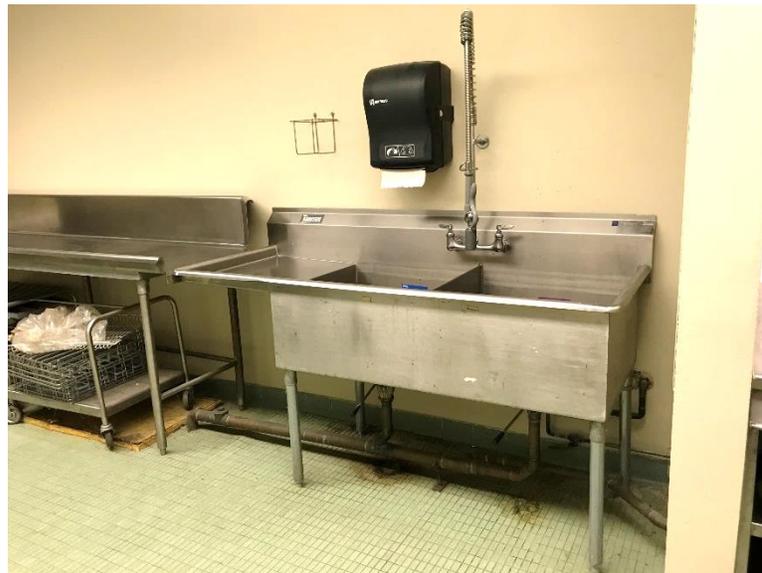
Kitchen pot sink with grease interceptor in floor.

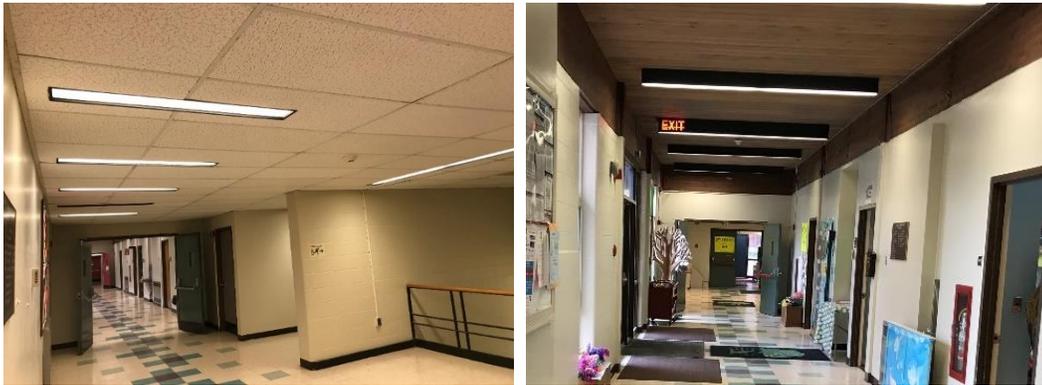
This building is not sprinklered, said to be exempt due to low water pressure

- a. Analysis by our Code consultant Robert Carasitti.
- b. MGL Chapter 148 Section 26g is applicable because this building is over 7,500 gsf. As an existing building, sprinklers would not be triggered until a project cause 33% of the area to be altered or they spend 33% of its assessed value. There is an exemption if there is no water pressure, but the Fire Chief would be the one to make the determination.

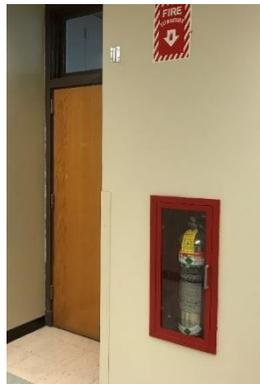
There are extinguishers throughout the building

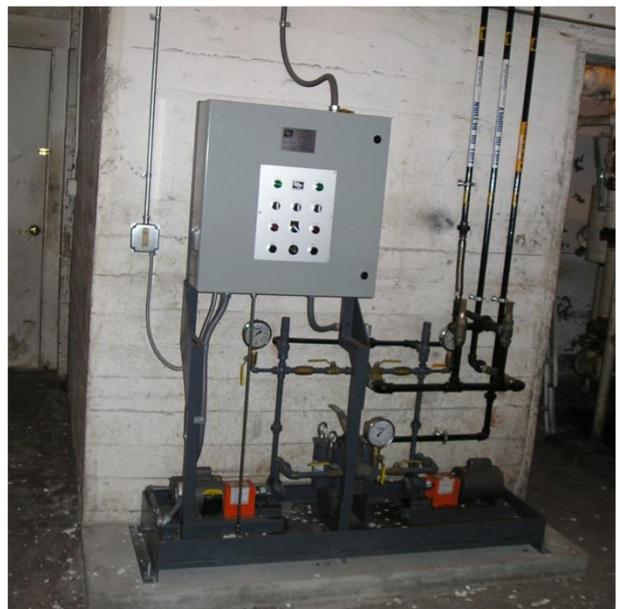
Heavily corroded existing valves

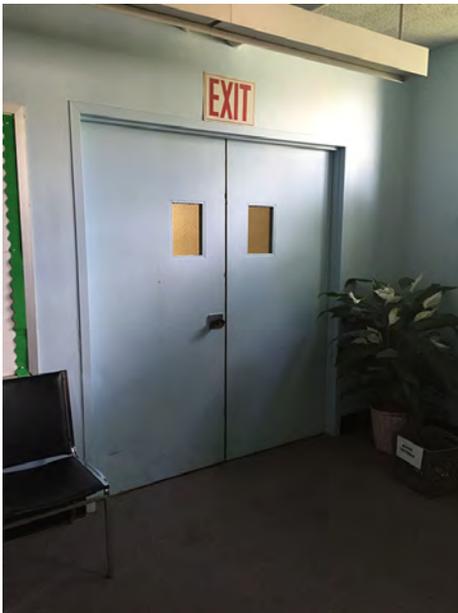
160609-IMG_4853.jpg

Locked Doorway to Blue Room Could Serve as Accessible Second Exit from Dining Room if Modified to be Double Egress Opening

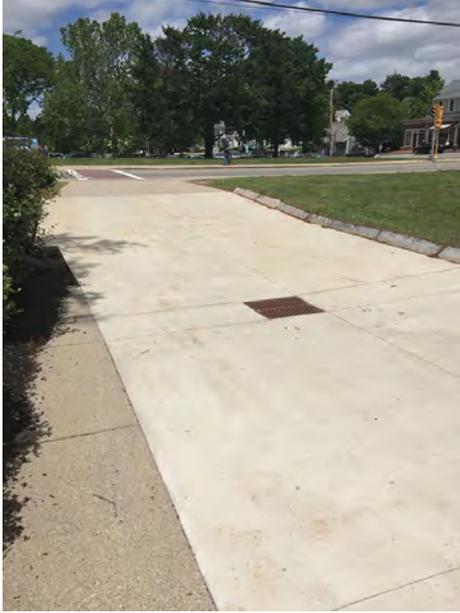
160609-IMG_4819.jpg

*Accessible Parking Space Adjacent to Front Entrance;
Both Spaces at Entry Creates Pedestrian Hazard*

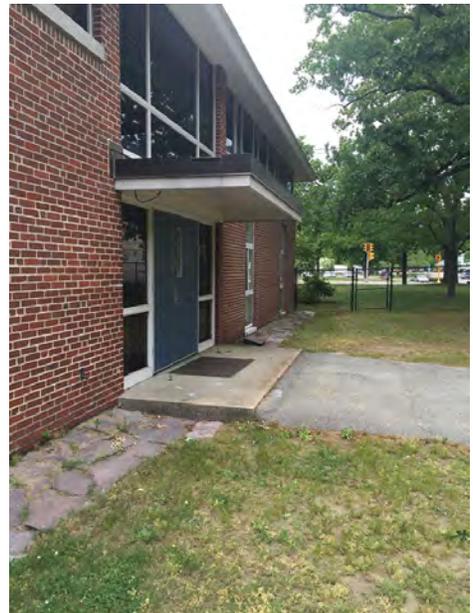
160609-IMG_4817.jpg

Steeply Sloping Walk at Blue Room Exit

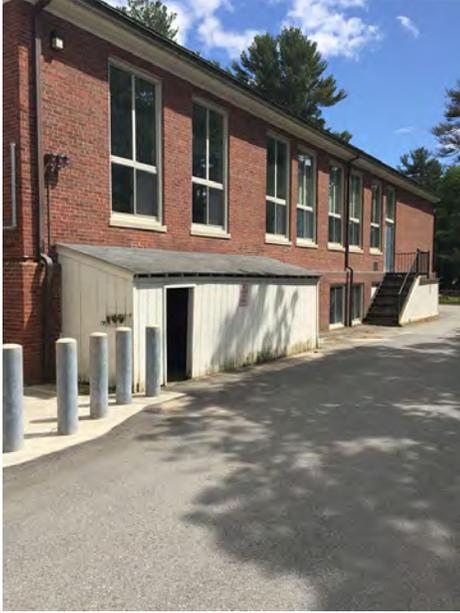
160609-IMG_4838.jpg

Door at Side Entrance Not Accessible Due to Limited Pull Side Clearance and Step Up at Door

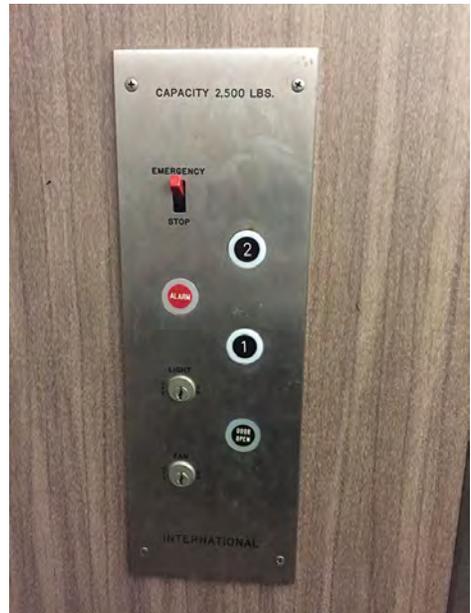
160609-IMG_4803.jpg

Cab Call Buttons Not in Compliance

1. *Upgrade deficiencies of the existing passenger elevator to bring into full compliance:*
 - a. *Provide hall and in-cab lanterns with visual and audible signals.*

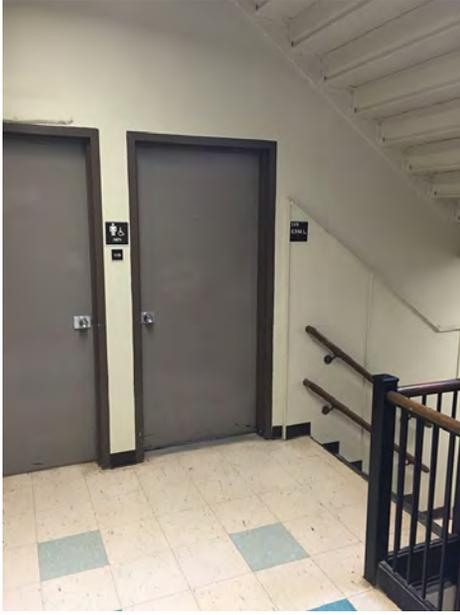
160609-IMG_4866.jpg

Proposed LU/LA Location at First Floor

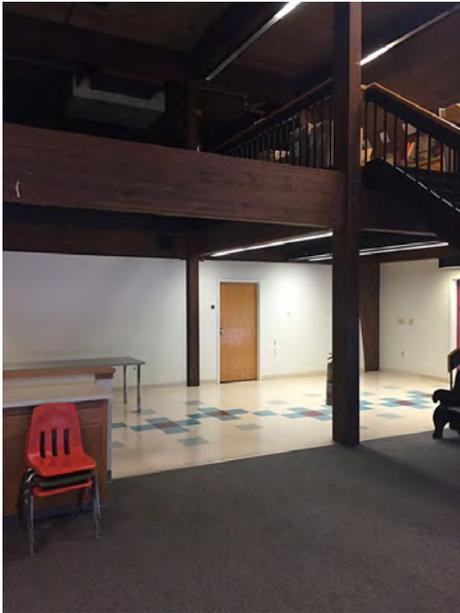
160609-IMG_4833.jpg

Library Area with Mezzanine Above

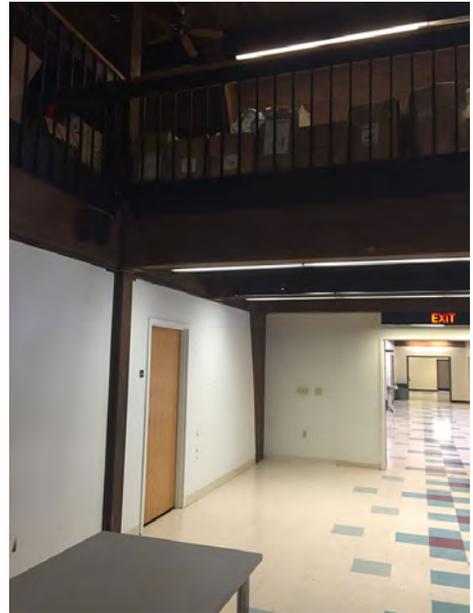
160609-IMG_4835.jpg

*Library Level with Mezzanine Above;
Proposed Location of Vertical Wheelchair Lift*

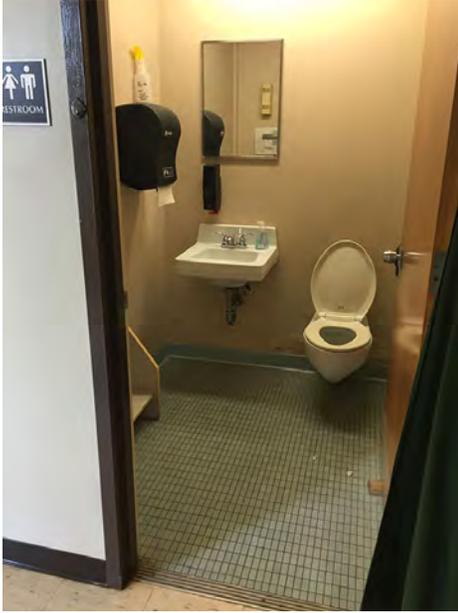
160609-IMG_4856.jpg

Single User Non-Accessible Toilet Room (1 of 4)

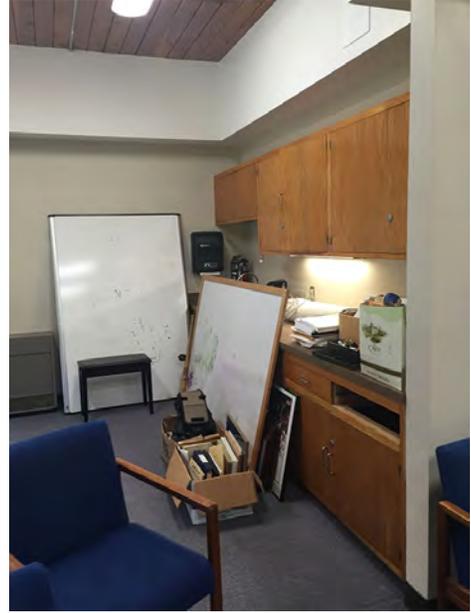
160609-IMG_4795.jpg

*Conference Room Kitchenette
for Staff Use Only*

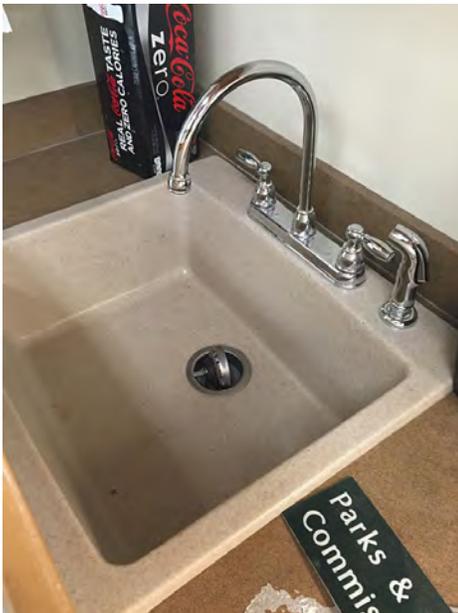
160609-IMG_4796.jpg

*Lever Handles and Gooseneck Faucet at
Conference Room Kitchenette*

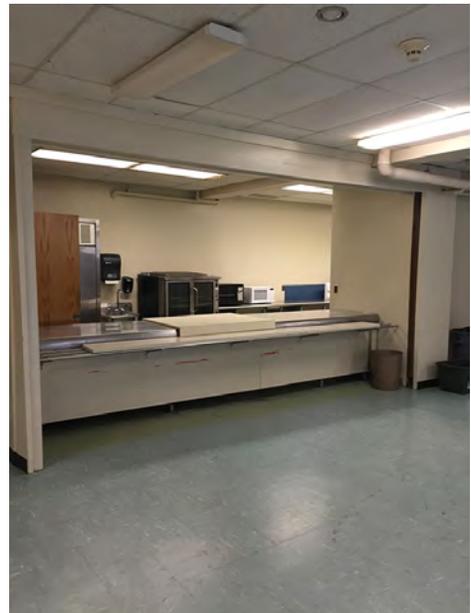
160609-IMG_4847.jpg

Dining Room Kitchen Serving Area

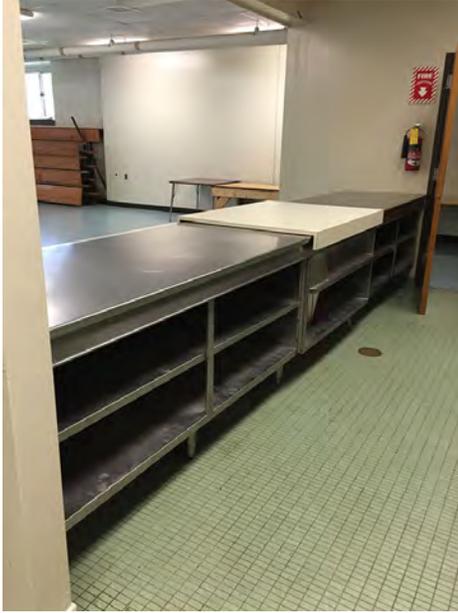
160609-IMG_4843.jpg

Serving Counter at Dining Room Kitchen

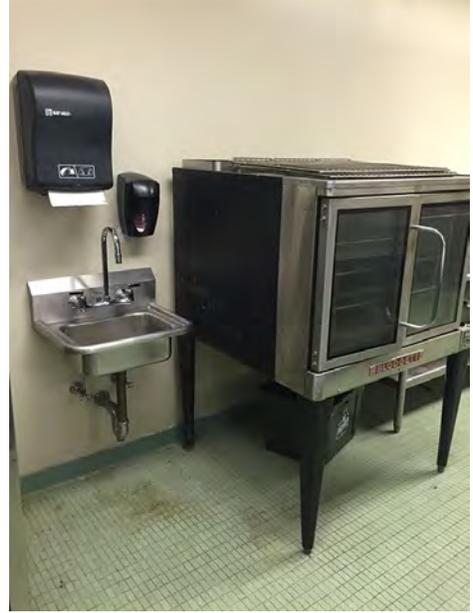
160609-IMG_4844.jpg

Hand-Washing Sink and Convection Oven

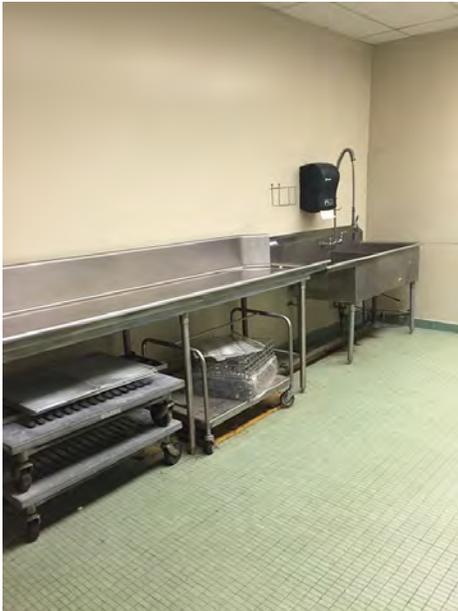
160609-IMG_4842.jpg

Dishwashing Station at Dining Room Kitchen

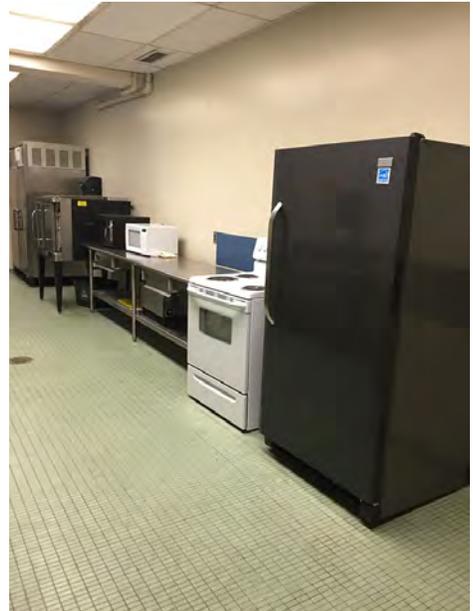
160609-IMG_4841.jpg

Residential Refrigerator & Range at Dining Room Kitchen

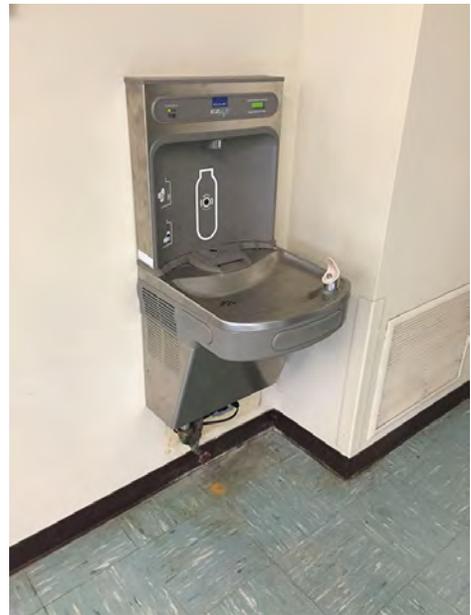
160609-IMG_4849.jpg

Accessible Drinking Fountain at Dining Room
